**System Failure – Anatomy of a Blackout
: Part I – Conditions Leading to the
Blackout**

Instructor: Lee Layton, PE

This course is based on a North American Electric Reliability Council report, Technical Analysis of the August 14, 2003 Blackout: What Happened, Why, and What Did We Learn? The Report has been edited for brevity and clarity for this course.

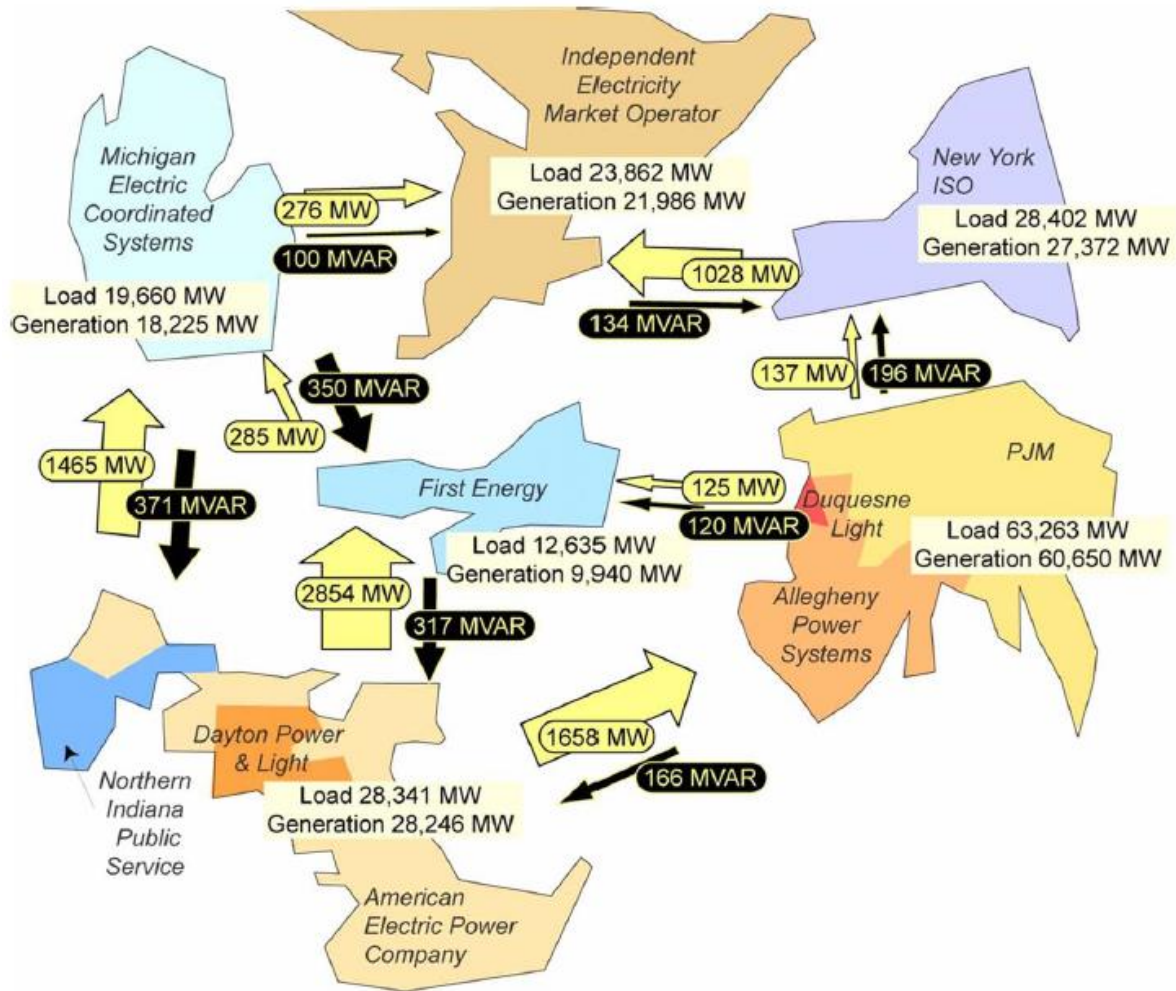
Figure 4 - Generation, Demand, and Interregional Power Flows on August 14 at 15:05

On August 14, the flow of power through the ECAR region was heavy as a result of large transfers of power from the south (Tennessee, Kentucky, Missouri, etc.) and west (Wisconsin, Minnesota, Illinois, etc.) to the north (Michigan) and east (New York). The destinations for much of the power were northern Ohio, Michigan, and Ontario, Canada.

While heavy, these transfers were not beyond previous levels or in directions not seen before. The level of imports into Ontario on August 14 was high but not unusually so.

Imports into the area comprising Ontario, New York, PJM, and ECAR on August 14 were near the peak amount of imports into that area although the August 14 imports did not exceed amounts previously seen.

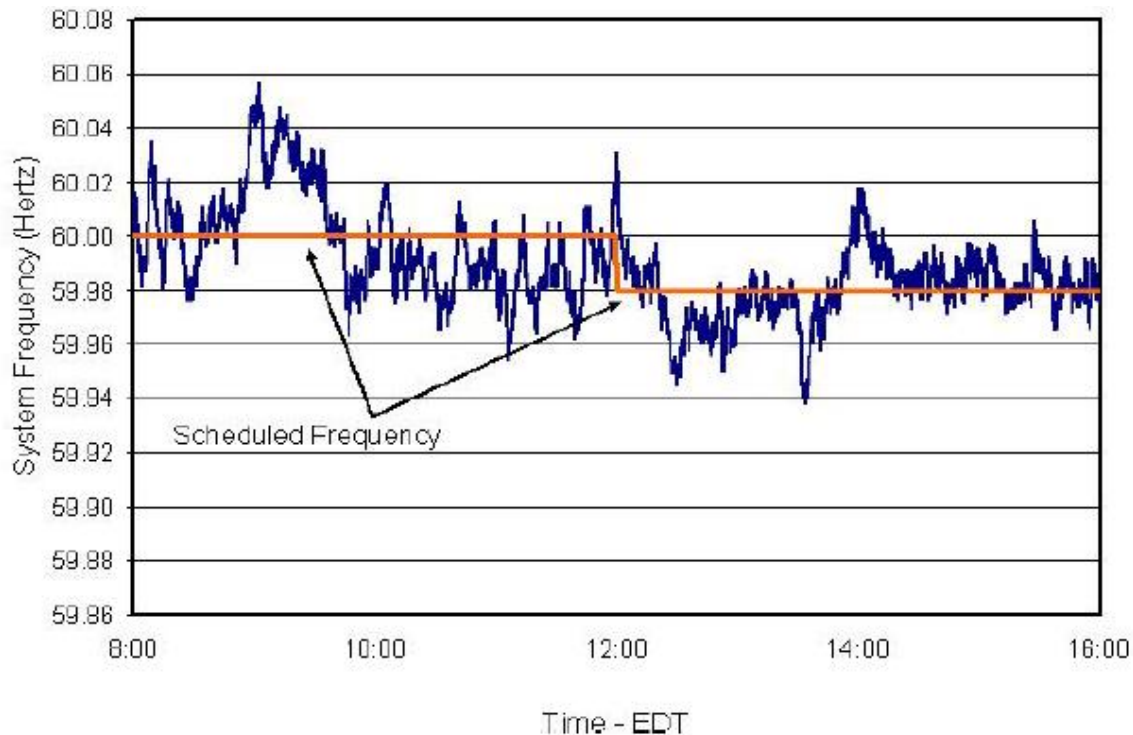
Figure 5 - Eastern Interconnection Frequency Plot for August 14, 2003

Figure 5 shows a plot of the frequency for the Eastern Interconnection on August 14. As is typical, frequency is highly random within a narrow band of several one hundredths of a hertz. Scheduled frequency was lowered to 59.98 at noon to conduct a time error correction. This is a routine operation. After the blackout, the frequency was high and highly variable following the loss of exports to the Northeast. Also, there appears to be a pattern relating to the times during which frequency deviations are larger.

System frequency anomalies earlier in the day on August 14 are explained by previously known interchange scheduling issues and were not a precursor to the blackout. Although frequency was somewhat variable on August 14, it was well within the bounds of safe operating practices as outlined in NERC operating policies and consistent with historical values.

Large signals in the random oscillations of frequency were seen on August 14, but this was typical for most other days as well, indicating a need for attention to the effects of scheduling interchange on interconnection frequency. Frequency generally appeared to be running high, which is not by itself a problem, but indicates that there were insufficient resources to control frequency for the existing scheduling practices. This behavior indicates that frequency anomalies seen on August 14 prior to the blackout were caused by the ramping of generation around regular scheduling time blocks and were neither the cause of the blackout nor precursor signals of a system failure. The results of this investigation should help to analyze control performance in the future.

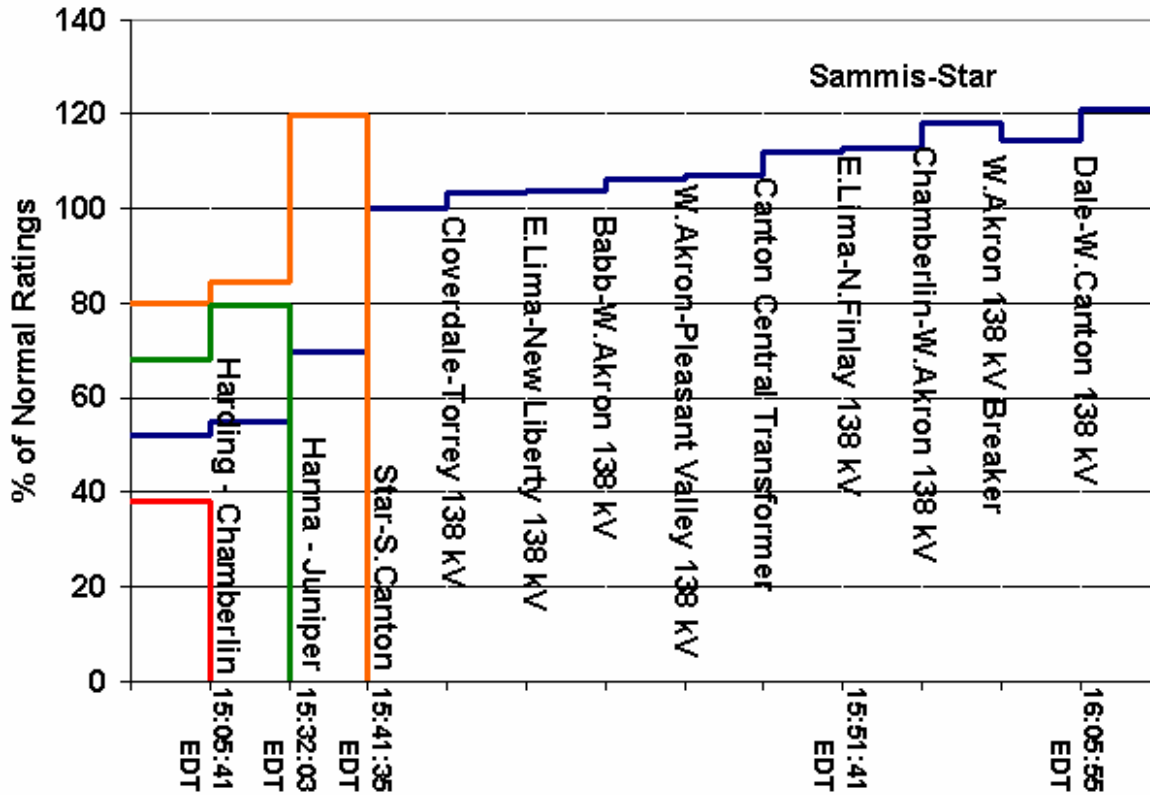
Figure 6 - Line Loadings as the Northeast Ohio 345-kV Lines Trip

Figure 6 shows the line loadings calculated by the investigation team as the 345-kV lines in northeast Ohio began to trip. Showing line loadings on the 345-kV lines as a percent of normal rating, the graph tracks how the loading on each line increased as each subsequent 345-kV and 138-kV line tripped out of service between 15:05 (Chamberlin-Harding) and 16:06 (Dale-West Canton). As the graph shows, none of the 345- or 138-kV lines exceeded their normal ratings on an actual basis (although contingency overloads existed) until after the combined trips of Chamberlin-Harding and Hanna-Juniper. But immediately after Hanna-Juniper was lost, Star-

South Canton’s loading jumped from an estimated 82 percent of normal to 120 percent of normal (still below its emergency rating) and remained at that level for ten minutes before tripping out. To the right, the graph shows the effects of the 138-kV line failures (discussed next) on the remaining 345-kV line, i.e., Sammis-Star’s loading increased steadily above 100 percent with each succeeding 138-kV line lost.
