Basics on Forensic Engineering - Part III

PRELIMINARY REPORT ON
ALLEGED DAMAGES TO A RESIDENTIAL WATERWELL AT
531 N.E. 37th STREET
POMPANO BEACH, FLORIDA 33064

FILE CASE #9367

DATE OF LOSS: 06-15-1993
DATE OF REPORT: 07-30-1993

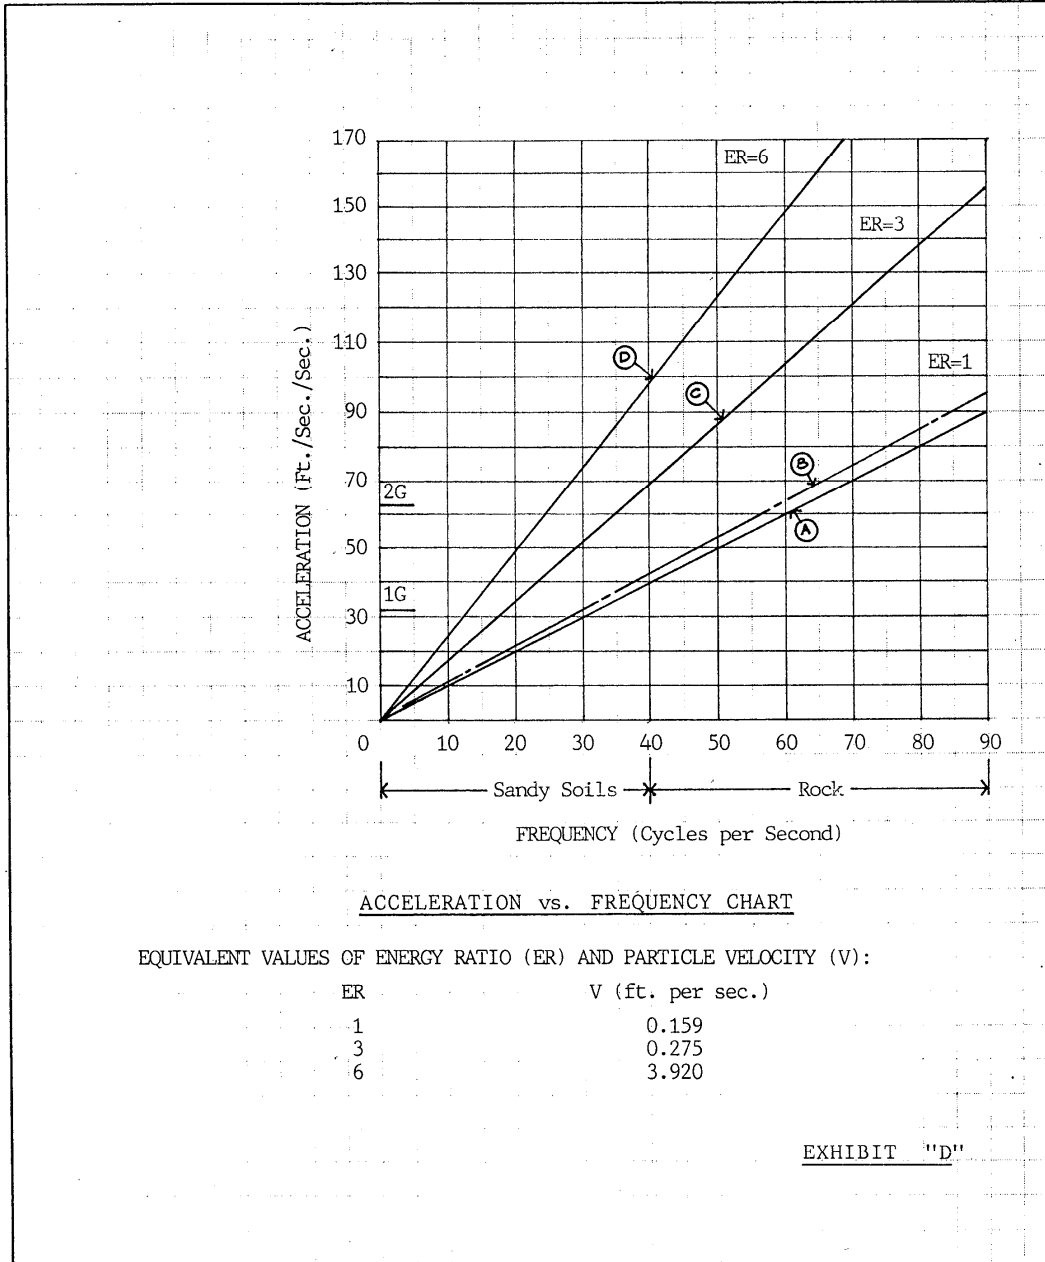
EXHIBIT "D"

ACCELERATION vs. FREQUENCY CHART

EQUIVALENT VALUES OF ENERGY RATIO (ER) AND PARTICLE VELOCITY (V):

ER	V (ft. per sec.)
1	0.159
3	0.275
6	3.920

If above ENERGY-RATIO values are plotted on the Acceleration vs. Frequency Chart on Exhibit "D", they will fall below line A, and are therefore, harmless to conventional construction.

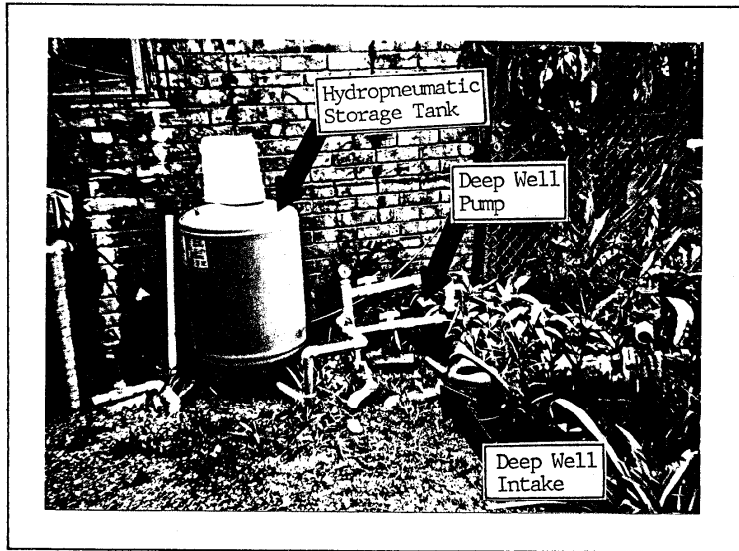
PICTURE No. 5

- 3.4 Our examination of the system resulted in the following observations:
 - 3.4.1 A 3/4 H.P., 115V, 6.2A pump serves the deep well.
 - 3.4.2 A short garden hose was used for the purpose of priming the pump and bypass the deep well, as can be seen on enclosed Pictures #4 and #5.

Subject Description: View of pumping equipment.

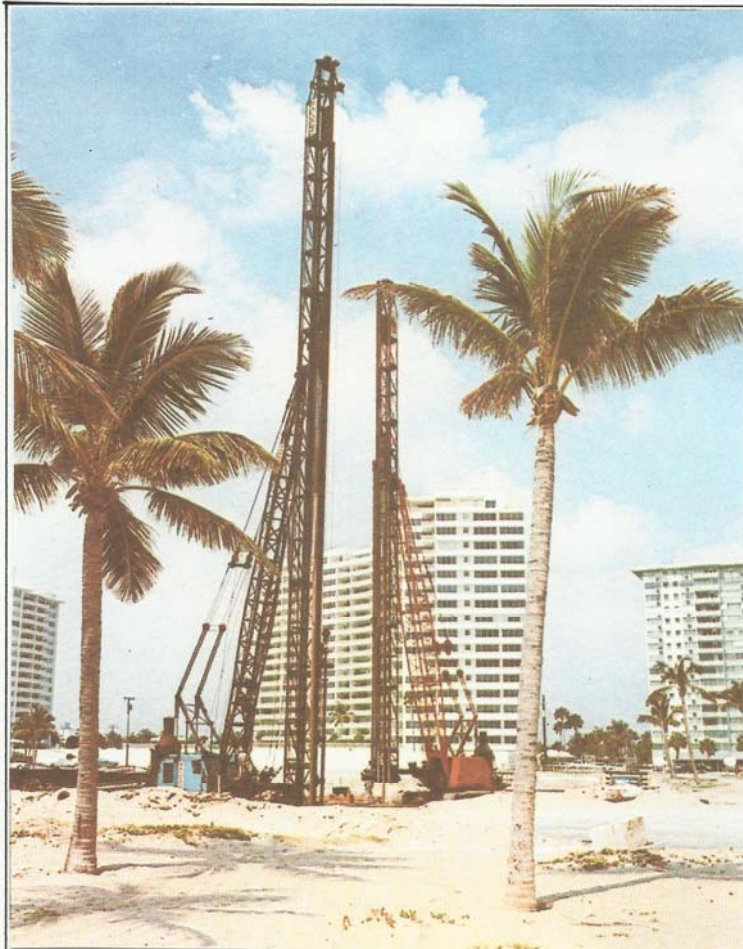
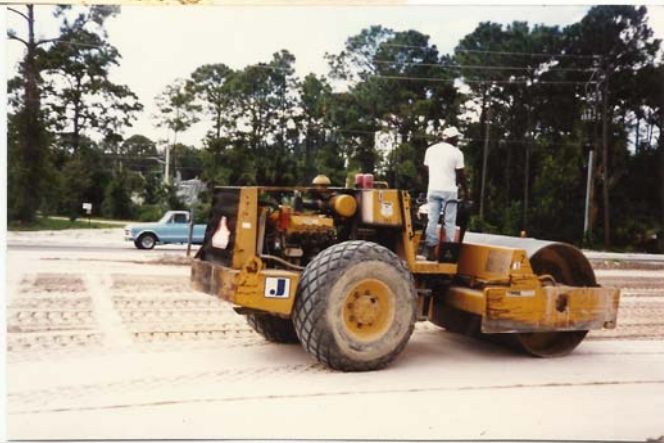
FIGURE 5.1

Enclosed Figure 5.1 has been assembled to show the two bullies of road and bridge construction. The upper picture shows two pile driving crawler rigs both equipped with a 14,000 pound diesel pile hammer, while the lower picture depicts a 24 ton vibratory roller. We have referred to them as “bullies” because that is what they really are, for they frighten the neighborhood residents but only in a few extreme cases have they lived up to the menacing image they project.

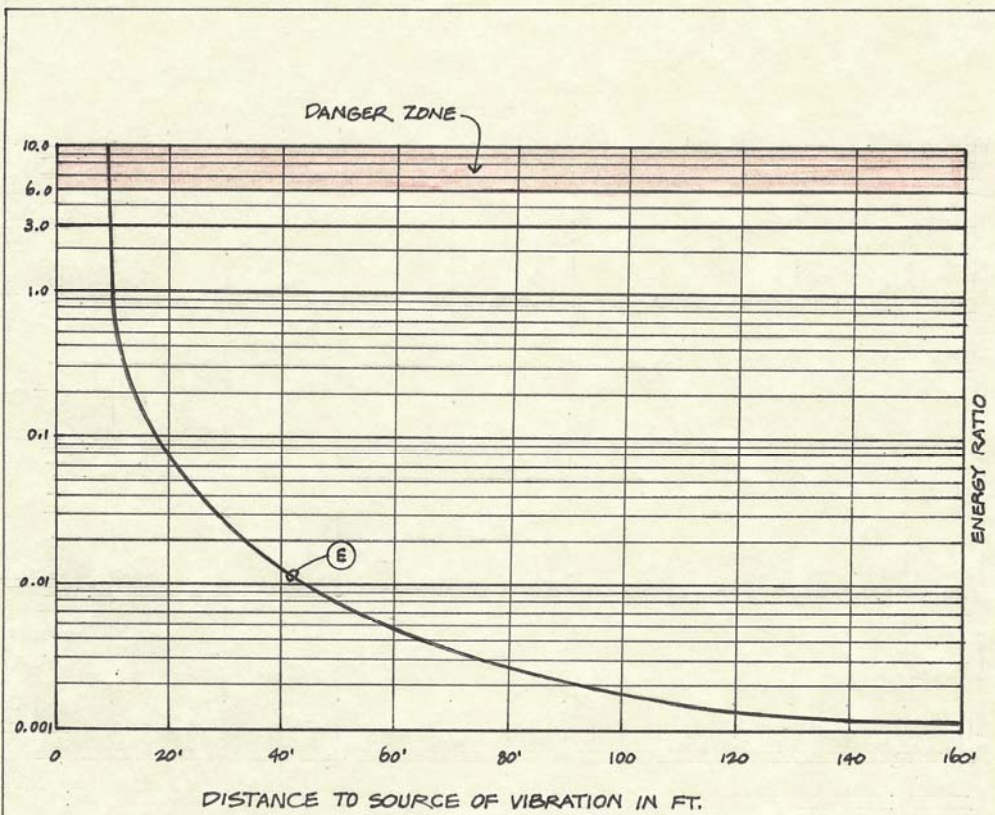
FIGURE 5.2

This graph is an extrapolation of the "Liberty Mutual's Graph" which was necessary to cover the 160 ft. from the vibration source to the deep well.

Applicability of this graph is limited to SANDY soils only.

All of the Energy-Ratio values shown on this course have been calculated by using the "Crandell's Formula": $ER = 39.47 \text{ times } "v" \text{ squared}$, where 39.47 is a constant and "v" is the "particle velocity".
