Ethical Issues from the Kansas City Hyatt Hotel Collapse (Live Webinar)

ETHICAL ISSUES FROM THE KANSAS CITY HYATT HOTEL COLLAPSE

In July 1981 the most disastrous structural engineering failure in U.S. history took place in Kansas City. Two interior walkways in the lobby atrium collapsed at the recently constructed Hyatt Regency Hotel in Kansas City, with a resulting loss of 114 lives and injuries to 200 others. This is the story of that tragic event.

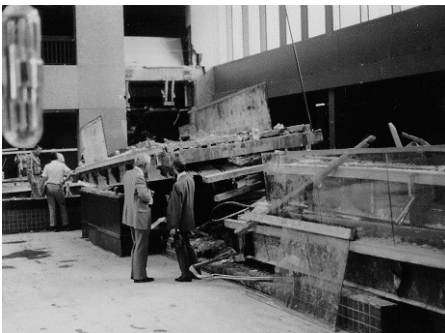
□ Here is what the incident scene looked like....

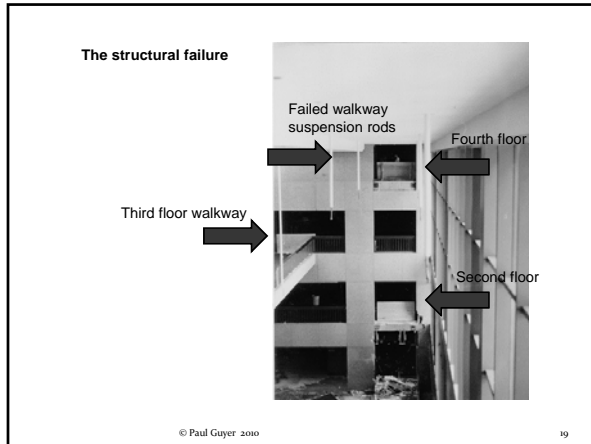
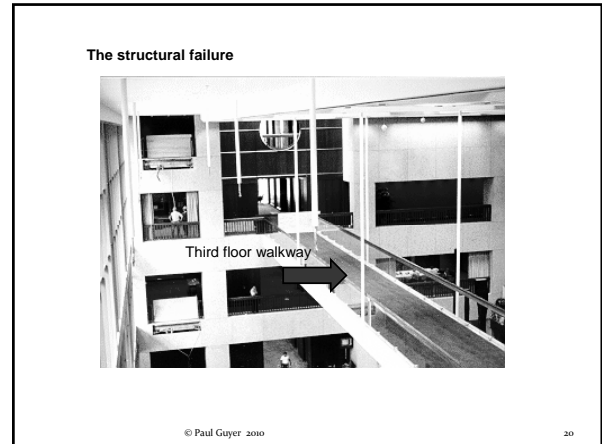
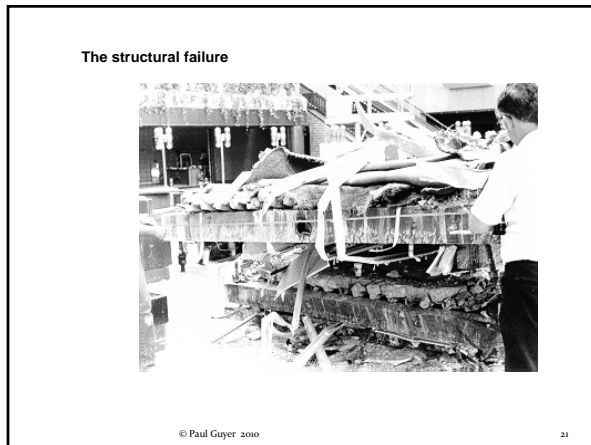
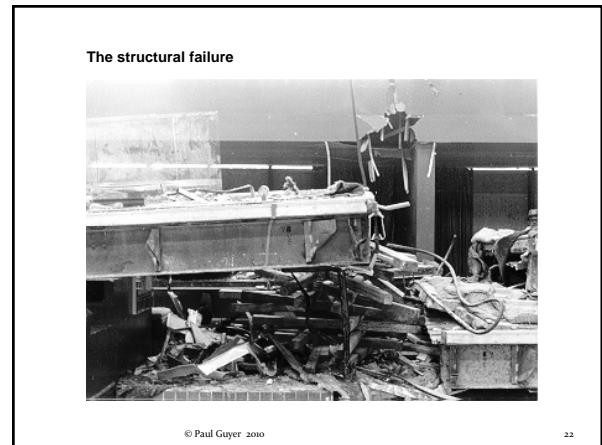
- ❑ What went wrong?
- ❑ One theory suggested at an early stage was that the people dancing on the fourth floor walkway induced harmonic vibrations that reached critical amplitude that resulted in failure. This theory was disregarded when evidence of a different cause became apparent.
- ❑ The cause of the failure was a change made by the steel detailer (WRW, a sub-contractor to Havens, which in turn was a sub-contractor to Eldridge) to the suspension rods design shown on the structural engineer Gillum's drawings.
- ❑ Why did WRW, at Haven's instigation, make this change? Because of two *constructability* issues....

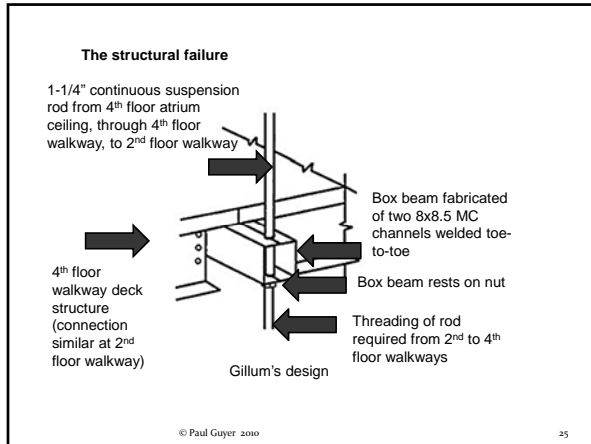
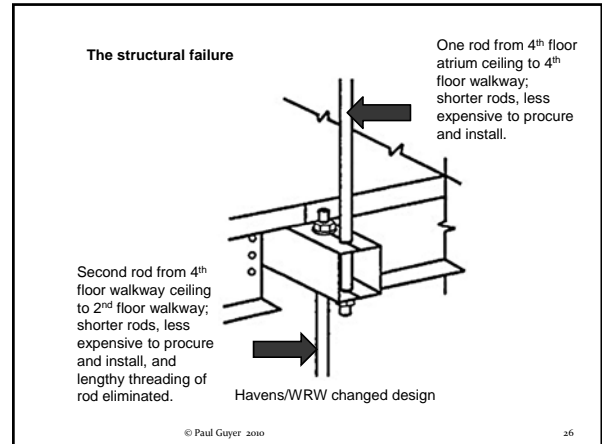
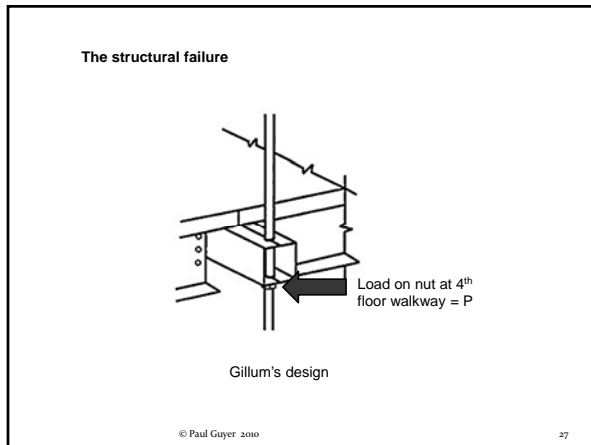
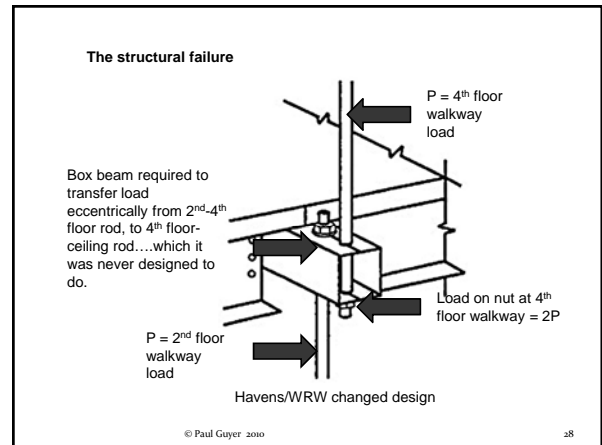
- ❑ First, the Gillum design required continuous suspension rods approximately 40-feet long. Havens determined these would be unacceptably expensive to procure and install.
- ❑ Second, the suspension rods would have to be threaded for approximately 30-feet of their length in order to install the nut on the rod that supported the fourth floor walkway. This was determined by Havens to be unacceptably expensive to fabricate and install.
- ❑ This is the change WRW/Havens made to Gillum's design....

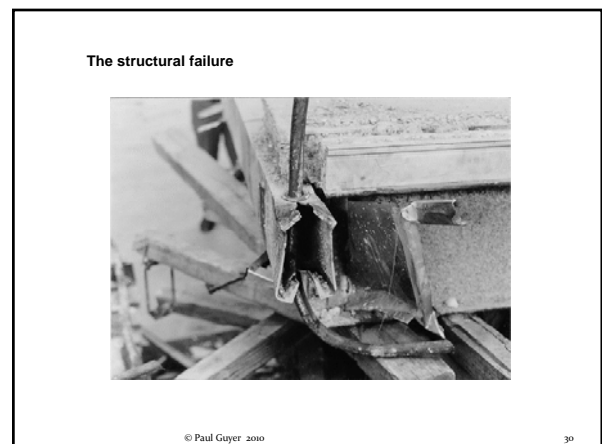
- And there was an additional consideration: Gillum's original design sized the suspension rods such that they were strong enough to support only 60% of the imposed load....based on code-allowable stresses.
- But given the difference between code-allowable and yield stresses of the materials....was this a fatal error?
- And here is what happened....
