Basics on Forensic Engineering - Part IV

PRINCESS ORCHARD PARKING GARAGE FAILURE

Ruben A. Gomez, P.E.
Forensic Engineering Corporation

Date of Loss: October 5, 1993
Date of Report: July 13, 1996

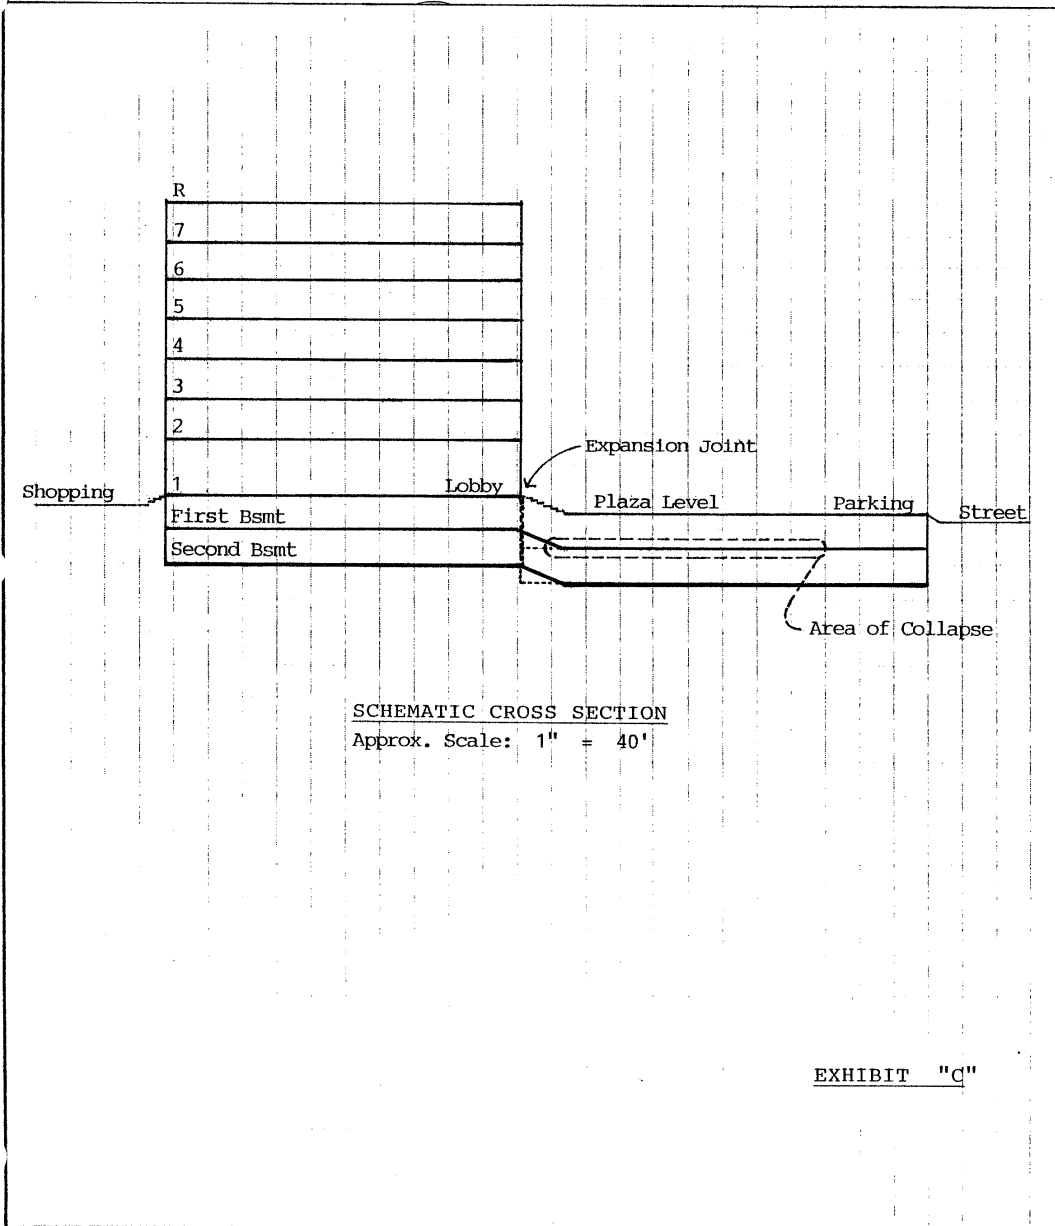
EXHIBIT "C"

3.7 The extent of the collapsed slab area were described in both, elevation and plan views, as they appear depicted herein on enclosed Exhibits C and D.

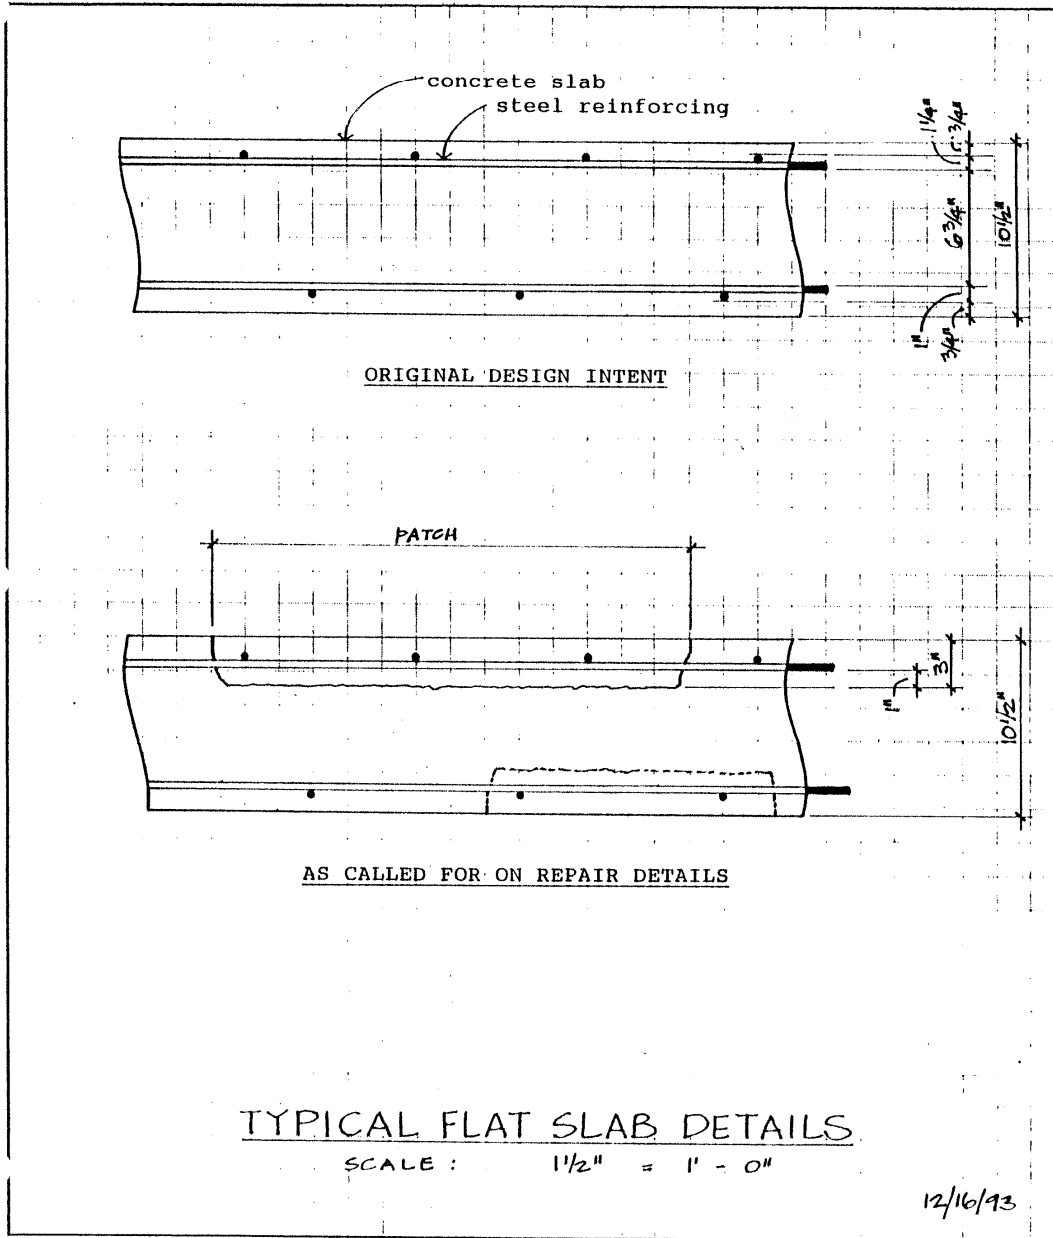
EXHIBIT "F"

3.10 Exhibits E and F were prepared to compare the proverbial *as designed vs. the as built* conditions. The comparison between the two came to show a loss of 1¼ in. in *effective depth*, not only having exceeded construction tolerances, but with the resulting loss in slab flexural capacity of some 20% in the best of scenarios.

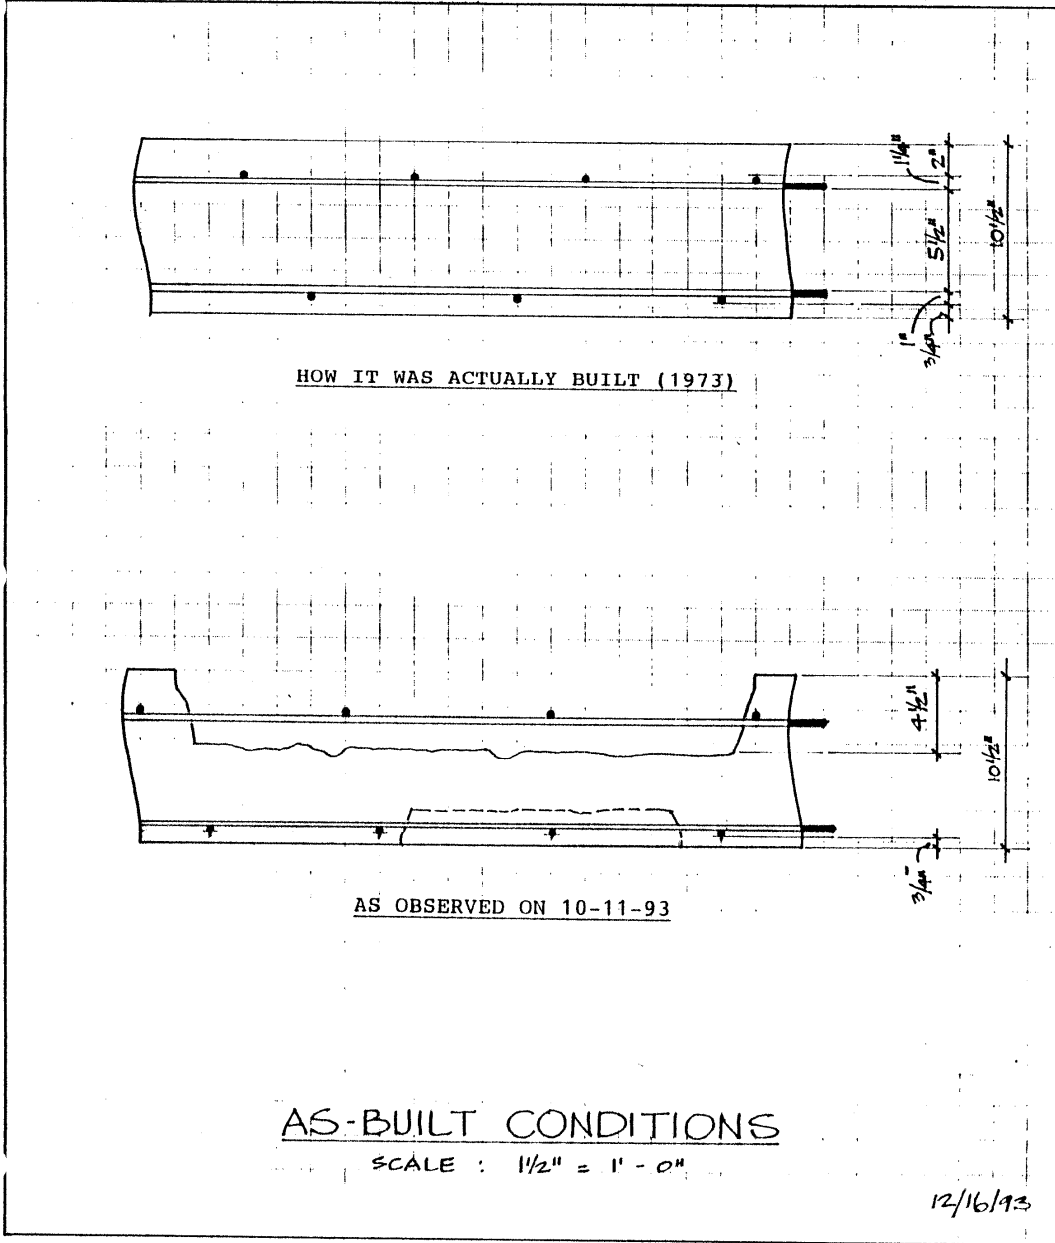
EXHIBIT "G"

4.2 Typical bays were selected in the vicinity of the loader location (see Exhibit G). Static and dynamic loading models were used in the determination of critical

On the other hand, our calculations indicated that the tensile strength in sections marked as C on the enclosed Exhibit G, should have reached a value of 273 PSI under static loading, which was three (3) times higher than the predicted ultimate tensile stress.

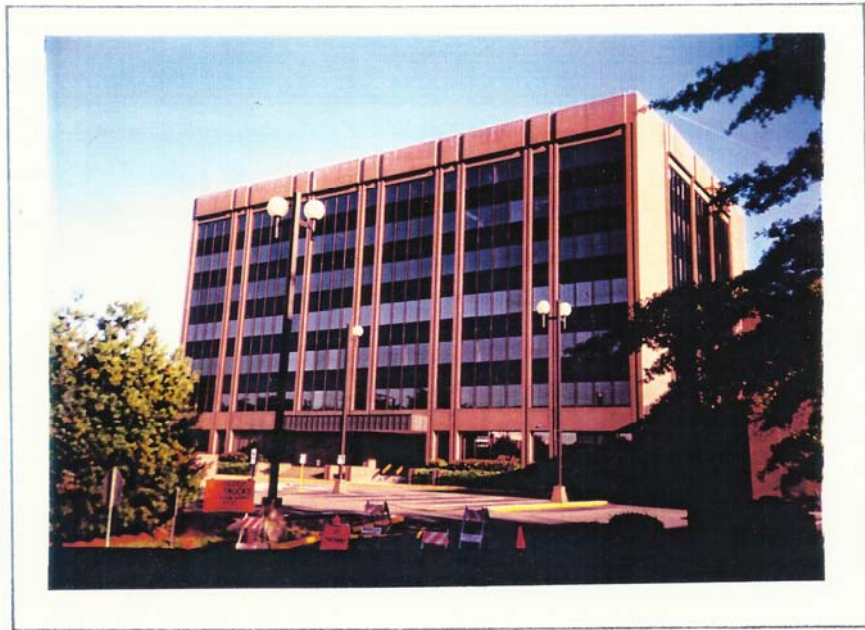
PICTURE #1

Office tower and plaza level as seen from Bank Street.

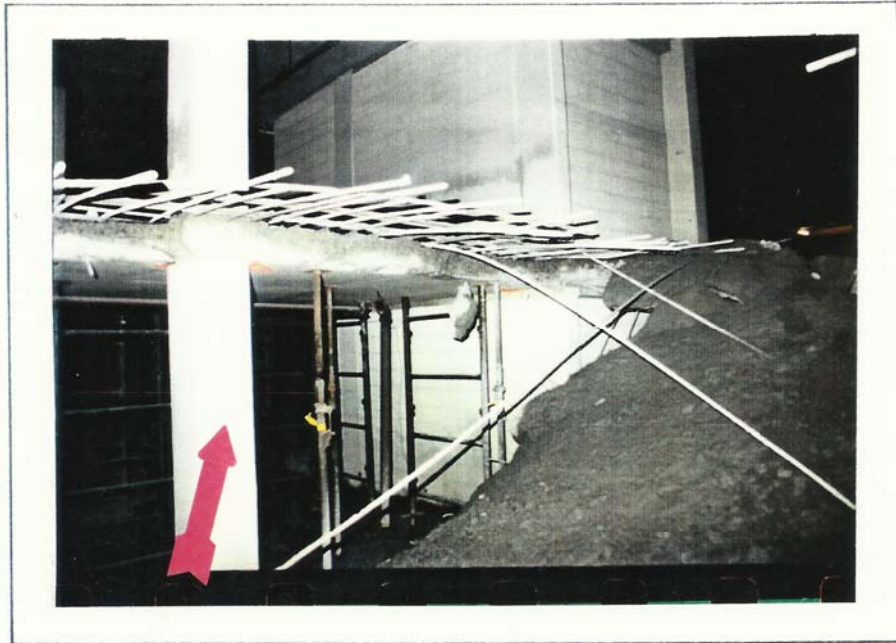
PICTURE #2

3.9 Our examination of the collapsed area, as shown on Exhibit D, was as thorough as the prevailing conditions allowed at the time. Of all conditions observed, two were of particular interest to us: a) a sheared off portion of the slab adjacent to the stairway and between columns M-4 and N-4, the exposed concrete coarse aggregate showed all the characteristics of being of the lightweight type. That was the first news for us, for nobody ever mentioned it before in all our inquiries. The second condition had to do with the fact that on the same column strip, concrete had been removed by the demolition subcontractor from both top and bottom layers, thus reducing the overall slab concrete thickness from 10½ down to an un-reinforced concrete core of just 5½ inches and technically unable to carry its own weight. Even worse, there was no evidence of even an attempt to shore the area to avoid what became the unavoidable result of such negligent act.

View of sheared concrete slab adjacent to stairway.
Arrow points at column marked M-4.

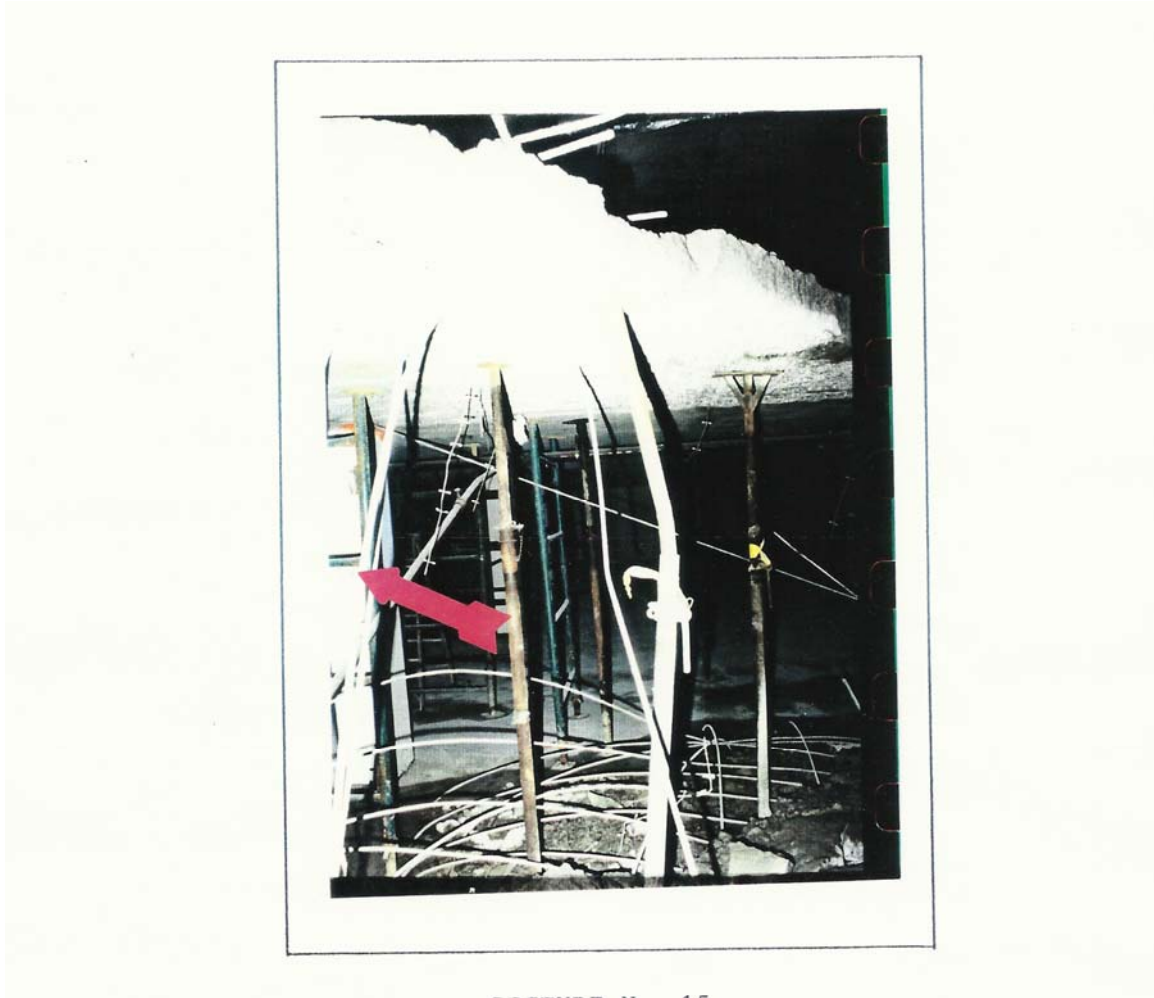
PICTURE #3

3.11 At first look, shoring seemed to be light and sparse enough to be of serious concern, some of the few visible shoring posts had buckled (see Picture #3) under the severe overload. As we walked deeper into the rubble, shoring became non-existent at the most critical areas. Approved shoring plans were unavailable at the contractor's site office, therefore, we requested from the contractor to furnish us with a set of those plans.

Area of failed slab which had been stripped off both top cover and bottom soffit.

Arrow points at column marked L-4.

Shoring on foreground had buckled under concrete weight.
