**PDHonline Course M399 (4 PDH)**

# **Plastics Fundamentals: Properties and Causes of Failures**

*Instructor: Semih Genculu, P.E.*

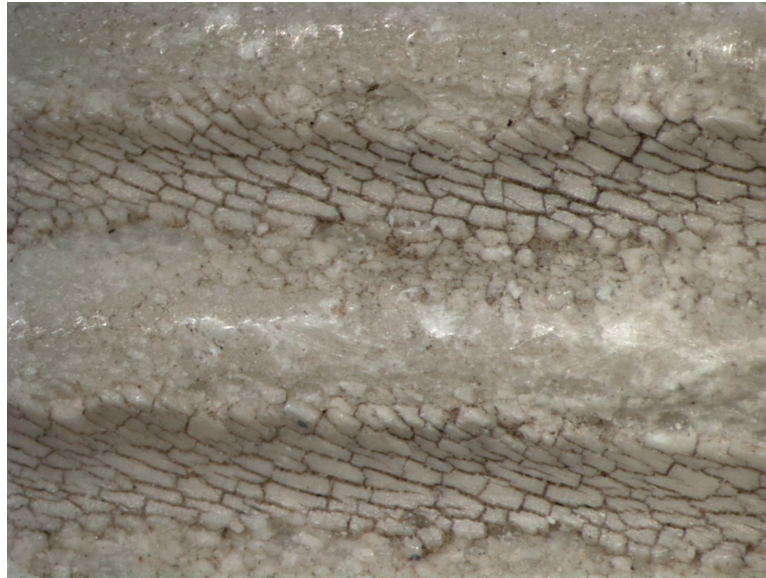
***Photograph showing an oxidized/degraded surface due to natural weathering***

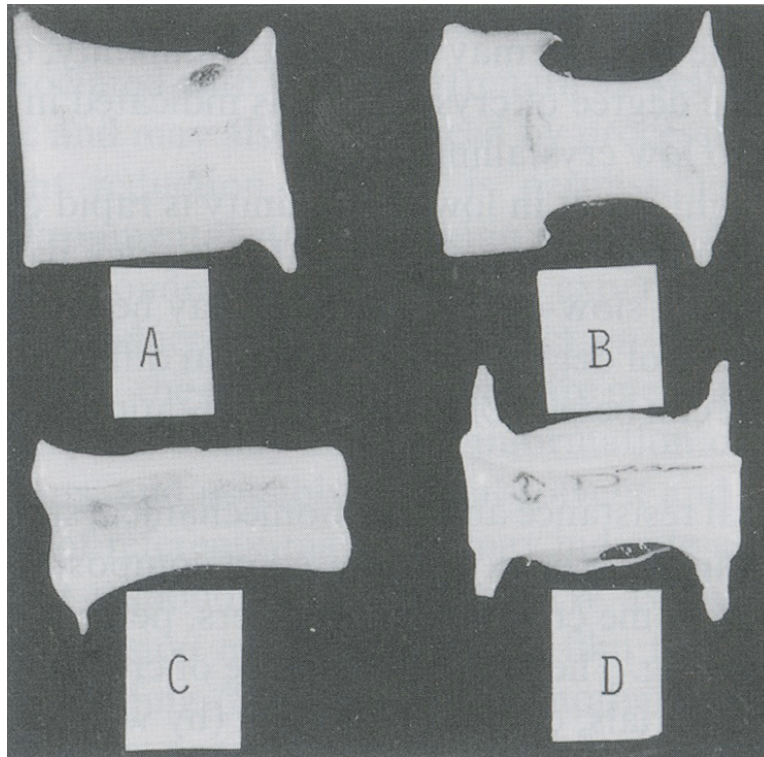
***Heat-shrunk PE samples (originally 1"x1") showing various degrees of frozen-in stress (the higher the shrinkage the higher the frozen-in stress, making them susceptible to failure in service)***

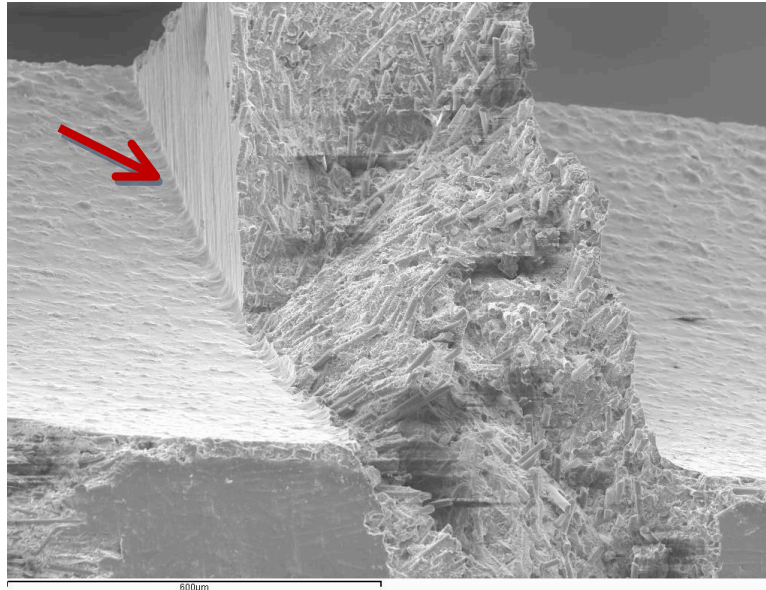
***A gear tooth fractured at its root where the sharp transition acted as a stress concentrator***

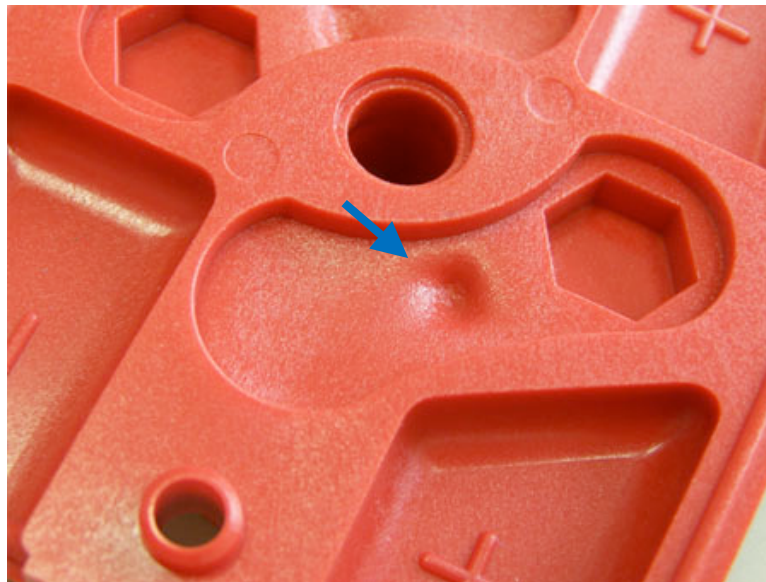
***Photograph showing a sink mark***

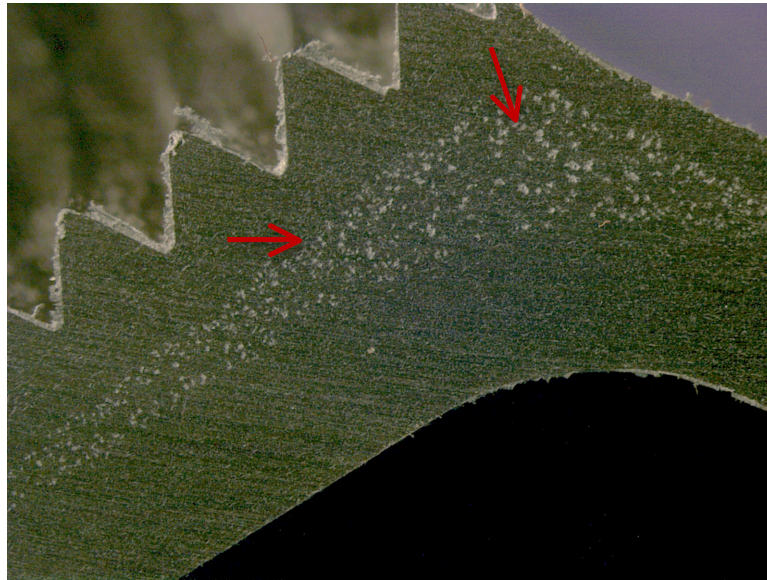
*Cross section of a threaded part showing voids (arrows)*

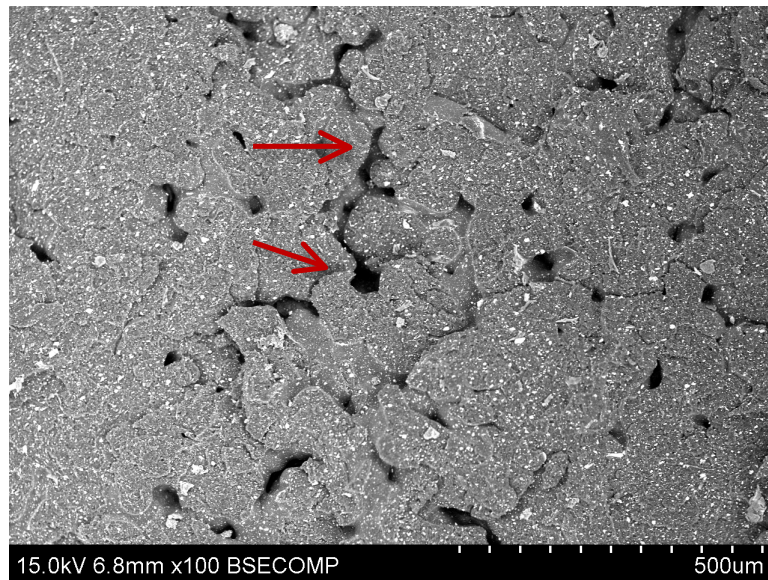
*SEM image showing voids on a fracture surface*

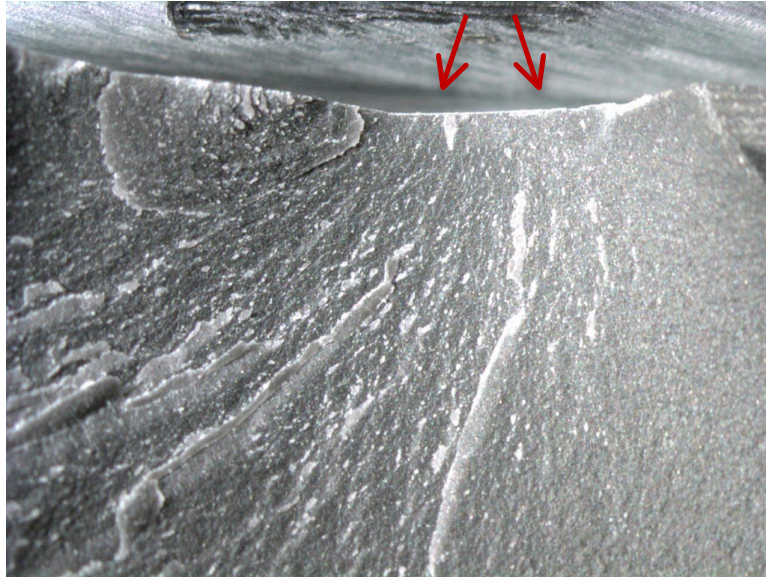
***Fracture surface with chevrons pointing back to the origin***

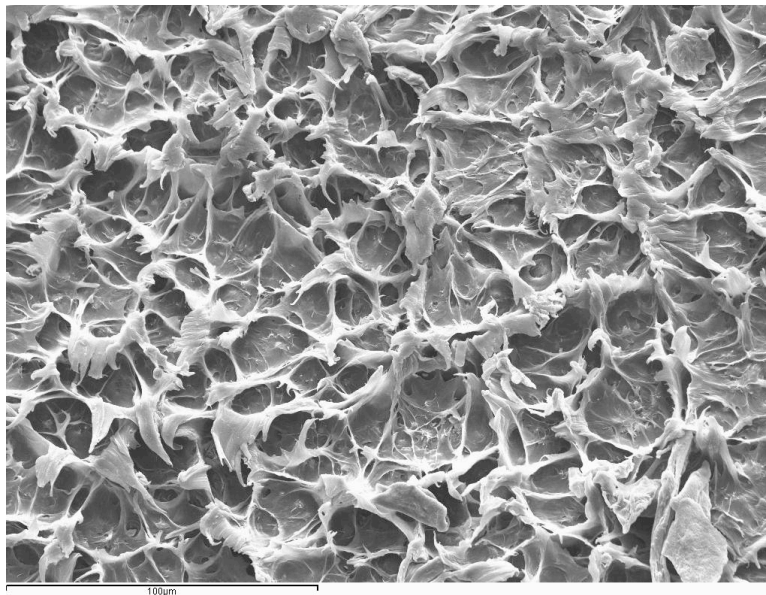
***Fracture surface showing ductile fibrous features***

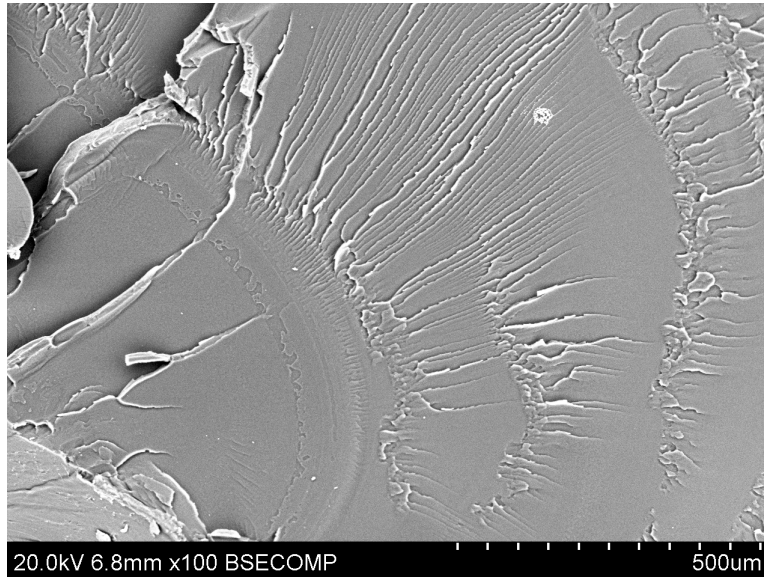
***Fracture surface of an impact failure showing mirror and mist areas, rib markings, wallner lines and hackles***

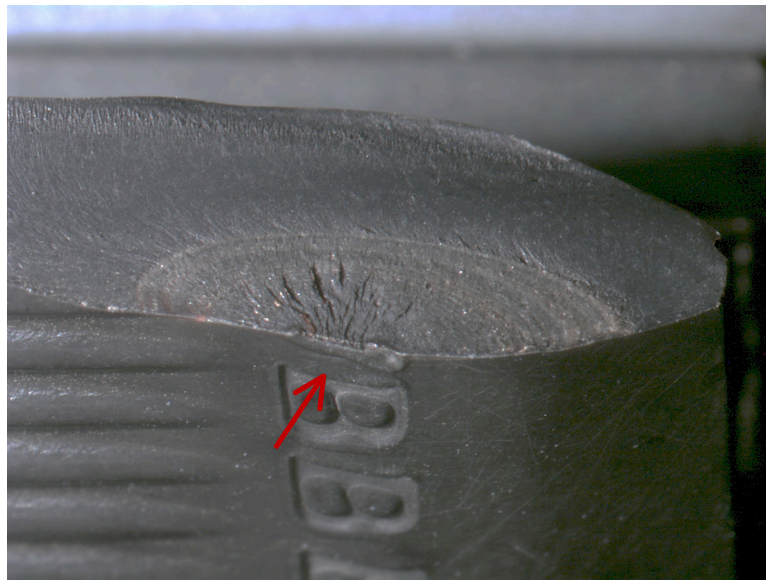
***Fracture surface showing fatigue initiating at a stress concentration created by the indented lettering***

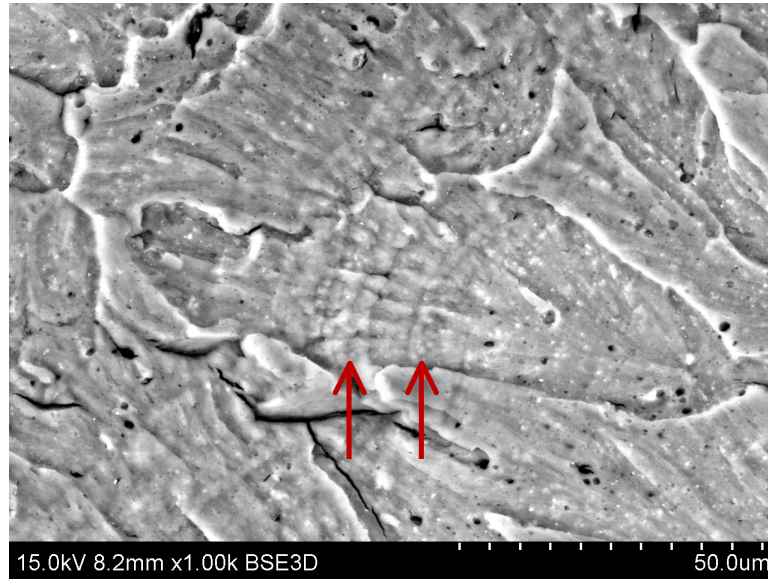
**Higher magnification SEM image showing fatigue striations**

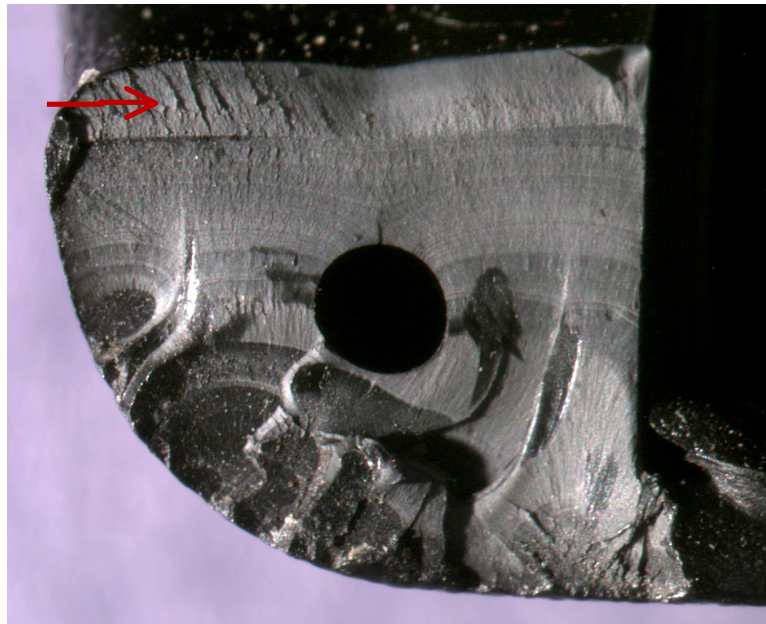
**Close-up view of a failed PPO part. The initial cracks (dark areas) were formed due to ESC followed by cyclic loading (fatigue-light areas). Hackles are evident in the final overload area (arrow). The dark circle in the middle is a hole.**

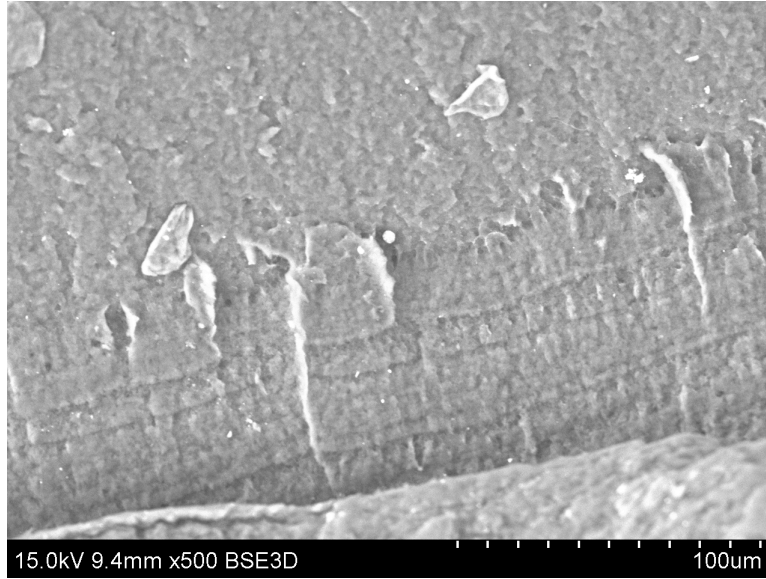
***Higher magnification SEM image of the transition zone from ESC to fatigue striations***

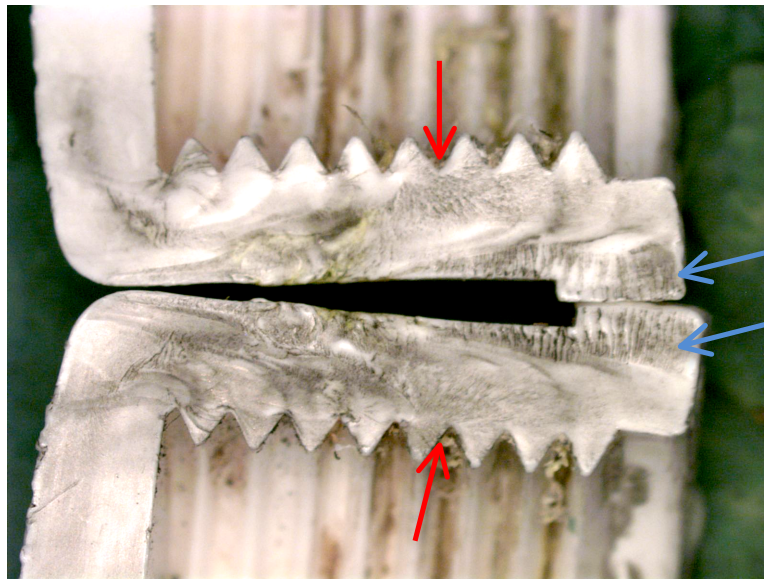
A view of the side opposite the ridge side revealed the features of a weld line failure. This weld line was where the initial failure occurred. A weak weld line would result from processing conditions (melt mold and/or core temperature too low). The crack initiated here and progressed up this side and across the top of the cap.

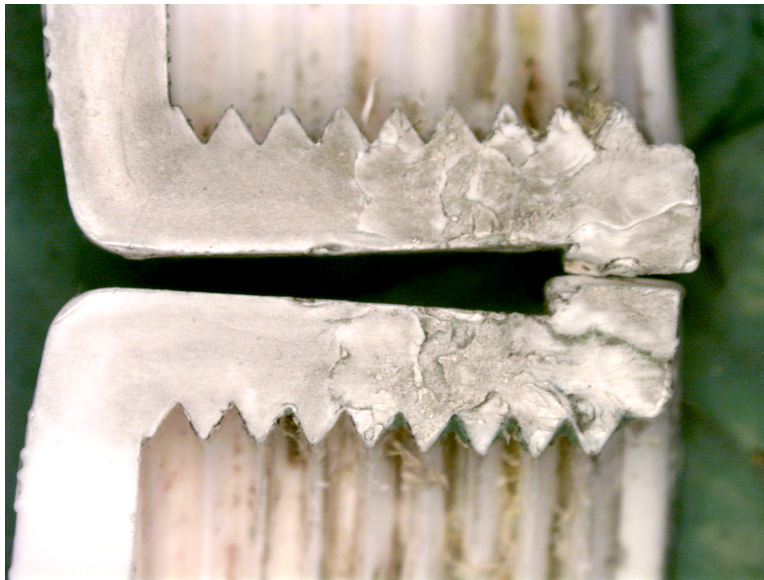
Overall view of the end cap showing the side where the fracture initiated at the weld line. After the weld line failed the fracture traveled up and across at high speed causing the cap to completely separate into two with the aid of the water pressure. The fast travelling crack with high energy left very few features (shear ridges, etc.) on the fracture surface.

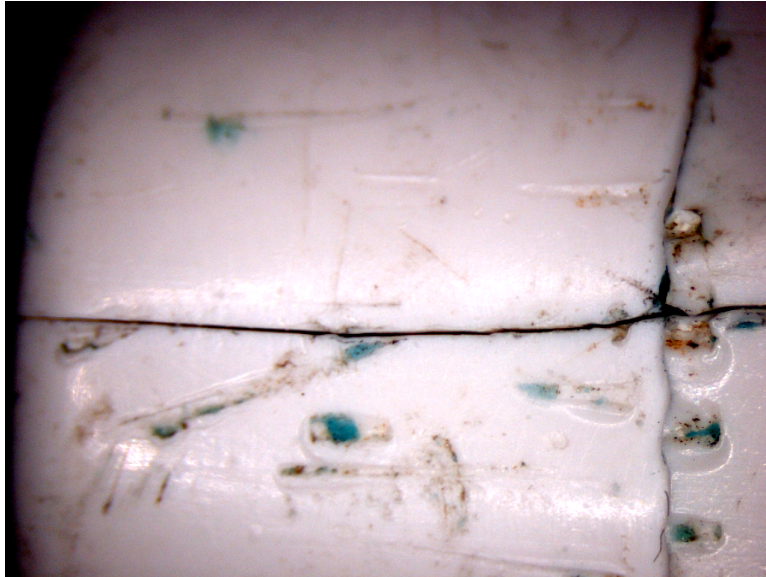
There was evidence of severe tool marks on the cap's exterior surface at the initiation point where the weld line was located. The installation practice and the undesirable location of the weld line combined to cause the failure under water pressure.

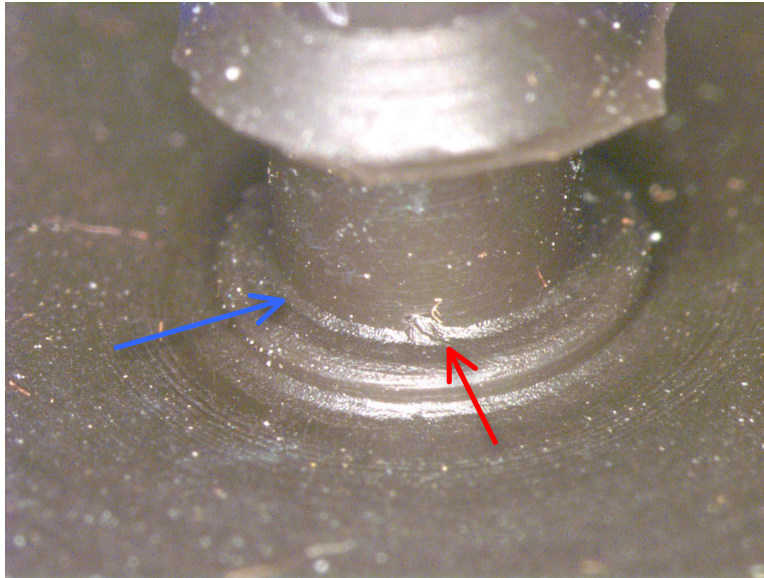
Junction between stem and flapper valve shows step ring (blue arrow) radius associated with failure and nick (red arrow).

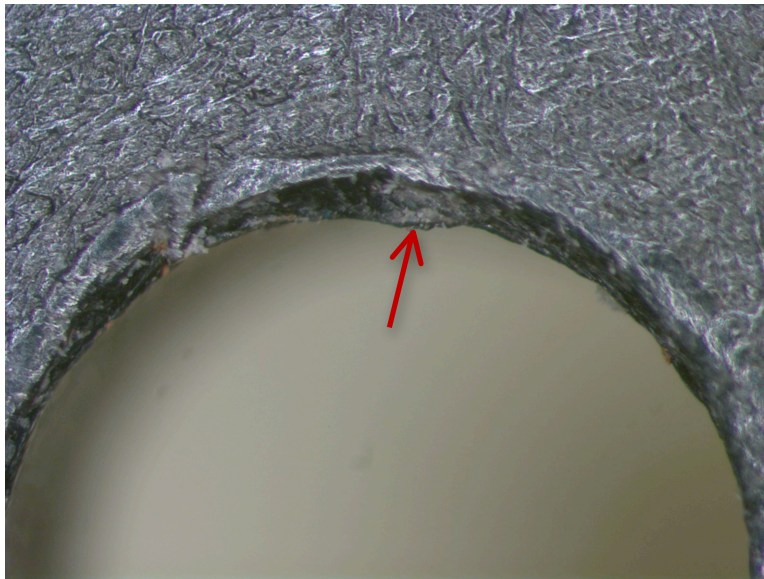
Further examination of the anchor hole showed a relatively sharp edge and protrusions shown below, which most likely caused the abrasion observed on the stem.

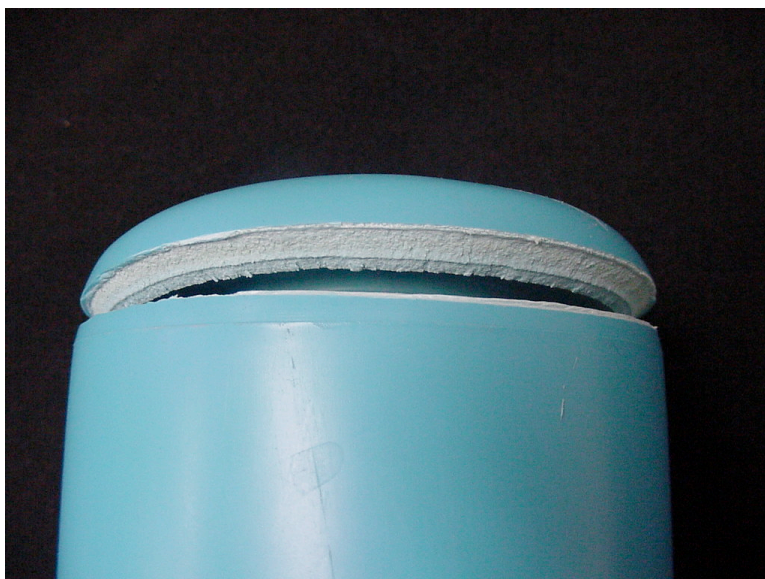
***Photograph showing a close-up view of the failure area***

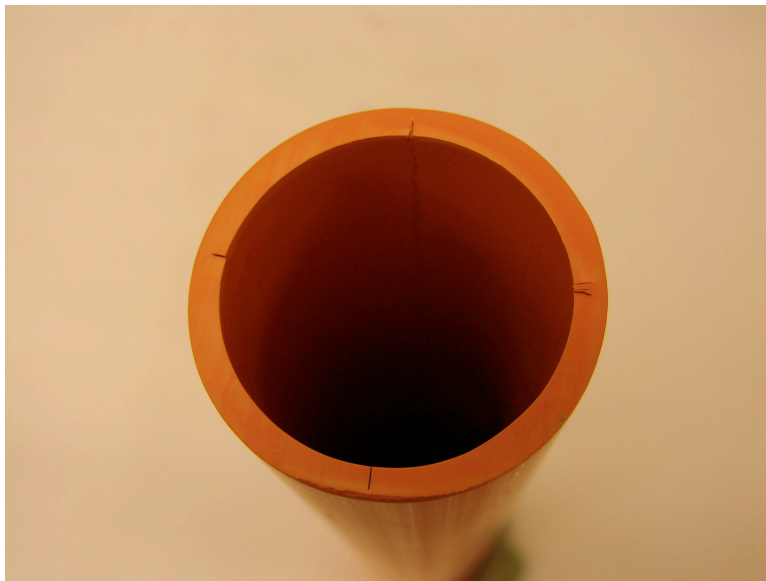
***Photograph showing the end view of the failed pipe section,  
with cracks that are approximately 90° apart.***

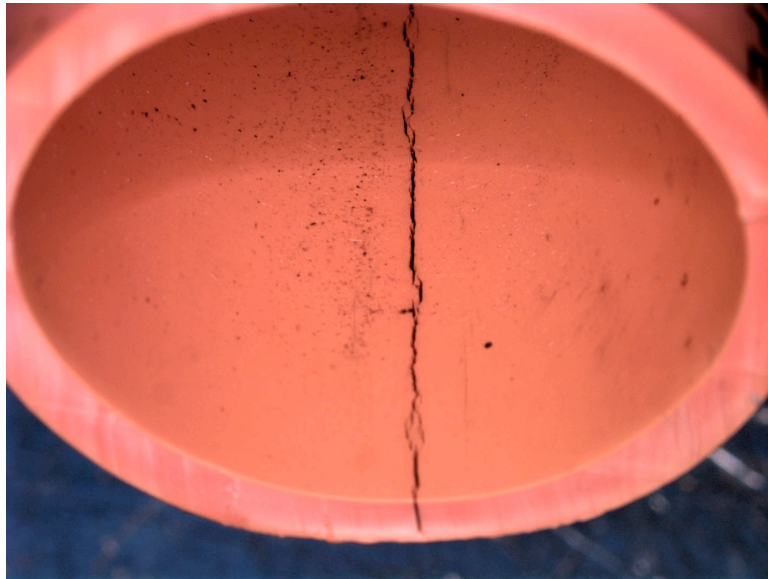
***Close-up view of one of the longitudinal cracks in the failed section***

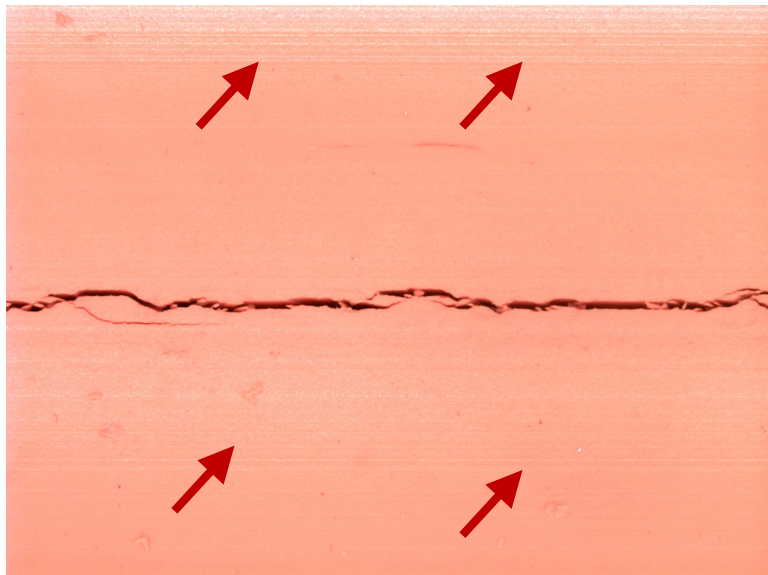
***Macro photograph at ~10X magnification showing a portion of the ID cracks.  
Note the arrows indicating extrusion lines running parallel to the crack.***

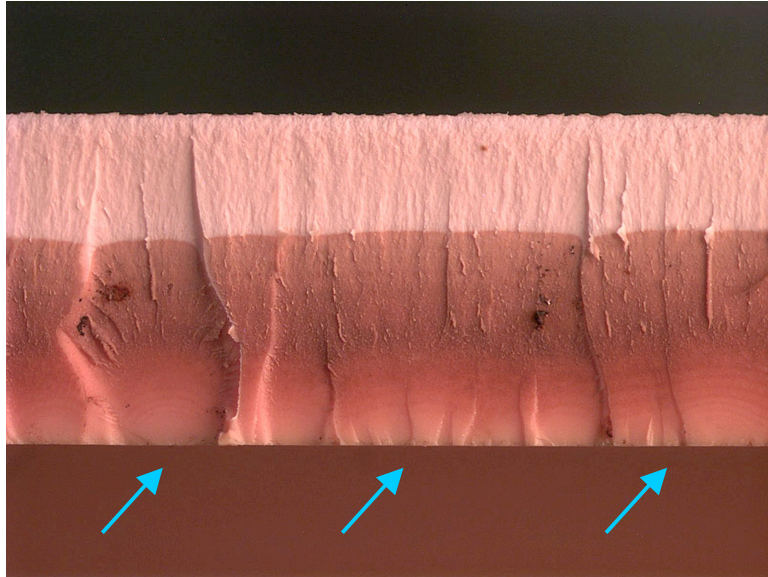
***Macro photograph showing the crack surface after opening it in the laboratory. The majority of the darker colored zone is the ESC area and the lightcolored final failure was induced in the laboratory. Note the multiple crack initiation sites on the pipe I.D. (arrows).***

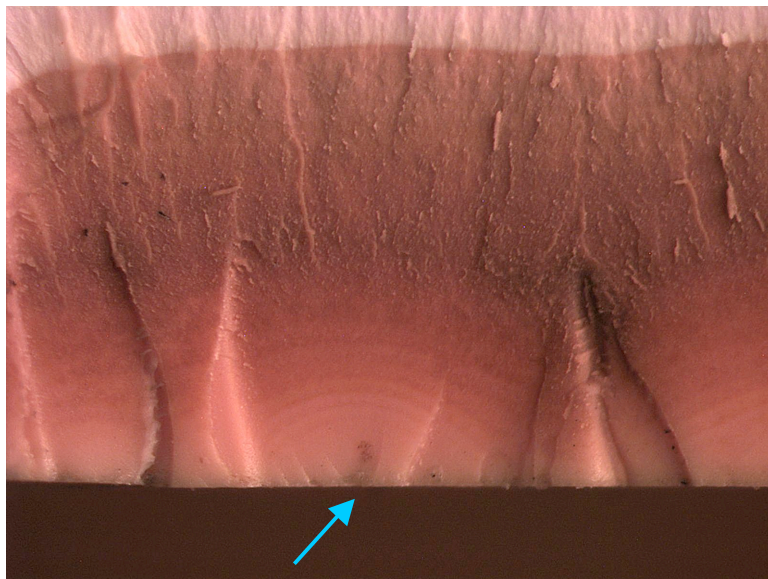
***Higher magnification view showing one of the crack origins***

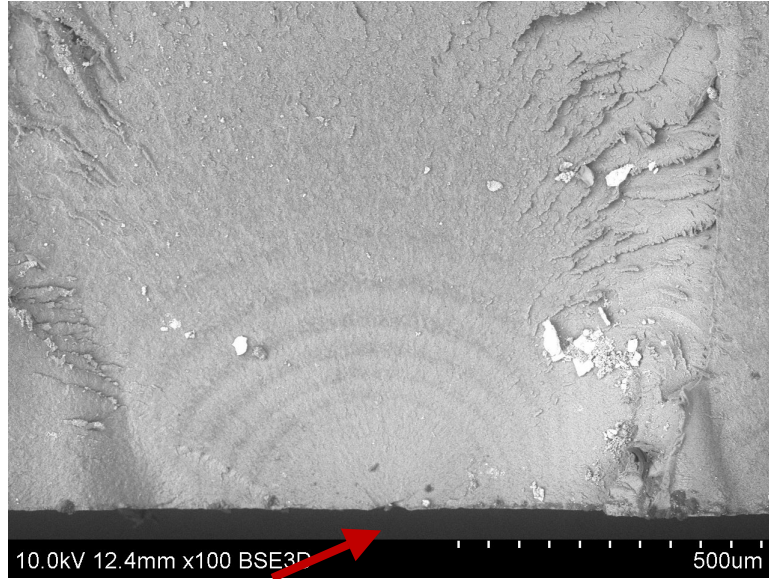
***SEM microphotograph at ~100X magnification showing one of the multiple crack origins***

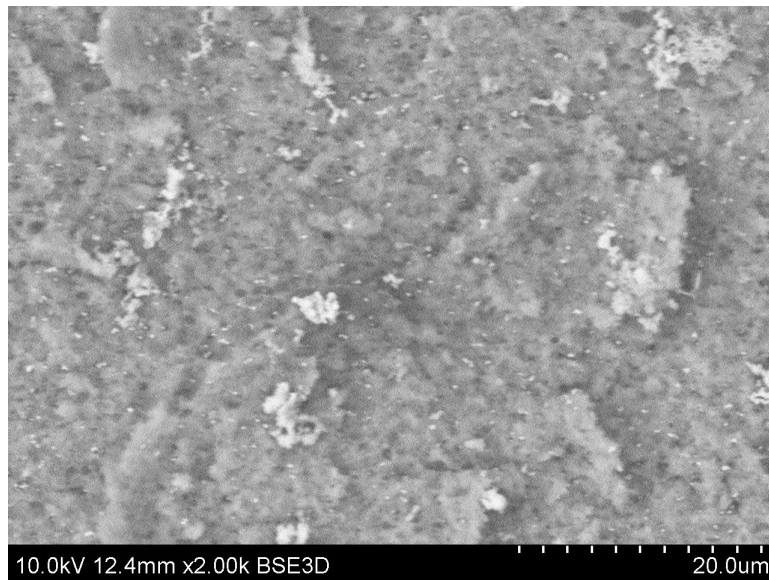
***SEM microphotograph showing the typical features of crack surface in the ESC zone***

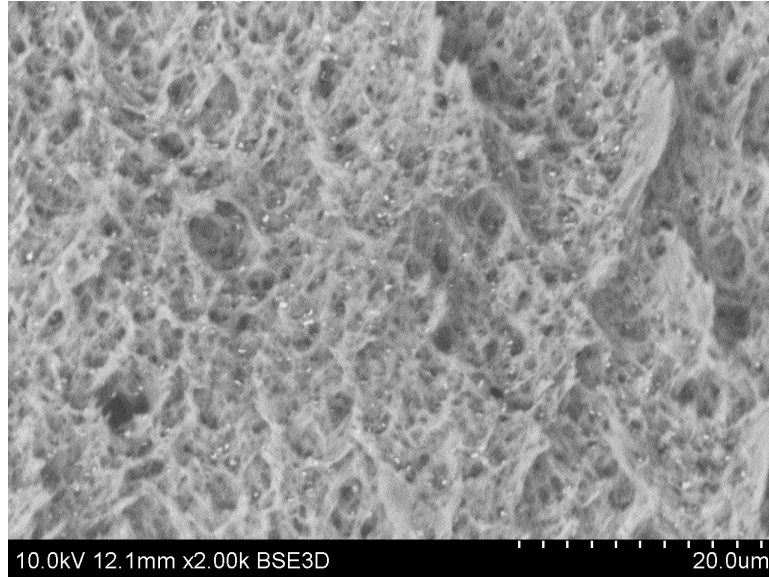
***SEM microphotograph showing the typical features of crack surface in the lab-induced overload zone (Note the fibrous, ductile nature of the fracture)***

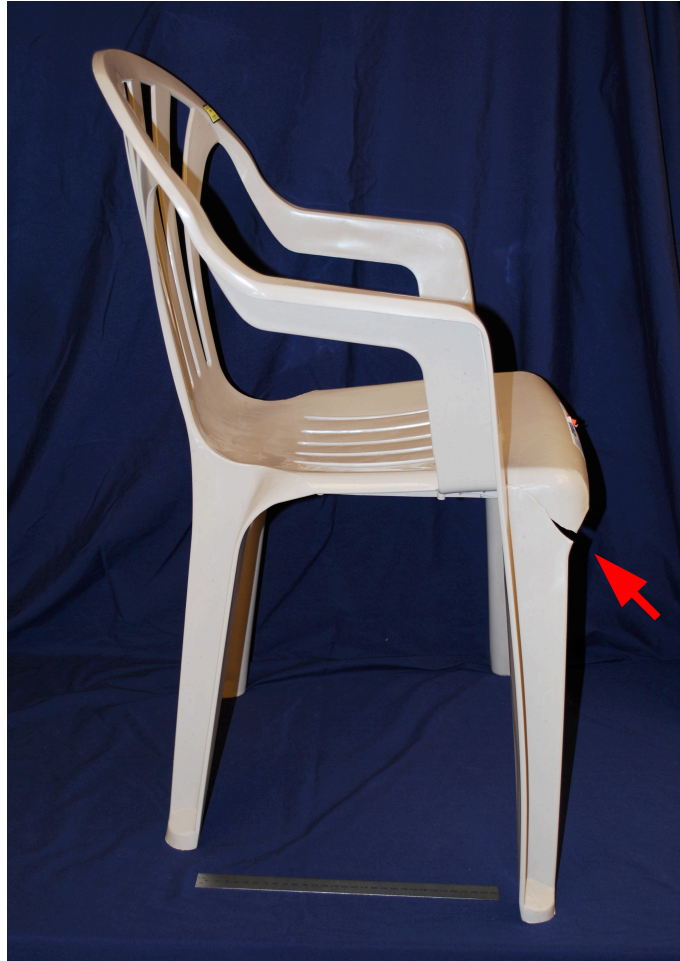
***Photograph showing the chair, with arrow pointing to the fracture location***

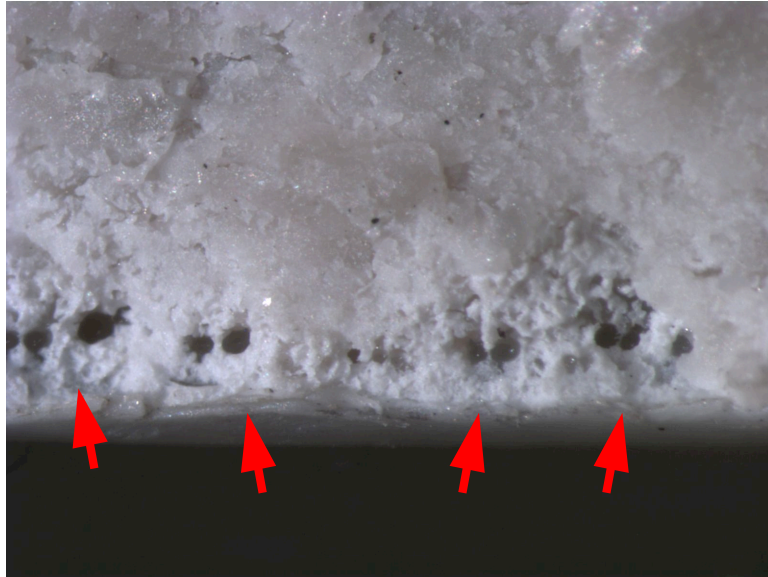
***Macrograph showing voids at the fracture initiation site (arrows)***

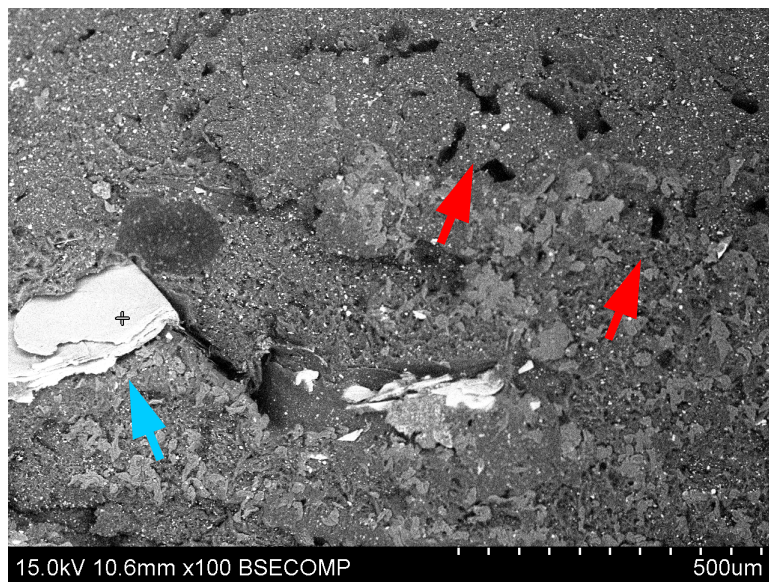
***SEM image showing voids at the fracture initiation site (red arrows).  
The “white” plate-like substance (blue arrow) was determined to be mica using EDS techniques.***

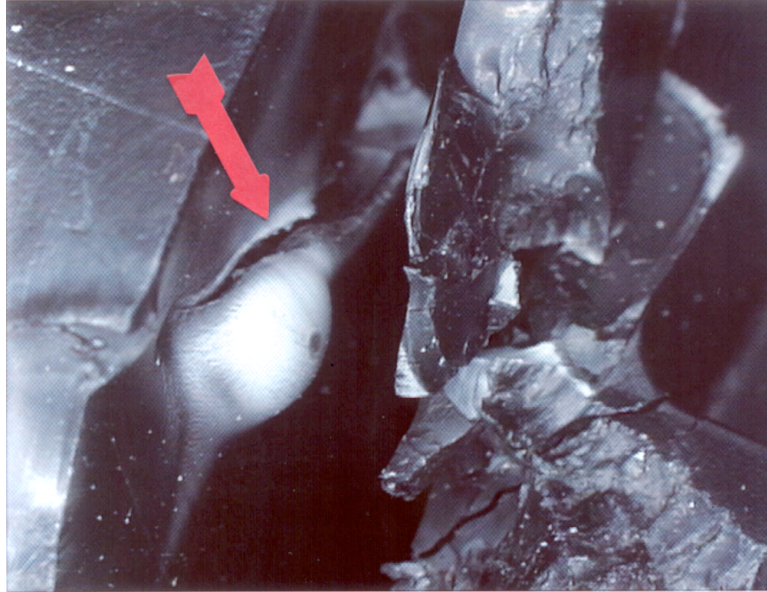
***Failure area with the crack initiating at the stressed area created by the overextended screw***

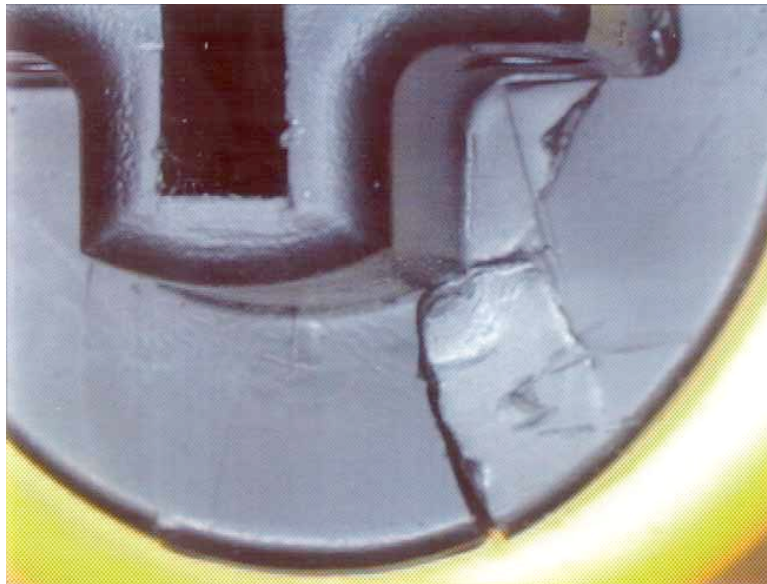
***Close-up view of cracked insert***

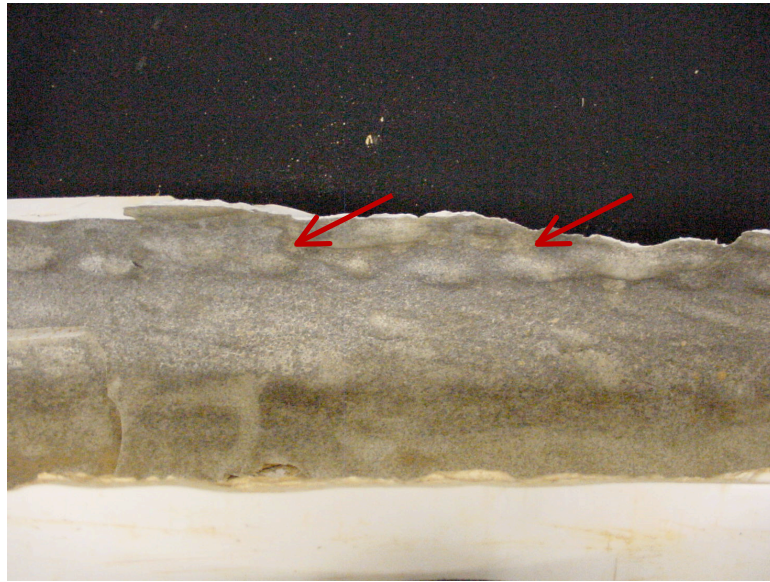
***Interior of pipe showing line of blisters***

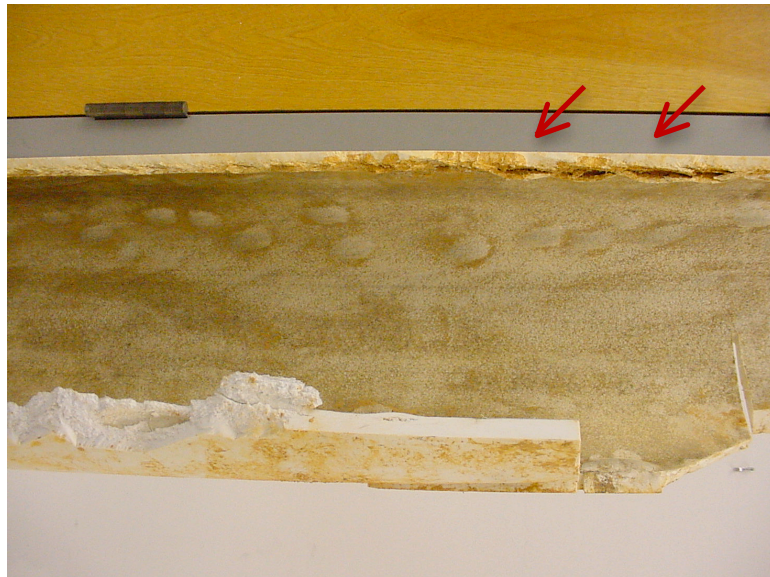
***Interior of pipe showing the delamination along the fracture***

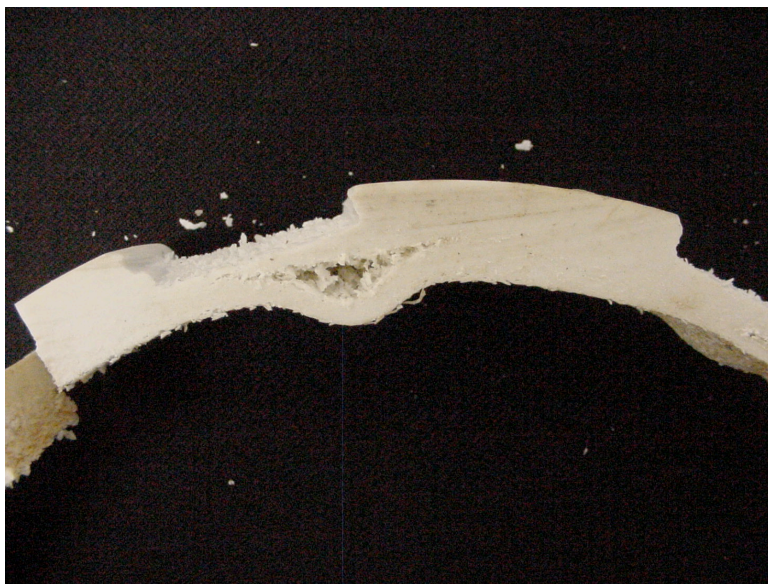
*Pipe section after acetone immersion, note further degradation that occurred during exposure*

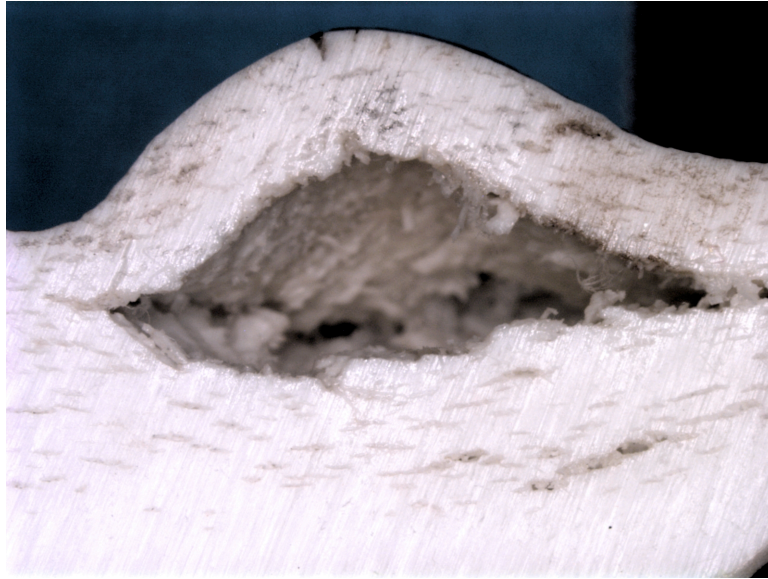
***Close-up of blister and delamination across the pipe wall***

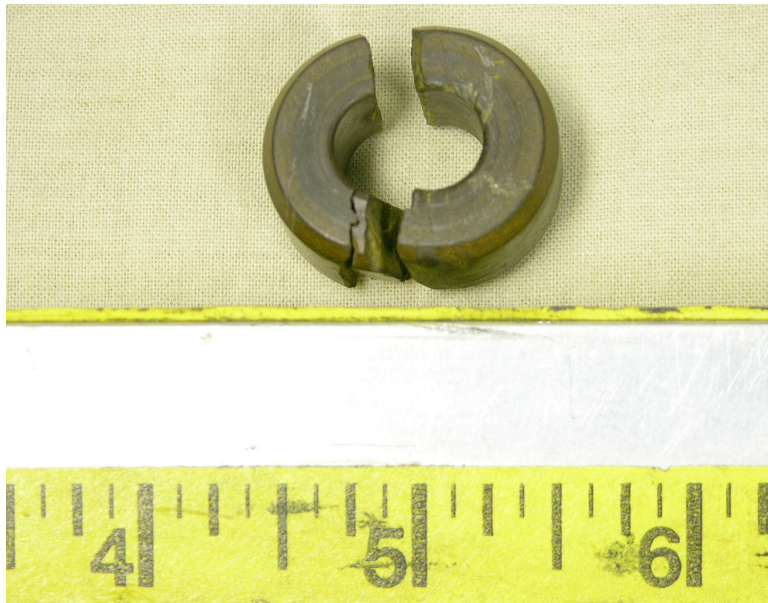
***Photograph showing fractured roller***

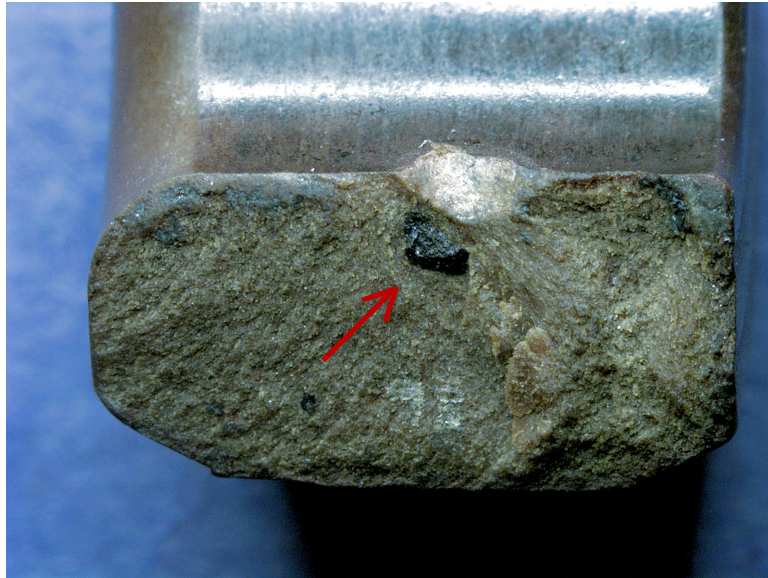
***Macrograph showing the inclusion on the fracture surface (arrow)***

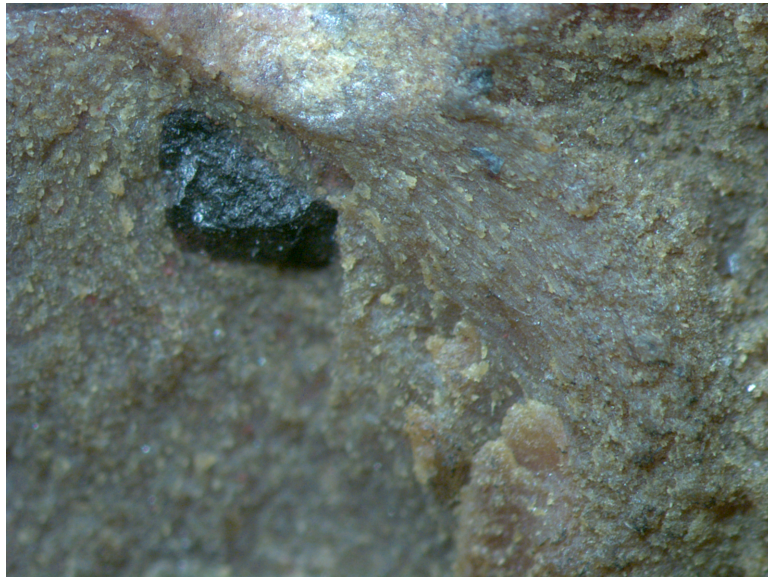
***Higher magnification view of inclusion and origin area***

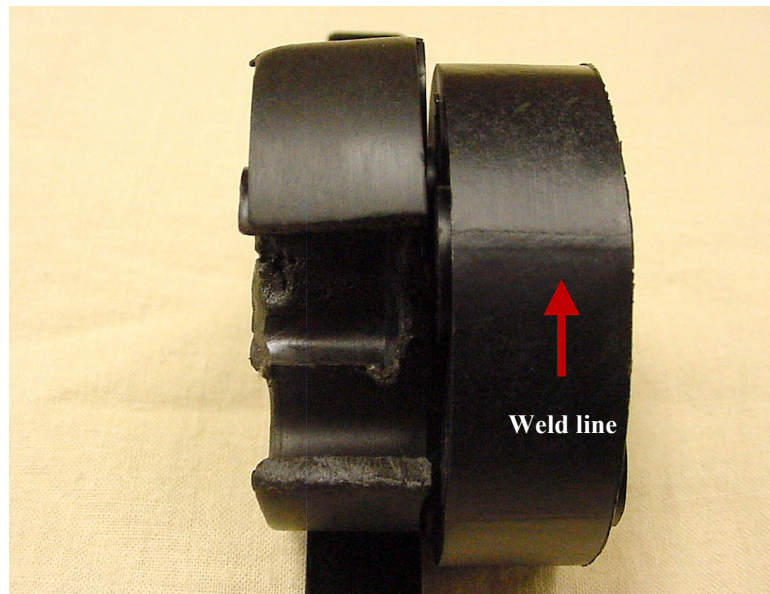
***Photograph showing the weld line observed on the side of the disk***

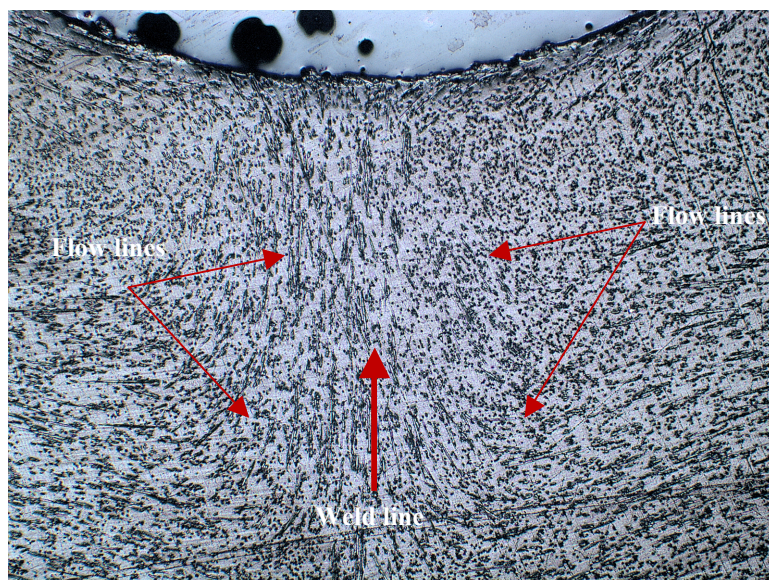
**Orientation of the glass fibers clearly indicate the weld (knot) line formed during molding**

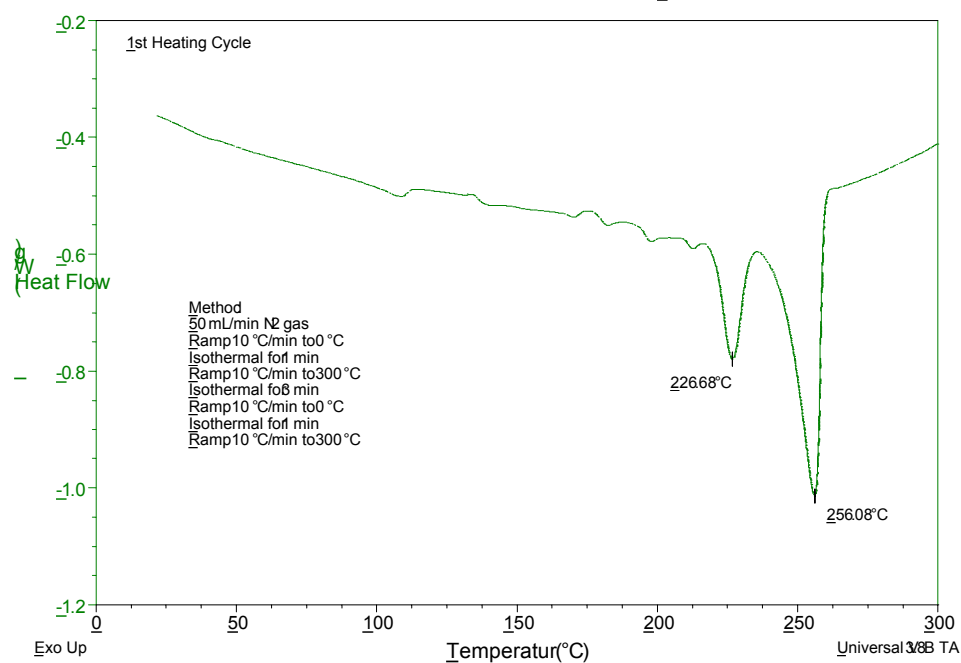
**DSC Thermogram of 1<sup>st</sup> heating cycle of Failed part showing two endotherms  
Nylon 6 and Nylon 66**

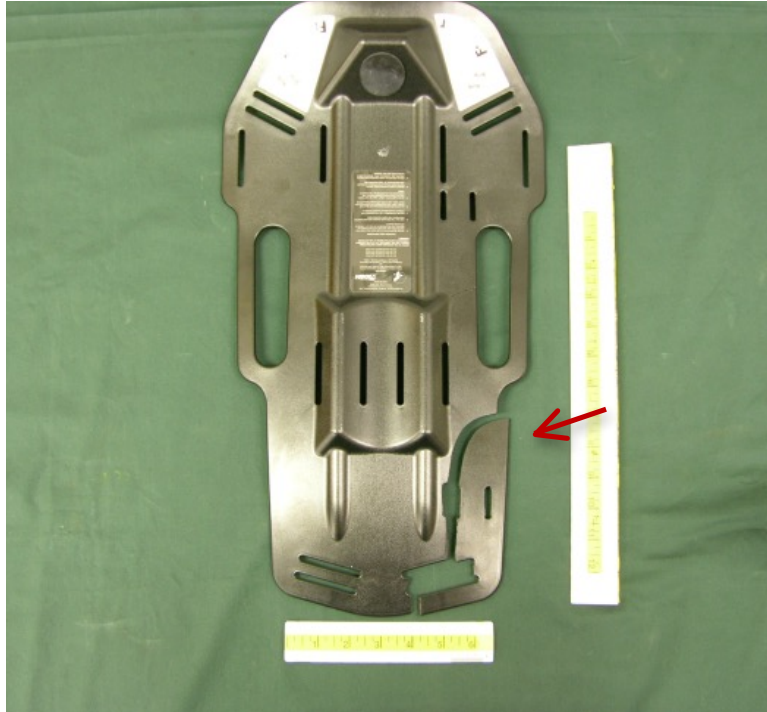
***Photograph of the failed part (arrow points to the broken section)***

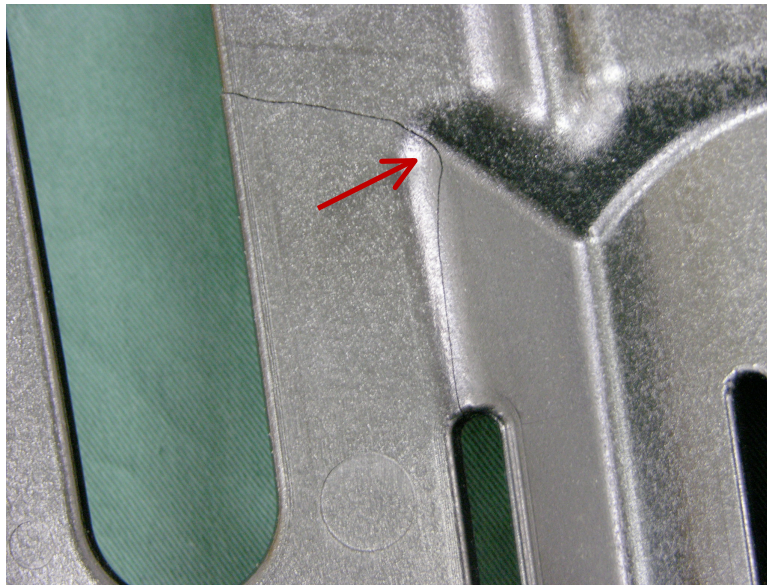
***Photograph showing one of the cracked areas on the failed part***

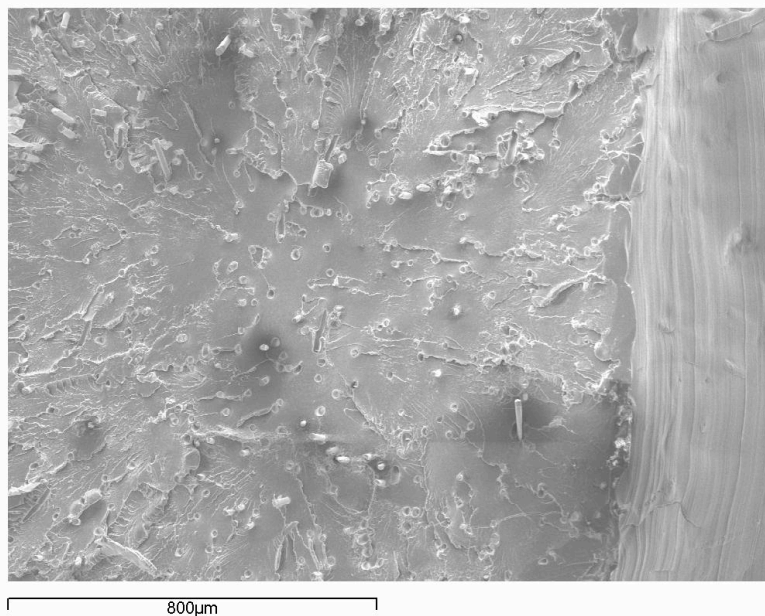
***SEM image of origin area. The rippled molded surface visible on right indicates the melt front was partially solidified at this point in the mold and did not flow as well.***

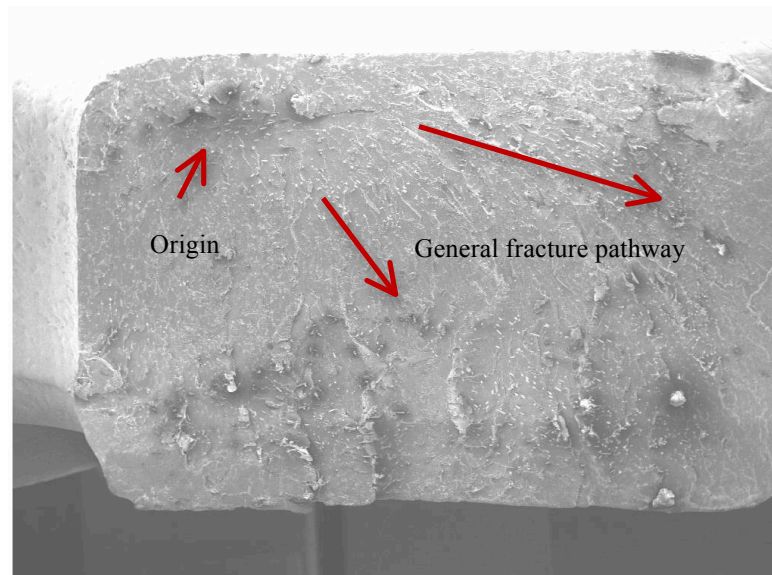
***One of the fracture surfaces showing the origin, wallner lines and hackles***

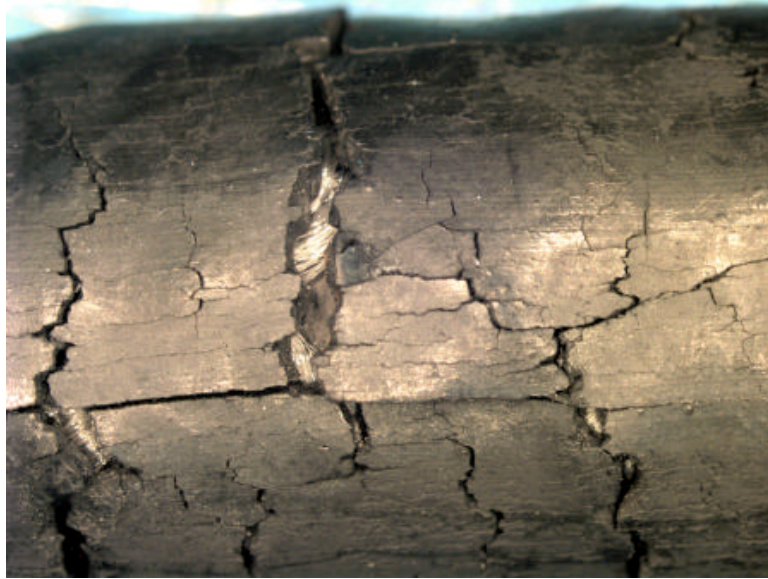
*Environmental cracking was observed on the fuel hoses*
