**PDHonline Course M399 (4 PDH)**

# **Plastics Fundamentals: Properties and Causes of Failures**

*Instructor: Semih Genculu, P.E.*

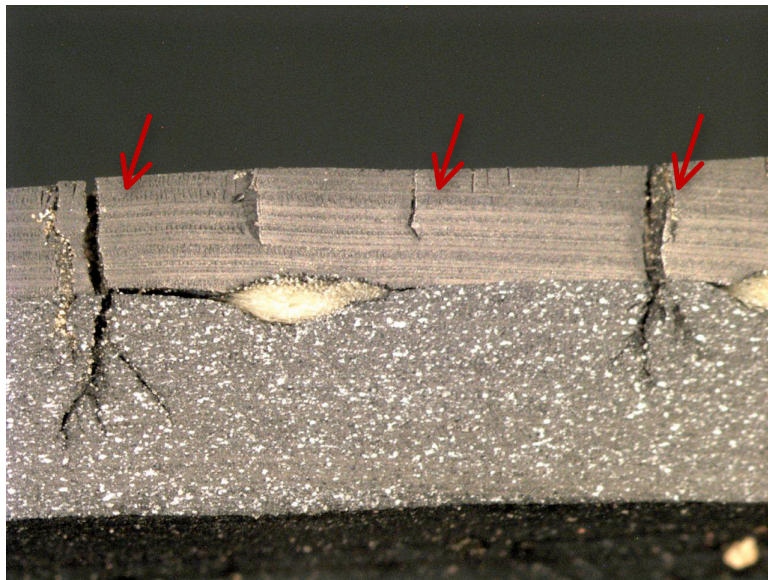
*Cross sectional view of the hose showing cracks initiating on the exterior layer and progressing to the interior (arrows)*
