PDHonline Course A110 (2 PDH)

The Preservation and Repair of Historic Stained and Leaded Glass

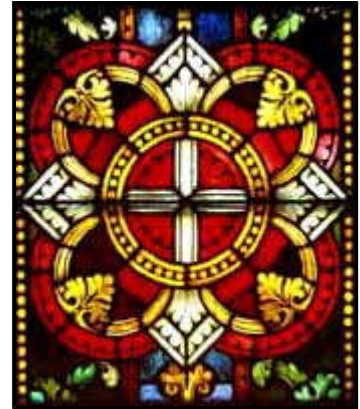
A NOTE TO OUR USERS: The web versions of the **Preservation Briefs** differ somewhat from the printed versions. Many illustrations are new, captions are simplified, illustrations are typically in color rather than black and white, and some complex charts have been omitted.

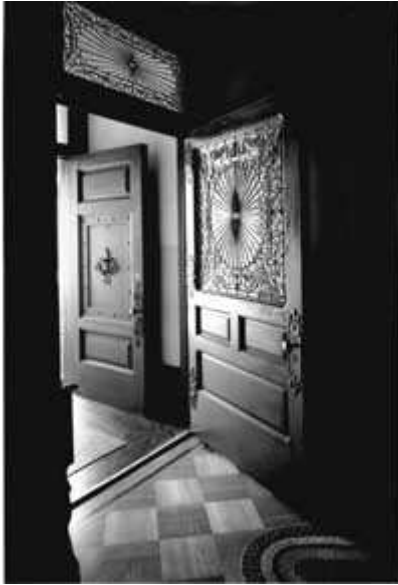
The door and transom of the Edward Hazlett House in Wheeling, West Virginia, (1891-92) suggest the richness of 19th century leaded glass. Photo: Jack E. Boucher, HABS.

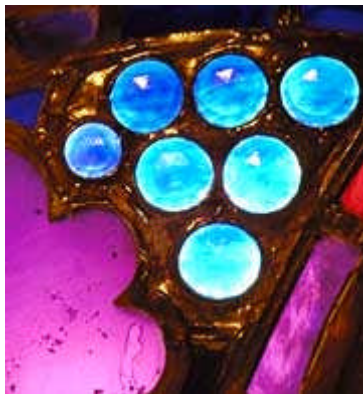
The faceted jewels set in a lead overlay from 1920 were made possible by one of the many glass innovations of the Tiffany Glass & Decorating Company several decades earlier. Photo: Neal A. Vogel.

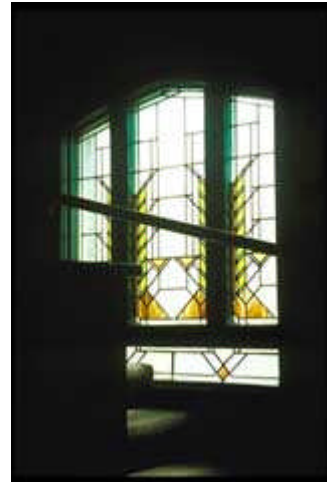
A typical ca. 1910 Prairie School art glass window in Riverside, Illinois, directly influenced by the work of Frank Lloyd Wright. Photo: Neal A. Vogel.

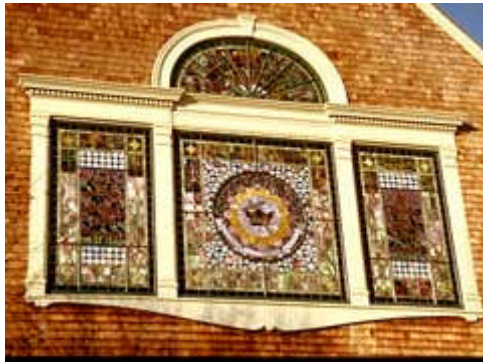
Stained glass is an exterior feature as well as an interior one. As part of any preservation project, it should be photographed from the outside as well as the inside. Photo: Neal A. Vogel.

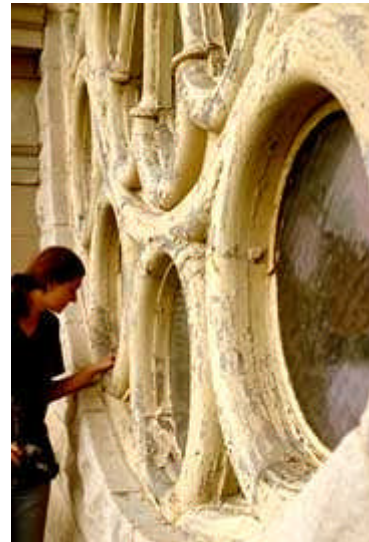
A condition assessment of the frame supporting the stained glass window is as important as evaluating the stained glass itself. Photo: Neal A. Vogel.

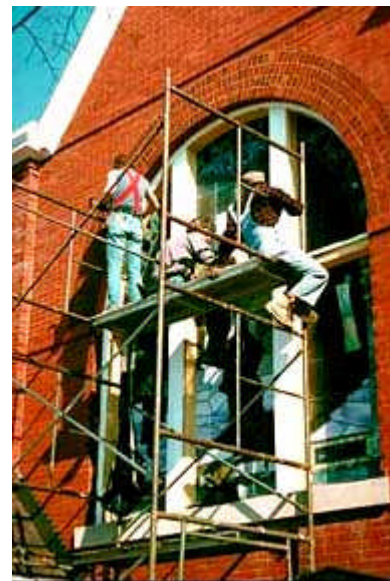
These workmen are performing exterior window maintenance after the protective glazing-- which had prevented maintenance--was removed. Photo: Neal A. Vogel.

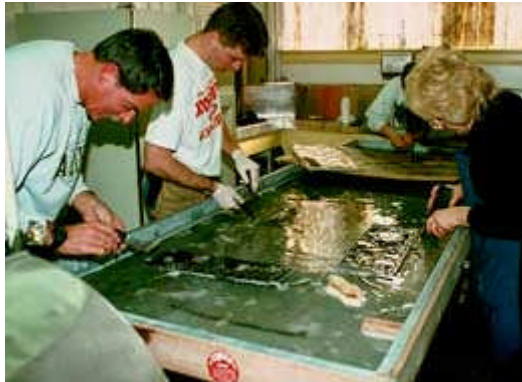
Disassembling leaded glass in warm water helps to soften the putty, minimize breakage, and reduce exposure to airborne dust. Photo: Neal A. Vogel.

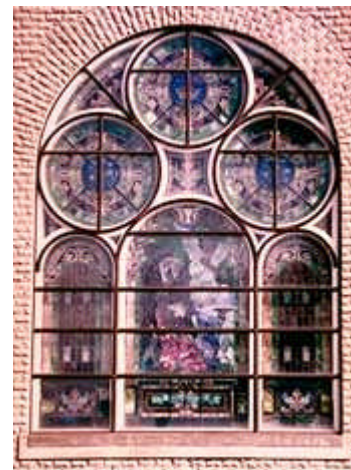
The grid for this protective glazing disregards the configuration of the historic window. The new framing system also causes distracting shadows on the interior. Photo: Neal A. Vogel.

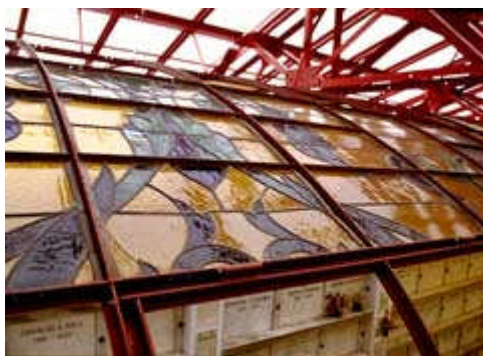
Before repairs began on the vaulted glass ceiling, a new diffusing skylight was installed to correct recurring leaks. Catacombs (ca. 1920), Cypress Lawn Memorial Park, Colma, California. Photo:
