The Preservation of Historic Barns

20 PRESERVATION BRIEFS

U.S. Department of the Interior
National Park Service
Cultural Resources
Heritage Preservation Services

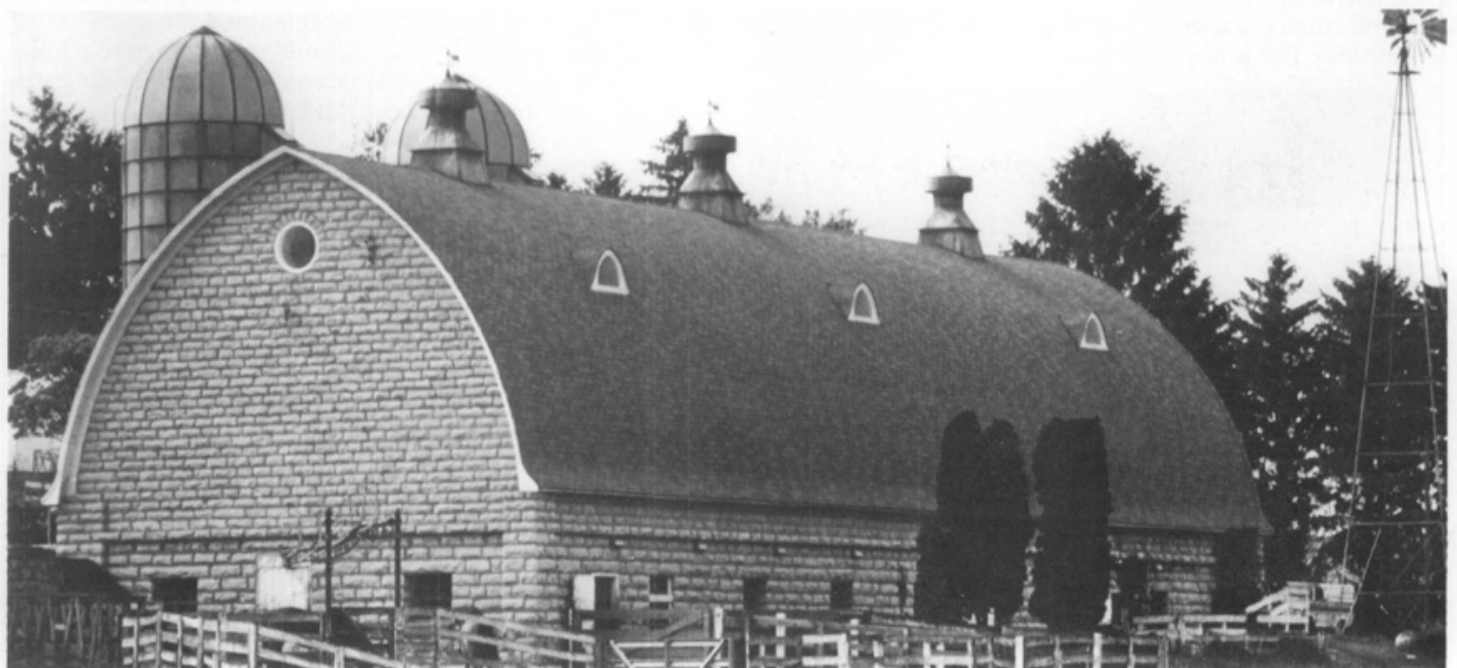
Fig. 1. Arch roof, native limestone walls two feet thick at the base, porthole window, dormers, silos, rooftop ventilators, weathervanes, windmill, fences, fields, and family pride in the builder are all components of the historic character of this Iowa barn. Photo: John Walter, Successful Farming.

From the days when Thomas Jefferson envisioned the new republic as a nation dependent on citizen-farmers for its stability and its freedom, the family farm has been a vital image in the American consciousness. As the main structures of farms, barns evoke a sense of tradition and security, of closeness to the land and community with the people who built them. Even today the rural barn raising presents a forceful image of community spirit. Just as many farmers built their barns before they built their houses, so too many farm families look to their old barns as links with their past. Old barns, furthermore, are often community landmarks and make the past present. Such buildings embody ethnic traditions and local customs; they reflect changing farming practices and advances in building technology. In the imagination they represent a whole way of life (Fig. 1).

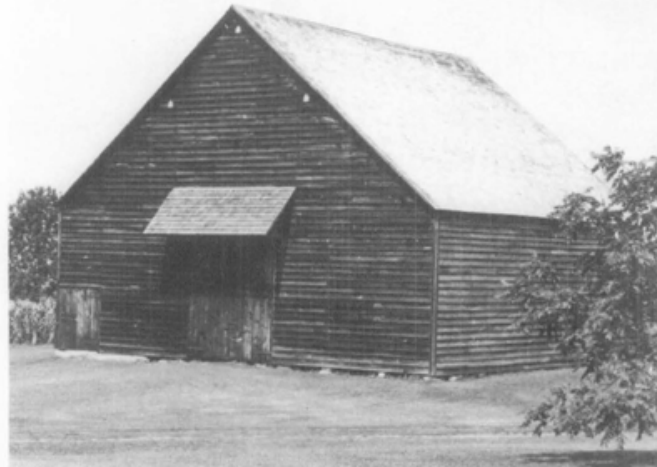
Built in the late 1700s, this New York Dutch barn survives in excellent condition. Gable roof, center wagon doors with pent roof, stock door at the corner and horizontal clapboarding are all typical features of the Dutch barn. Three holes for martins, traditional features of Dutch barns, can be seen near the top of the facade (they have been plugged and are lighter than the surrounding clapboards). Photo: Clarke Blair.

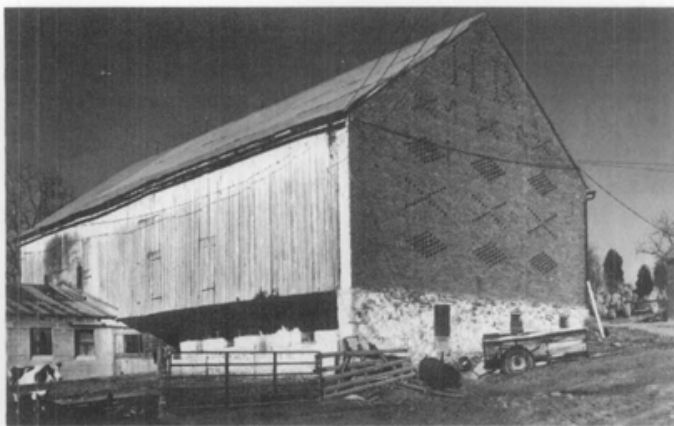
The gently sloping roadbed in this photograph shows the "bank" from which bank barns get their name. Massive timbers stretching across the full width of the barn create the overhang that also characterizes these barns. In barns with brick end walls, patterns were sometimes created by leaving spaces between bricks. The device furnishes ventilation as well as decoration. Photo: Jack E. Boucher, HABS.

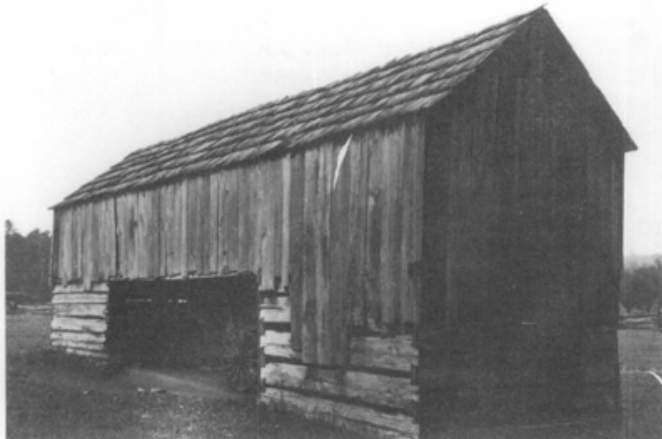
This late-nineteenth century crib barn is located in eastern Tennessee, in what is now the Great Smoky Mountains National Park. The central driveway between the cribs allowed a team and wagon to drive through after unloading. The materials and details are typical of the region. They include, on the exterior: hand-hewn saddle notched logs on the lower, crib portion; board framing on the upper, loft area; wood shingle roof. The interior features wood hinges on the crib doors and earth floor. Photo: Robert Madden.

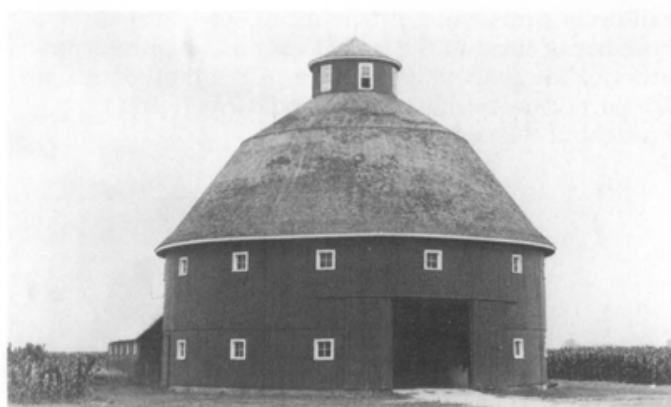
Circular barns are found throughout the country, but are especially numerous in the Midwest. This 1911 Illinois round barn is 60 feet in diameter. The cupola atop the hipped roof is 60 feet above ground. Its 10 single and 5 double stalls on the ground floor were fed from a loft. The square windows spaced at regular intervals around the perimeter add a note of simple contrast to the overall circular motif. Photo: Keith A. Sculle, Illinois Historic Preservation Agency.

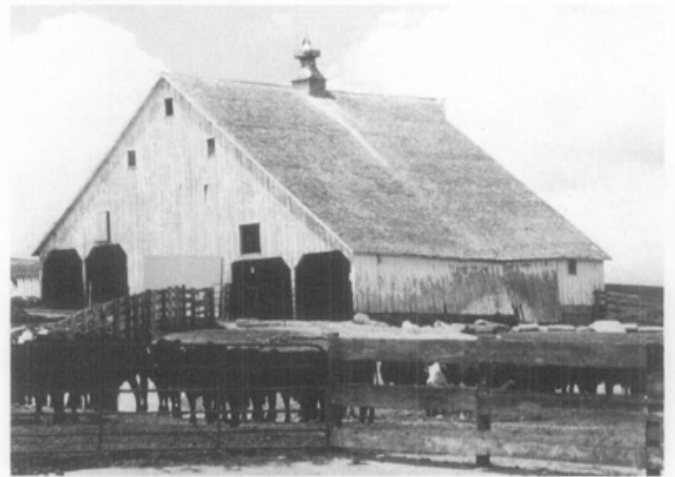
The long, sweeping roof is a characteristic of the Prairie or Western barn. The projecting peak over the hayloft is another. This Iowa barn was built about 1910. Photo: Mary Humstone.

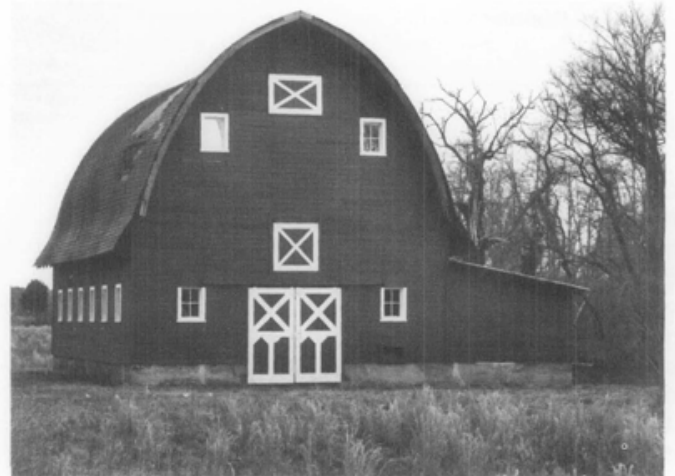
In the early 20th century barn patterns were developed by agricultural schools and prefabricated units were sold by mail-order firms. This Maryland barn was bought about 1920 from a Sears catalogue. Photo: Robert J. Hughes

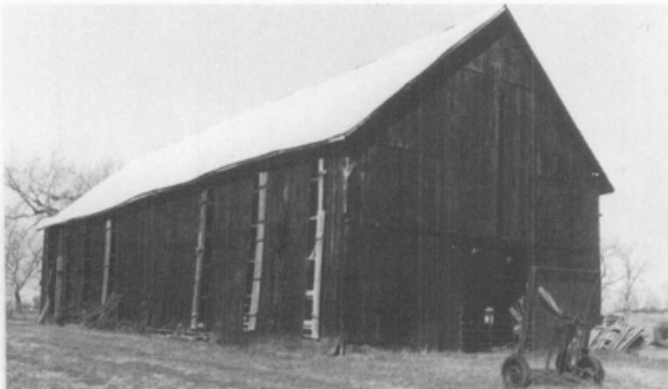
Panels on this 1900 Kentucky tobacco barn open to aid in the curing process. Photo: Christine Amos, Kentucky Heritage Council.

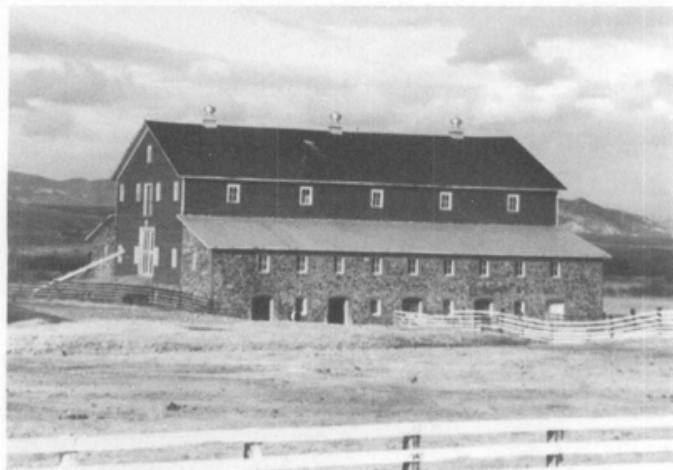
Fig. 2. Mountains, fields, fences, sheds, trees: The setting of this enormous Montana barn is an important element of its character. The barn was built in 1887–1889 after disastrous livestock losses in the winter of 1886–1887. It could hold 500 cattle and store a quarter-million cubic feet of hay. Photo: John N. DeHaas, Jr., Montana Historical Society.

Setting. Setting is one of the primary factors contributing to the historic character of a barn (see Fig. 2). Farmers built barns in order to help them work the land; barns belong on farms, where they can be seen in relation to the surrounding fields and other structures

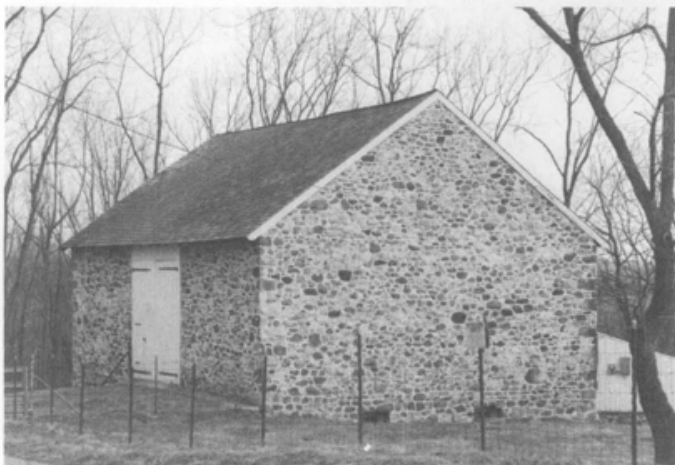
Fig. 3. The stone walls of this Delaware barn are its most notable feature. Built about 1810, the barn is a bank barn. Photo: Valerie Cesna, Delaware Bureau of Archeology and Historic Preservation.

Materials. Among the major impressions given by well-maintained historic barns are those of strength, solidity and permanence (see Fig. 3). These impressions largely result from the durability and ruggedness of the materials used in them. Weathered wood siding, irregularly shaped stones, or roughhewn logs on the exterior; dressed beams, posts scarred by years of use, and plank flooring on the interior all contribute to the special character of barns.

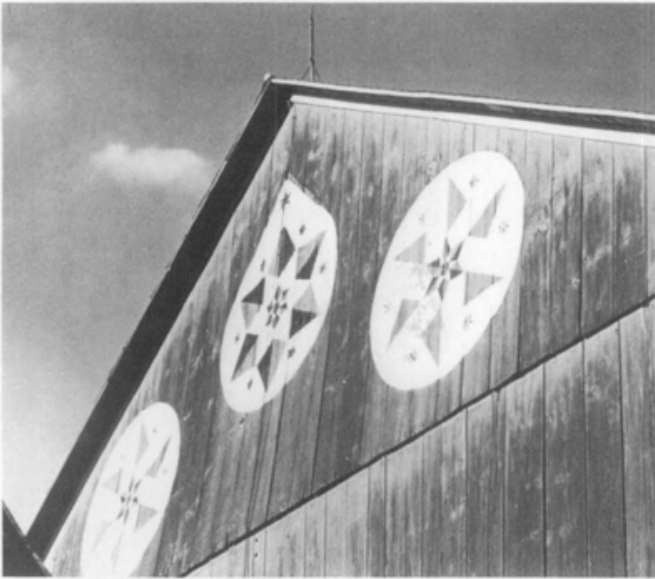
Fig. 6. Hex signs are among the wide range of decorative elements found on American barns. Photo: Lee H. Nelson.

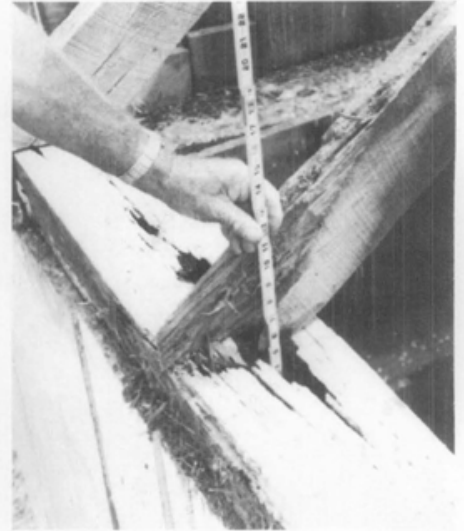
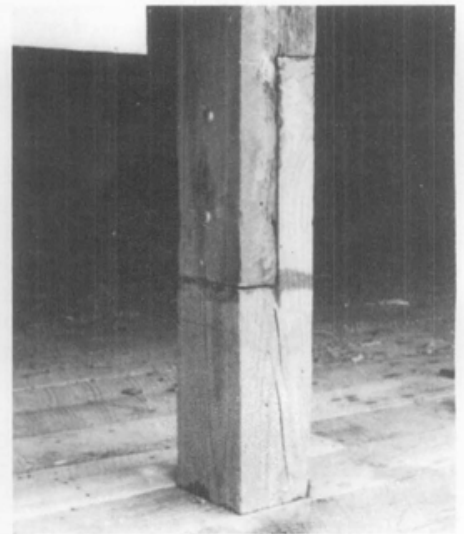
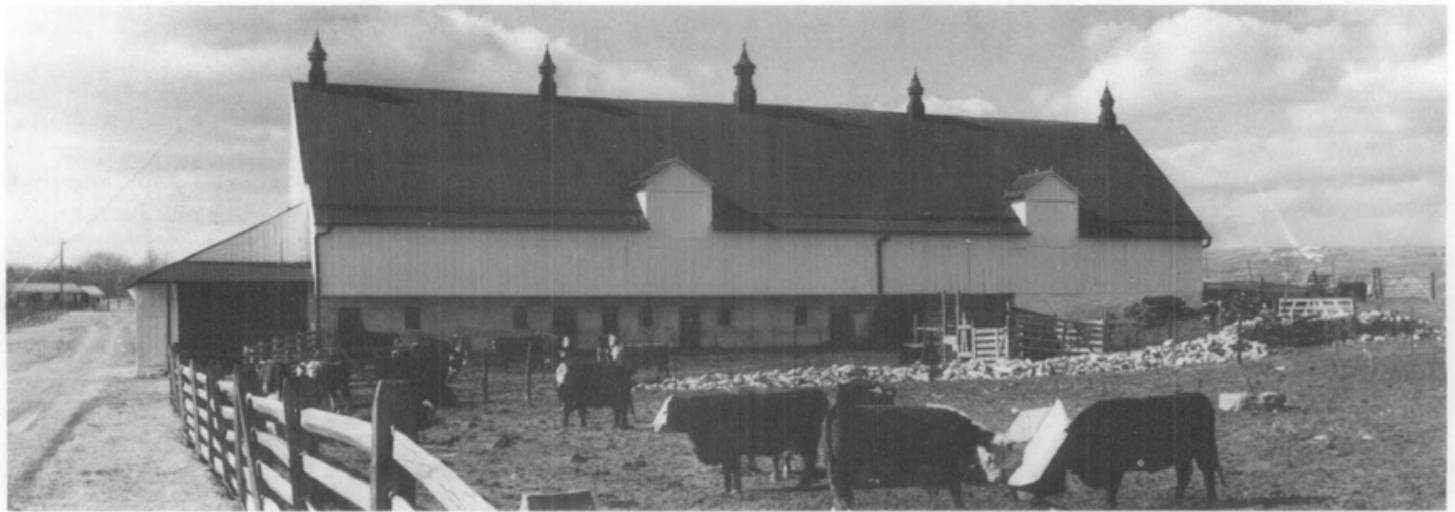
Fig. 7. Now part of Antietam National Battlefield, this bank barn (built in the 1820s and enlarged in 1898 and 1914) looks out over fields and hills where Union and Confederate armies fought on the bloodiest day in American history. Owned by the National Park Service, the barn underwent major repairs: (a) the foundation was regraded for better drainage; (b) the deteriorated metal roof was removed; (c) removal of the metal roof disclosed the rotten wall plate and roof rafters; (d) these elements were replaced, and collars to hold a new gutter system were added; (e) new downspouts and drain pipes were installed to carry water off the roof and away from the foundation; (f) damaged structural members were strengthened with new sections; (g) new roof and other work finished, the barn remains a working farm structure. Photos: (a-f), Courtesy, Williamsport Preservation Training Center, NPS; (g), Jack E. Boucher, HABS.

Many historic barns require more serious repairs than those normally classed as "routine maintenance" (see Fig. 7). Damaged or deteriorated features should be repaired rather than replaced wherever possible. If replacement is necessary, the new material should match the historic material in design, color, texture, and other visual qualities and, where possible, material. The design of replacements for missing features (for example, cupolas and dormers) should be based on historic, physical, or pictorial evidence.

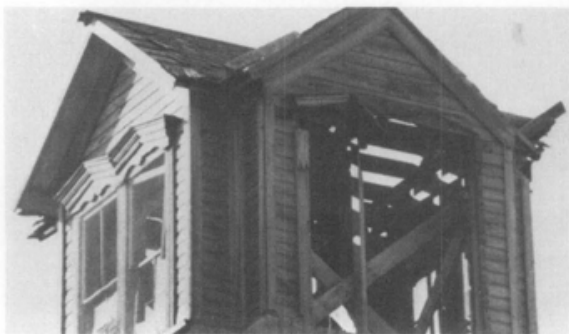
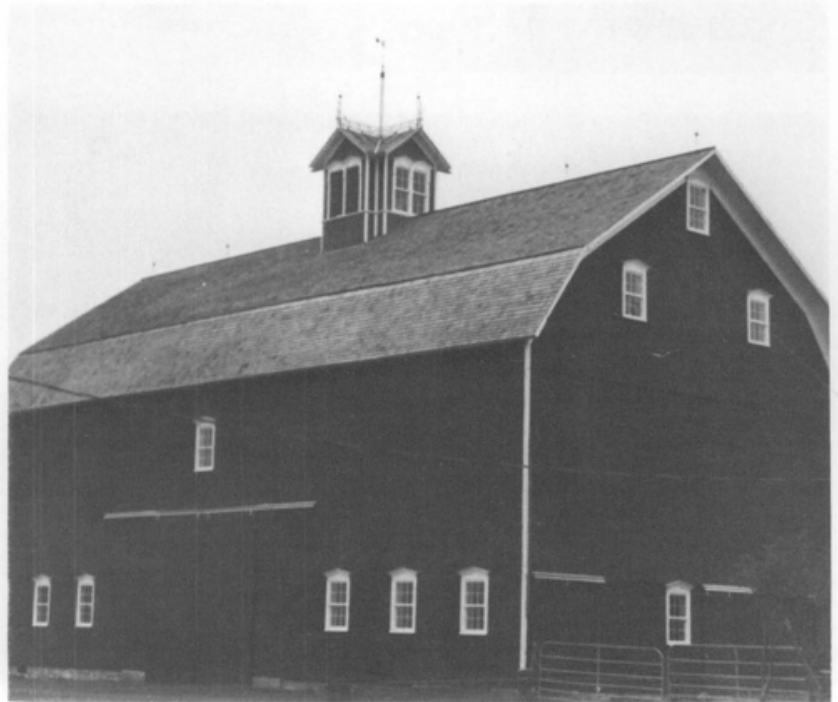
Fig. 8. Built in the Gothic Revival style in the 1890s, this four-story Indiana barn had fallen into disuse, and was deteriorating. In the process of returning it to use, the owner installed a new roof that matches the wooden shingles found beneath the deteriorating asphalt shingle roof; removed the modern asbestos shingle siding; repaired the windows, and reconstructed the cupola (including its lightning rod and weathervane). (Before and after views are of opposite sides of barn.) Photos: Before, Courtesy, Gary Post-Tribune; After, Courtesy, Kankakee Valley News.

Some barns have served the same uses for generations, and need only periodic repairs and routine maintenance. Others have become obsolete and need extensive updating for modern farming methods. (To house livestock, for example, a barn may need new feeding, watering, waste removal, electrical, plumbing and ventilation systems.) Similarly, barns that can no longer be used for agriculture at all normally require changes to adapt them for commercial, office, or residential use. In such cases barns need more extensive work than the maintenance and repair treatments outlined above. However, when rehabilitating a historic barn for a new farming operation or a new use entirely, care must be taken to preserve its historic character while making needed changes (see Figs. 8, 9 and 10).

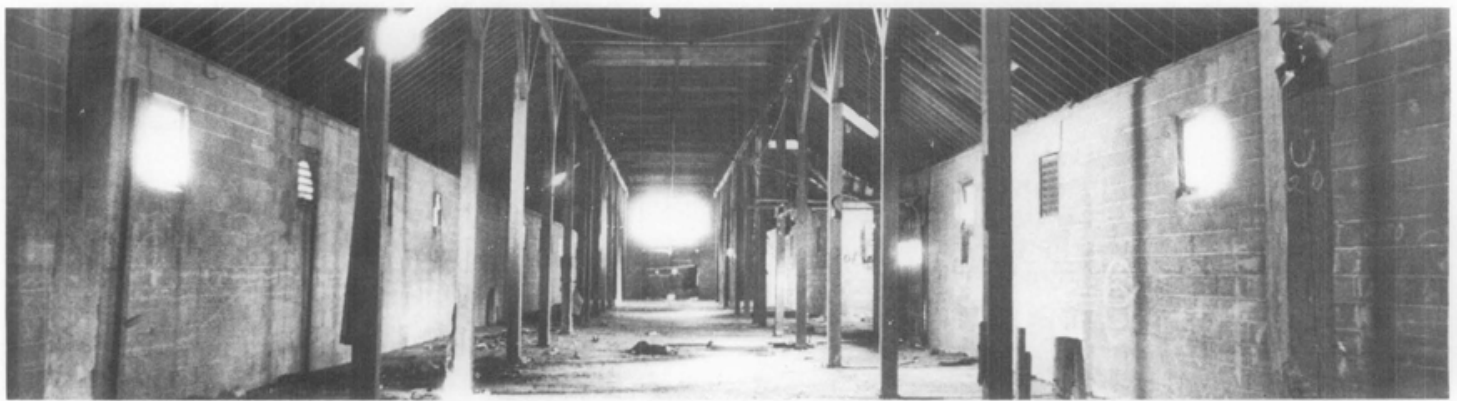
Fig. 9. This enormous Ohio barn (285 feet by 125) was built between 1909 and 1912. It was one of 102 structures on "America's Finest Farm." (Other buildings included the world's largest greenhouse and the world's largest barn—nearly 800 feet long). The barn seen here was rehabilitated for use as headquarters for an international agricultural firm. Although the use has changed, comparison of the interior photographs shows that the barn has retained its historic character. (After view, interior, is taken from a cross axis; distortion is from fish-eye lens.) Photos: Exterior and interior, after: Ron Kuntz, UPI; Interior, before: Courtesy, Barberton (Ohio) Historical Society.

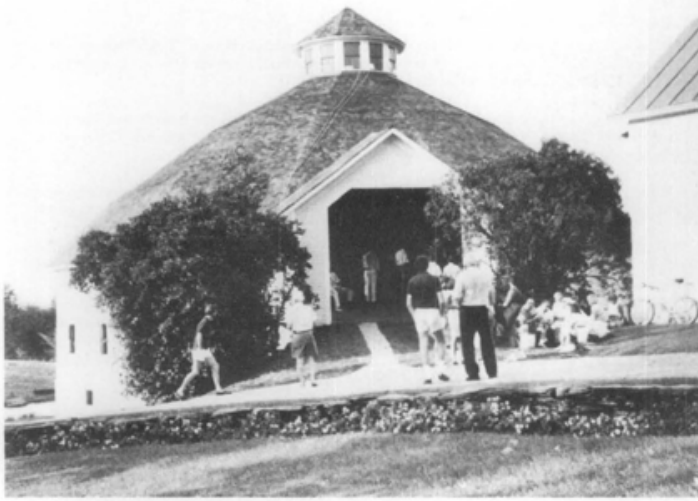
Fig. 10. This 1910 Vermont round barn is 80 feet in diameter. Disused and decaying, the building was converted to a community center, with artists' studios and spaces for weddings, parties and conferences. The barn underwent extensive structural repair and other work. Careful selection of new use permitted the building to be rehabilitated while retaining its principal spaces and features—and its historic character—intact. Photos: Jay White.
