PDHonline Course A114 (1 PDH)

Preservation of Historic Adobe Buildings

5 Preservation Briefs

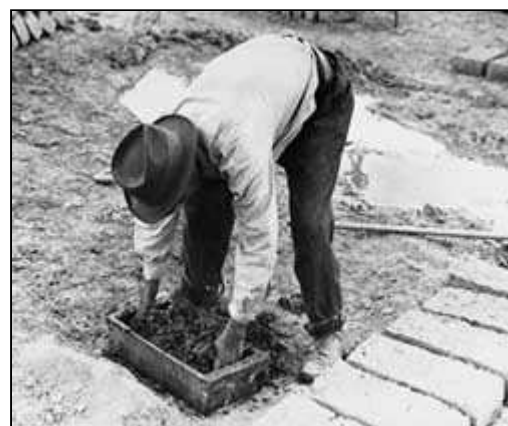
A mixture of mud and straw is pressed into a mold to form an adobe brick. After the adobe brick is removed from the mold, it must dry in the open air for a month or more before it can be used. Photo: Russell

The Brick: The adobe brick is molded from sand and clay mixed with water to a plastic consistency. Commonly, straw or grass is included as a binder. Although they do not help reinforce the bricks or give them added long-term strength, straw and grass do help the bricks shrink more uniformly while they dry. More important for durability, however, is the inherent clay-to-sand ratio found in native soil. The prepared mud is placed in wooden forms, tamped, and leveled by hand. The bricks are then "turned-out" of the mold to dry on a level surface covered with straw or grass so that the bricks will not stick. After several days of drying, the adobe bricks are ready for air-curing. This consists of standing the bricks on end for a period of 4 weeks or longer.

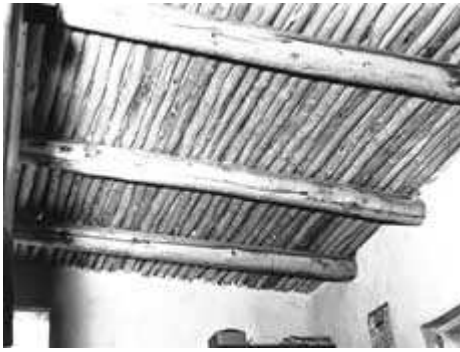
Viga logs and savinos are seen in the interior of the adobe building. Often the wooden materials that comprise the traditional flat adobe roof create interesting and pleasing patterns on the ceilings of interior rooms. Photo: Russell Lee, Farm Security Administration Collection, Library of Congress.

lathing or layers of twigs covered with packed adobe earth. The wood was aspen, mesquite, cedar, or whatever was available. Roughly dressed logs (called "vigas") or shaped squared timbers were spaced on close (23 feet or less) centers resting either on the horizontal wooden member which topped the adobe wall, or on decorated cantilevered blocks, called "corbels," which were set into the adobe wall. Traditionally, these vigas often projected through the wall facades creating the typical adobe construction detail copied in the 20th century revival styles. Wooden poles about 2 inches in diameter (called "latias") were then laid across the top of the vigas. Handsplit planks (called "cedros" if cedar and "savinos" if cypress) instead of poles were used when available. In some areas, these were laid in a herringbone pattern. In the west Texas and Tucson areas, "saguaro" (cactus) ribs were used to span between vigas. After railroad transportation arrived in most areas, sawn boards and planks, much like roof sheathing, became available and was often used in late-19th and early-20th century buildings or for repairs to earlier ones.

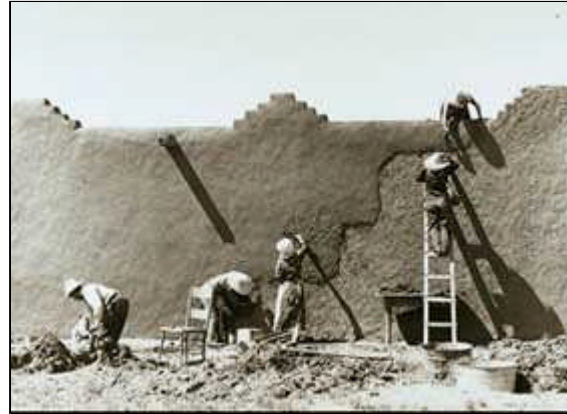
Traditionally, adobe surface coatings that protected the fragile adobe building fabric were renewed every few years. Women are seen here recoating an adobe wall with mud plaster mixed with straw at Chamisal, New Mexico. Photo: Russell Lee, Farm Security Administration Collection, Library of Congress.

Mud Plaster: Mud plaster has long been used as a surface coating. Like adobe, mud plaster is composed of clay, sand, water, and straw or grass, and therefore exhibits sympathetic properties to those of the original adobe. The mud plaster bonds to the adobe because the two are made of the same materials. Although applying mud plaster requires little skill, it is a time-consuming and laborious process. Once in place, the mud plaster must be smoothed. This is done by hand; sometimes deerskins, sheepskins, and small, slightly rounded stones are used to smooth the plaster to create a "polished" surface. In some areas, pink or ochre pigments are mixed into the final layer and "polished."

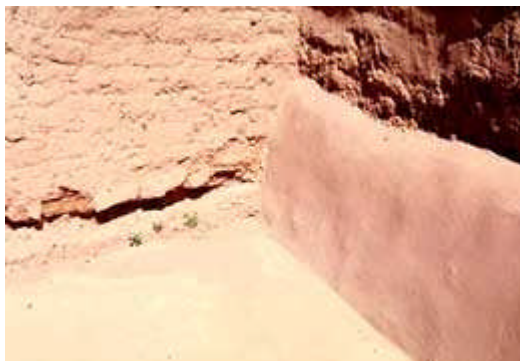
Coving at the base of this adobe wall may have been caused by salts deposited by rising groundwater and/or rainwater splash. Photo: NPS files.

The erosive action of rainwater and the subsequent drying out of adobe roofs, parapet walls, and wall surfaces can cause furrows, cracks, deep fissures, and pitted surfaces to form. Rain saturated adobe loses its cohesive strength and sloughs off forming rounded corners and parapets. If left unattended, rainwater damage can eventually destroy adobe walls and roofs, causing their continued deterioration and ultimate collapse. Standing rainwater that accumulates at foundation level and rain splash may cause "coving" (the hollowing-out of the wall just above grade level).

In repairing "coving," the damage caused by rain splash, adobe bricks stabilized with soil cement might be considered. On the other hand, concrete patches, cement stucco, and curb-like buttresses against the coving usually have a negative effect because moisture may be attracted and trapped behind the concrete.

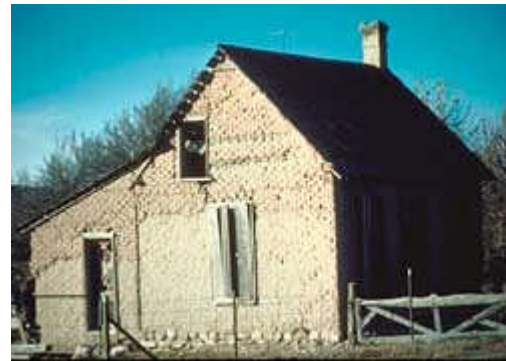
A traditional mixture of mud and straw plaster should be applied to stabilize the exterior of this house. Photo: NPS files.

When the coating has been mud plaster, the process requires that the deteriorated mud plaster be scraped off and replaced with like materials and similar techniques, attempting in all cases to match the repair work as closely as possible to the original. It is always better to cover adobe with mud plaster even though the mud plaster must be renewed more frequently.
