Historic Roofing Materials in America

4 Preservation Briefs

>Roofing for Historic Buildings

Sarah M. Sweetser

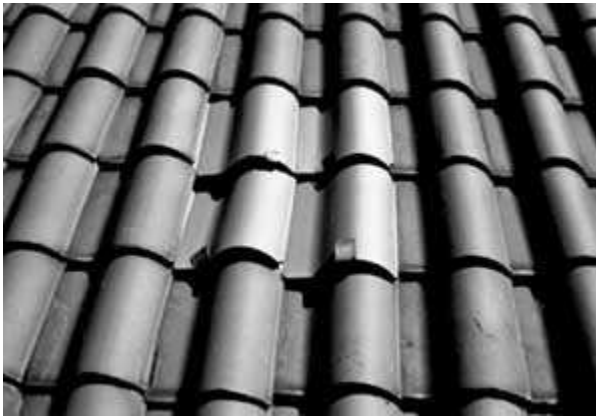
Repairs on this pantile roof were made with new tiles held in place with metal hangers. Photo: NPS files.

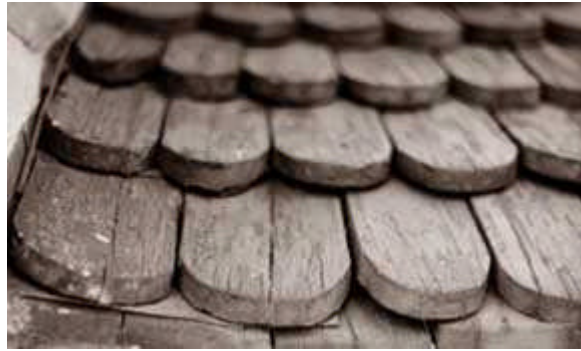
Replacement of particular historic details is important to the individual historic character of a roof, such as this rounded butt wood shingle roof. In the restoration, the drainage around a dormer was improved by the addition of carefully concealed modern metal flashing. Photo: NPS files.

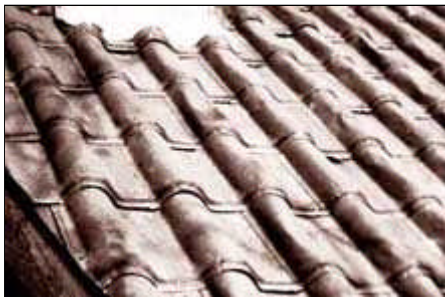
Galvanized sheet-metal shingles imitating the appearance of pantiles remained popular from the second half of the 19th century into the 20th century. Photo: NPS files.

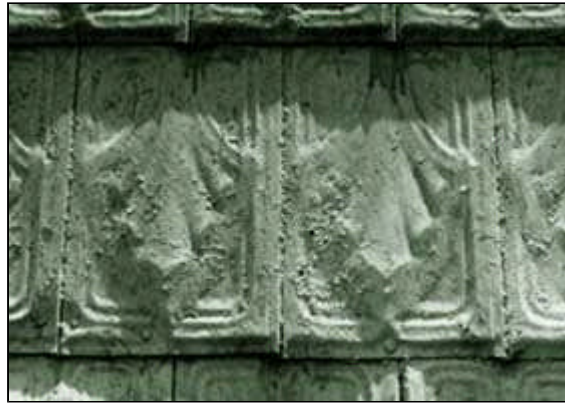
Tin shingles, commonly embossed to imitate wood or tile, or with a decorative design, were popular as an inexpensive, textured roofing material. Photo: NPS files.

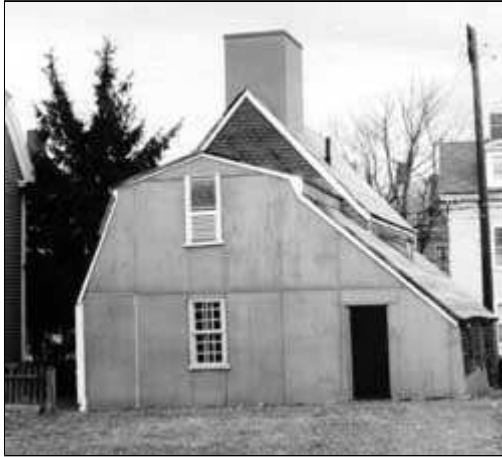
Temporary stabilization or "mothballing" with materials, such as plywood and building paper, can protect the roof of a project until it can be properly repaired or replaced. Photo: NPS files.

It may be necessary to carry out an immediate and temporary stabilization to prevent further deterioration until research can determine how the roof should be restored or rehabilitated, or until funding can be provided to do a proper job. A simple covering of exterior plywood or roll roofing might provide adequate protection, but any temporary covering should be applied with caution. One should be careful not to overload the roof structure, or to damage or destroy historic evidence or fabric that might be incorporated into a new roof at a later date. In this sense, repairs with caulking or bituminous patching compounds should be recognized as potentially harmful, since they are difficult to remove, and at their best, are very temporary.

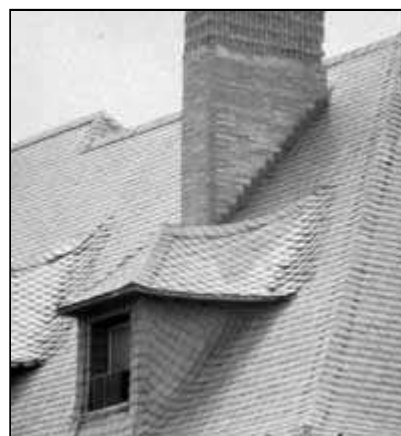
Because of the roof's visibility, the slate detailing around the dormers is important to the character of this structure. Photo: NPS files.

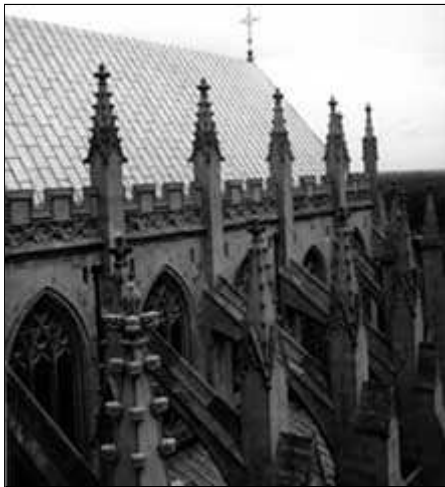
Good design and quality materials for the roof surface, fastenings, and flashing minimize failures. Photo: NPS files.

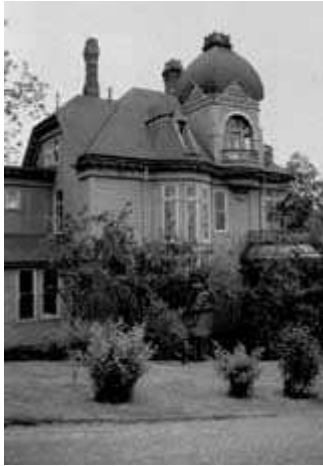
Special problems inherent in the design of an elaborate historic roof can be controlled through regular maintenance. The shape and detailing are essential elements of the building's historic character, and should not be modified, despite the use of alternative surface materials. Photo: NPS files.
