PDHonline Course C370 (5 PDH)

Geotechnical Exploration and Testing for Roads

1.4 PAVEMENT PERFORMANCE WITH TIES TO GEOTECHNICAL ISSUES

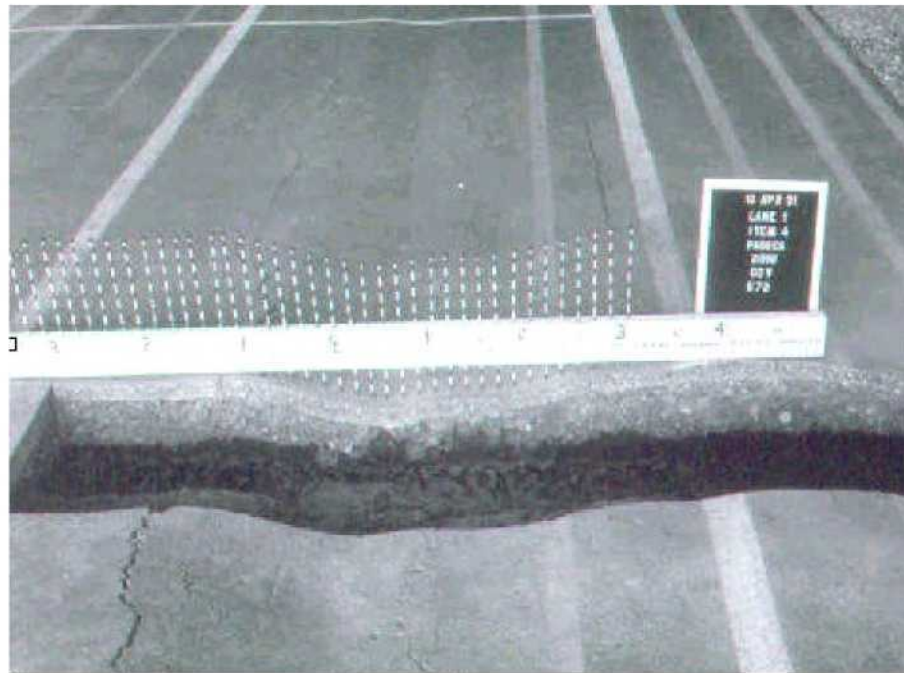
Figure 1-6. Normal rutting.

The shape of the rut trough is usually a good indicator of the source of the permanent deformations. Permanent deformations concentrated in the surface asphalt layers tend to give a narrow rut trough (individual wheel tracks may even be evident), while deep seated permanent deformations from the underlying unbound layers and subgrade typically give a much broader rut trough at the surface.

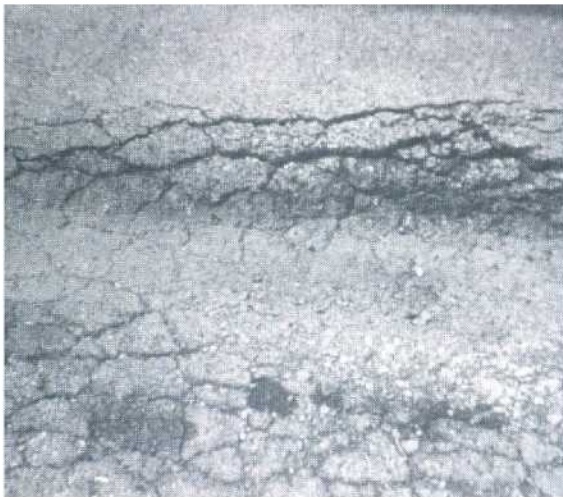
a) Excessive rutting

Permanent Deformations (Rutting, Bumps, Corrugations, and Depressions). Surface rutting is often the controlling stress mode for flexible pavements. It is sometimes caused by an unstable asphalt concrete mixture that deforms plastically within the first few inches beneath the wheel paths. For a well-designed mixture, however, any rutting observed at the surface will be only partly due to permanent deformations in the asphalt layer, with the remainder due to accumulated permanent deformations in the underlying unbound layers and

the subgrade. For example, at the AASHO road test, the percent of final total surface rutting attributable to the asphalt layer averaged 32%, versus 18% for the granular base layer, 39% for the granular subbase, and 11% for the subgrade. In other words, two-thirds of the rutting observed at the surface was due to accumulated permanent deformations in the geomaterials in the pavement structure. Potential causes for excessive permanent deformations in the pavement geomaterials include

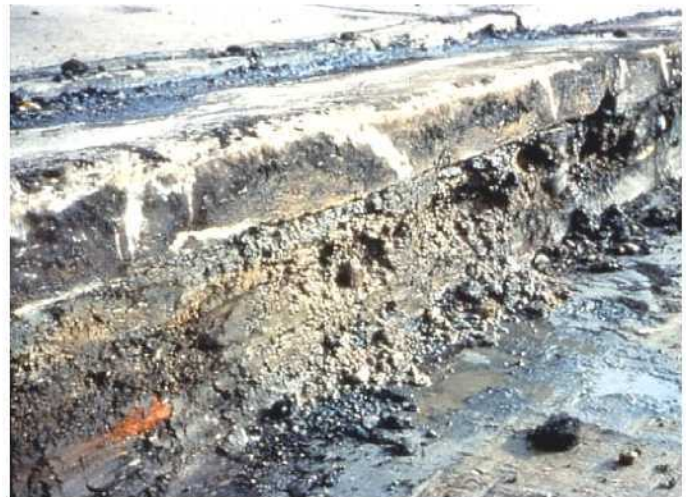
b) Aggregate contamination or degeneration

Figure 1-7. Examples of geotechnical related pavement failures.

- inadequate inherent strength and stiffness of the material.
- degradation of strength and stiffness due to moisture effects (including freeze/thaw); inadequate or clogged drainage systems will contribute to this degradation.
- contamination of base and subbase materials by subgrade fines (*i.e.*, inadequate separation of layer materials).

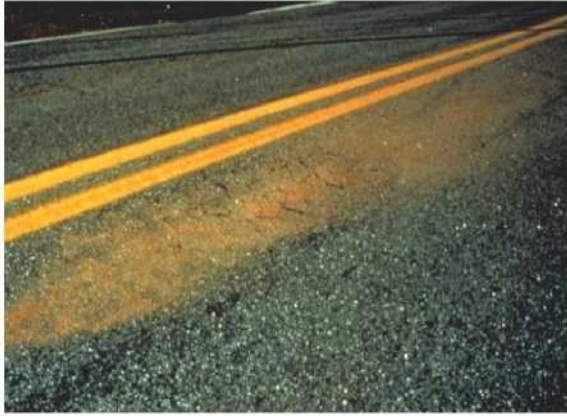
c) Subgrade pumping

Pumping. Pumping is the ejection of foundation material, either wet or dry, through joints or cracks, or along edges of rigid slabs, resulting from vertical movements of the slab under traffic, or from cracks in semi-rigid pavements.

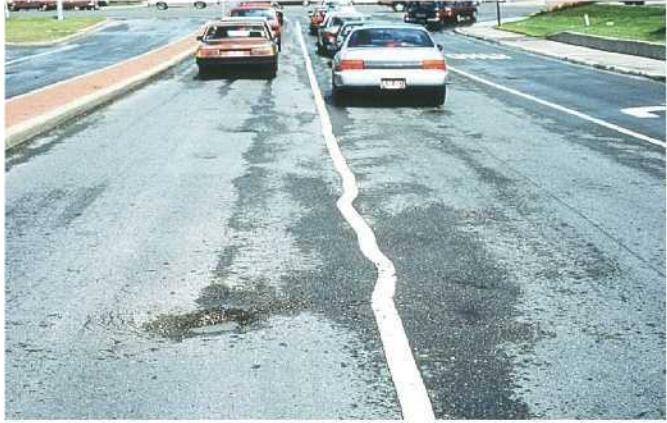
d) Drainage problems

A major effect of the moisture/drainage, freeze/thaw, and contamination (material from one layer intermixing with another) factors listed in Table 1-1 through 1-3 is to degrade the stiffness and strength of the affected unbound materials. Moisture and drainage are combined here because excessive moisture in the pavement system is often the result of inadequate or malfunctioning drainage systems. Freeze/thaw and swelling can cause heaving of the pavement surface. Erosion can produce voids beneath the surface layers, causing a complete loss of foundation support. The spatial variability factor represents the nonuniformity of the geotechnical factors along the pavement and will, in general, apply to all of the other geotechnical factors.

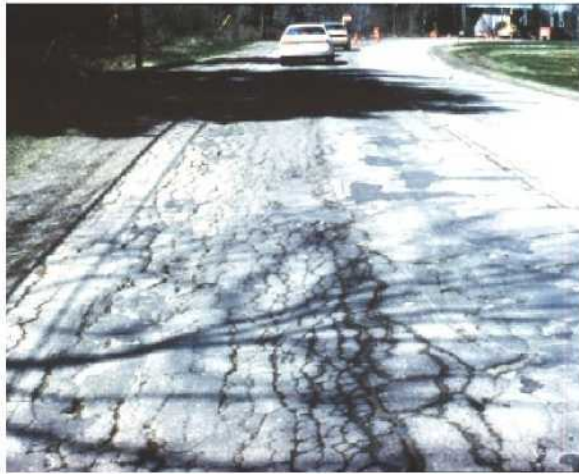
e) Frost action

Potholes. Potholes are formed due to a localized loss of support for the surface course through either a failure in the subgrade or base/subbase layers. Potholes are often associated with frost heave, which pushes the pavement up due to ice lenses forming in the subgrade during the freeze. During the thaw, voids (often filled with water) are created in the soil beneath the pavement surface due to the melting ice and/or gaps beneath the surface pavement resulting from heave. When vehicles drive over this gap, high hydraulic pressure is created in the void, which further weakens the surrounding soil. The road surface cracks and falls into the void, leading to the birth of another pothole. Potholes can also occur as a result of pumping problems.

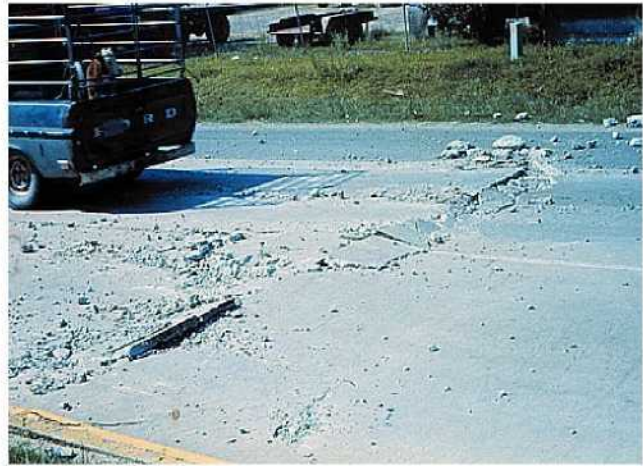
f) Swelling soils

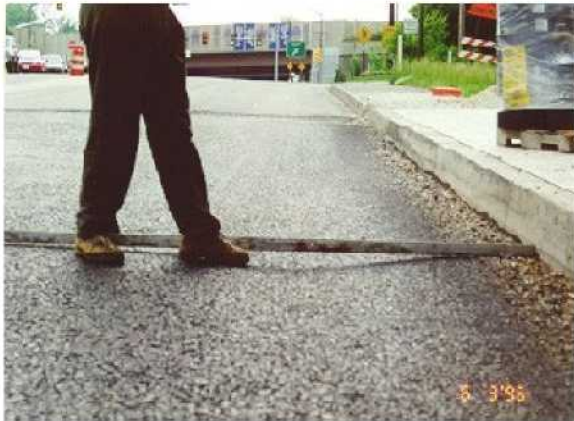
g) Differential settlement

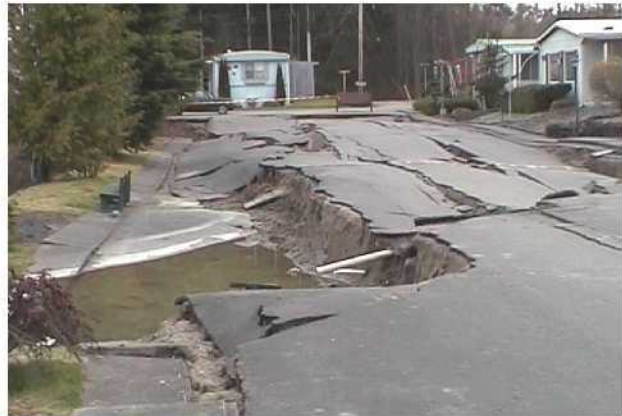
h) Collapsing soils, karst conditions, or liquefaction

Liquefaction. The process of transforming any soil from a solid state to a liquid state, usually as a result of increased pore pressure and reduced shearing resistance (ASTM, 2001) is called liquefaction. Spontaneous liquefaction may be caused by a collapse of the structure by shock or other type of strain, and is associated with a sudden, but temporary, increase of the prefluid pressure.

Sections of Interstate 15 within a 27 km (17-mi) length of roadway in a western state have been experiencing considerable distress since construction. Maintenance costs have been significant, and it appears that distress may not simply be due to an inadequate pavement section. The problems associated with bumps, cracks, and edge failures were likely associated with troubles in the subgrade soils along the alignment. Potential causes could have included collapsible soil, expansive soil, compressible soil, poorly compacted fill, and poor drainage. A study was performed with the objectives of determining the causes for the problems and developing potential solutions prior to design and reconstruction of the area in question. Based on surficial geology and borehole data, zones were identified where collapsible soils were likely the culprit. Because the zone of collapsible soil extends to depths of up to 6 m (20 ft) below the ground surface, deep dynamic compaction was recommended over excavation and replacement as a treatment method in these zones. Distress related to expansive soils exists throughout the study area, but significant damage concentrations are located in a cut section between mileposts 208 and 207 along I-15. This area is long enough to propose treatments for the area, in order to improve ride quality throughout the cut section. This study recommends a combination of methods to improve the odds of success. Because of the potential for differential settlement on the roadway, asphalt pavement should be used in reconstructing the roadway in the study area. A lack of adequate surface drainage is another critical factor leading to problems with both collapsible and expansive subgrade soils in this area. Deep dynamic compaction was found not to be feasible during construction, most likely due to an intervening fine-grained layer in the deposit.
