**PDHonline Course G387 (4 PDH)**

## **Tips for Avoiding Design Blunders**

*Instructor: John C. Huang, Ph.D., PE*

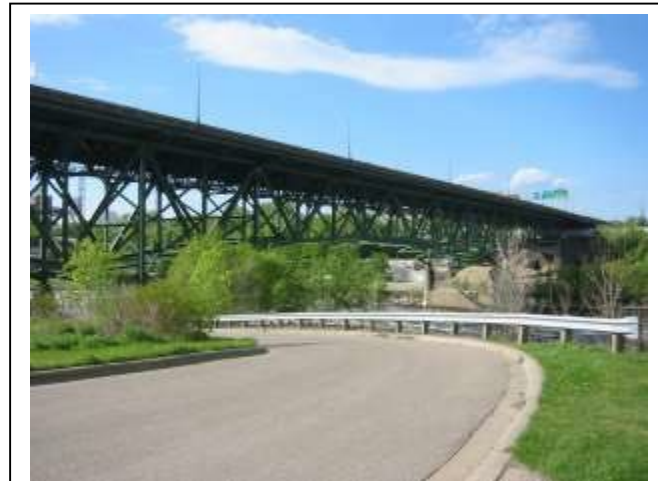
I-35W Highway Bridge before collapse

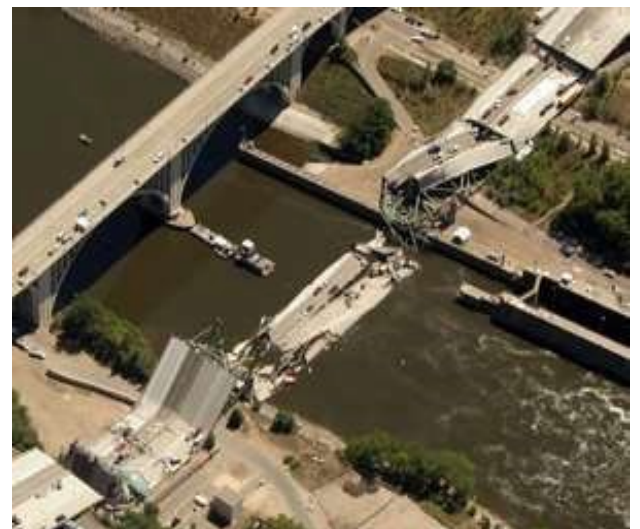
I-35W Highway Bridge after collapse  
Photo: NTSB

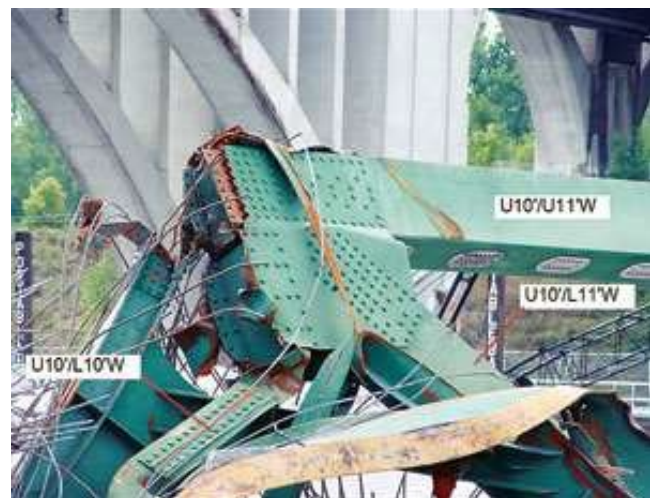
By early 2008, NTSB team knew gusset plates, half as thick as required, were critical factors behind 2007 bridge collapse. Photo: NTSB

The National Transportation Safety Board determines that the probable cause of the collapse of the I-35W bridge in Minneapolis, Minnesota, was the inadequate load capacity, due to a design error by Sverdrup & Parcel and Associates, Inc., of the gusset plates at the U10 nodes, which failed under a combination of (1) substantial increases in the weight of the bridge, which resulted from previous bridge modifications, and (2) the traffic and concentrated construction loads on the bridge on the day of the collapse. Contributing to the design error was the failure of Sverdrup & Parcel's quality control procedures to ensure that the appropriate main truss gusset plate calculations were performed for the I-35W bridge and the inadequate design review by Federal and State transportation officials. Contributing to the accident was the generally accepted practice among Federal and State transportation officials of giving inadequate attention to gusset plates during inspections for conditions of distortion, such as bowing, and of excluding gusset plates in load rating analyses.

1. The initiating event in the collapse of the I-35W bridge was a lateral shifting instability of the upper end of the L9/U10W diagonal member and the subsequent failure of the U10 node gusset plates on the center portion of the deck truss.

5. The damage to bridge components that occurred during victim recovery did not, in this case, prevent determination of the collapse sequence.
6. The gusset plates at the U10 nodes, where the collapse initiated, had inadequate capacity for the expected loads on the structure, even in the original as-designed condition.

20. The bowing of the gusset plates at the U10 and U10' nodes was symptomatic of the inadequate capacity of the plates and occurred under an undetermined load condition before 1999.

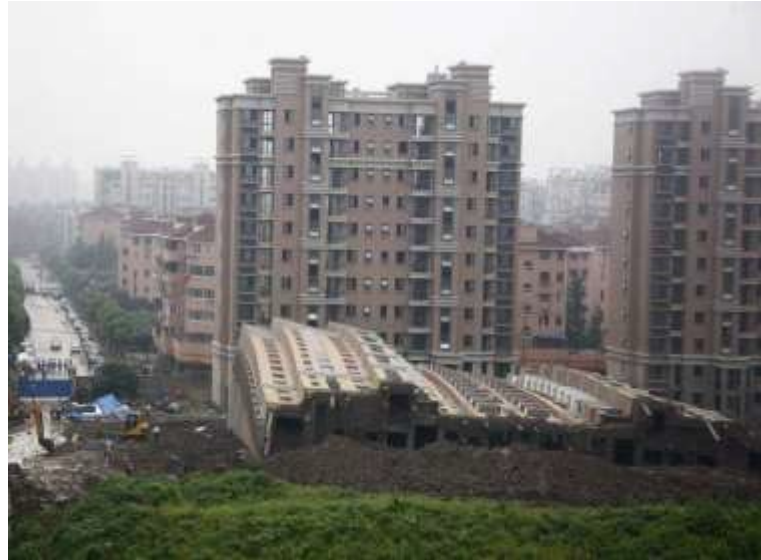
(4) This resulted in a lateral pressure of 3,000 tones, which was greater than what the foundation piles could tolerate. Thus the building toppled over in the southerly direction.

Obviously, improper planning and failure to stabilize the structural foundation had led to the collapse of this residential building – a typical human error. Luckily, the building was not occupied and did not hit other building when collapsed.

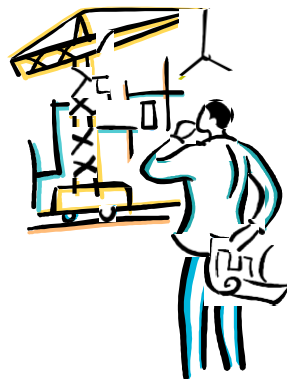
The first Quebec Bridge collapse on August 29, 1907 (during construction) can be partially attributed to the lack of site visits during the construction by the bridge designer.

The Quebec Bridge was twenty years in the making, from the founding of the Quebec Bridge Company in 1887 to the bridge's collapse in 1907. A cantilever bridge was proposed as the most feasible design to bridge the harsh, icy waters of the St. Lawrence River. A riveted steel truss structure, the Quebec Bridge has an eighteen-hundred-foot main span, exceeding in length by some ninety feet the then-longest cantilever, the Forth Bridge in Scotland. The original design for the bridge called for a span of sixteen hundred feet, but Theodore Cooper, the consulting engineer, recommended changing the design after the contract for construction had been drawn up. Thus, cost projections were modified; resulting design changes led to strain on the lower compression members and the bridge's collapse.

Unfortunately, the Quebec Bridge suffered the second construction failure nine years later during its reconstruction. This time, 13 lives were lost. The bridge was finally completed in 1917, and stands today.

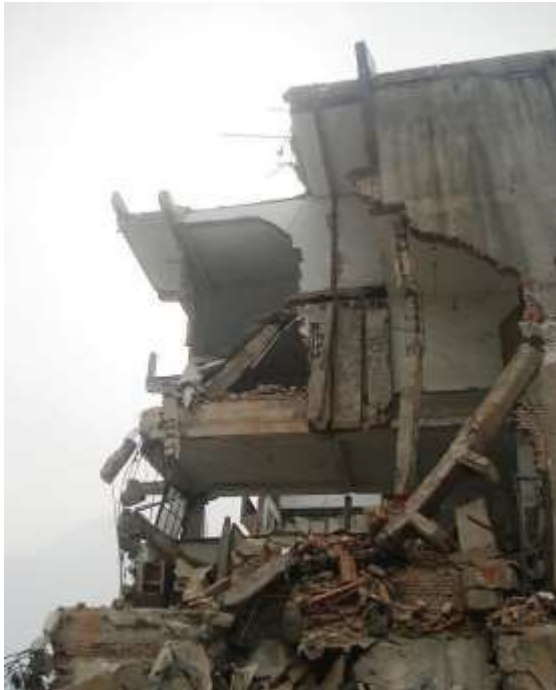
The redundancy in the reinforced concrete floor construction prevented the total collapse of the building shown on the left even when one of the supporting columns was completely destroyed during the Great Sichuan Earthquake on May 12, 2008 (China). Many buildings with precast concrete floor planks in the same region fared much worse than this cast-in-place concrete floor.

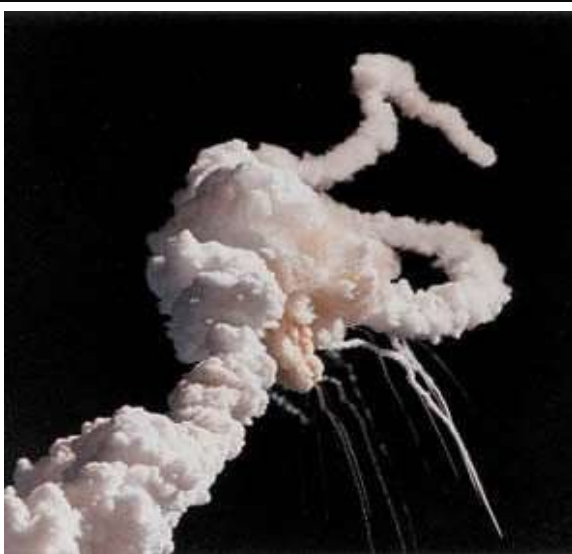
Space Shuttle Challenger's smoke plume after its in-flight breakup, resulting in its destruction and the deaths of all seven crew members. Afterwards, there was a total redesign of the solid rocket boosters, in which three O-rings were incorporated to increase the redundancy and reliability.  
Photo: NASA

On 28 January 1986, space shuttle Challenger broke apart, killing its seven crew members just 73 seconds after its launch. The subsequent Rogers Commission found the cause of the accident was the failure of both primary and secondary O-rings on the right solid rocket booster, allowing pressurized gas to reach the outside. This in turn caused the external tank to dump its payload of liquid hydrogen causing a massive explosion. The problems with the O-rings had been known about for nine years but had been ignored, partly because safety was deemed ensured with the presence of the second ring. However, as was later made clear, the second ring was there for unforeseen failure, not a failure that had been considered. Engineers'

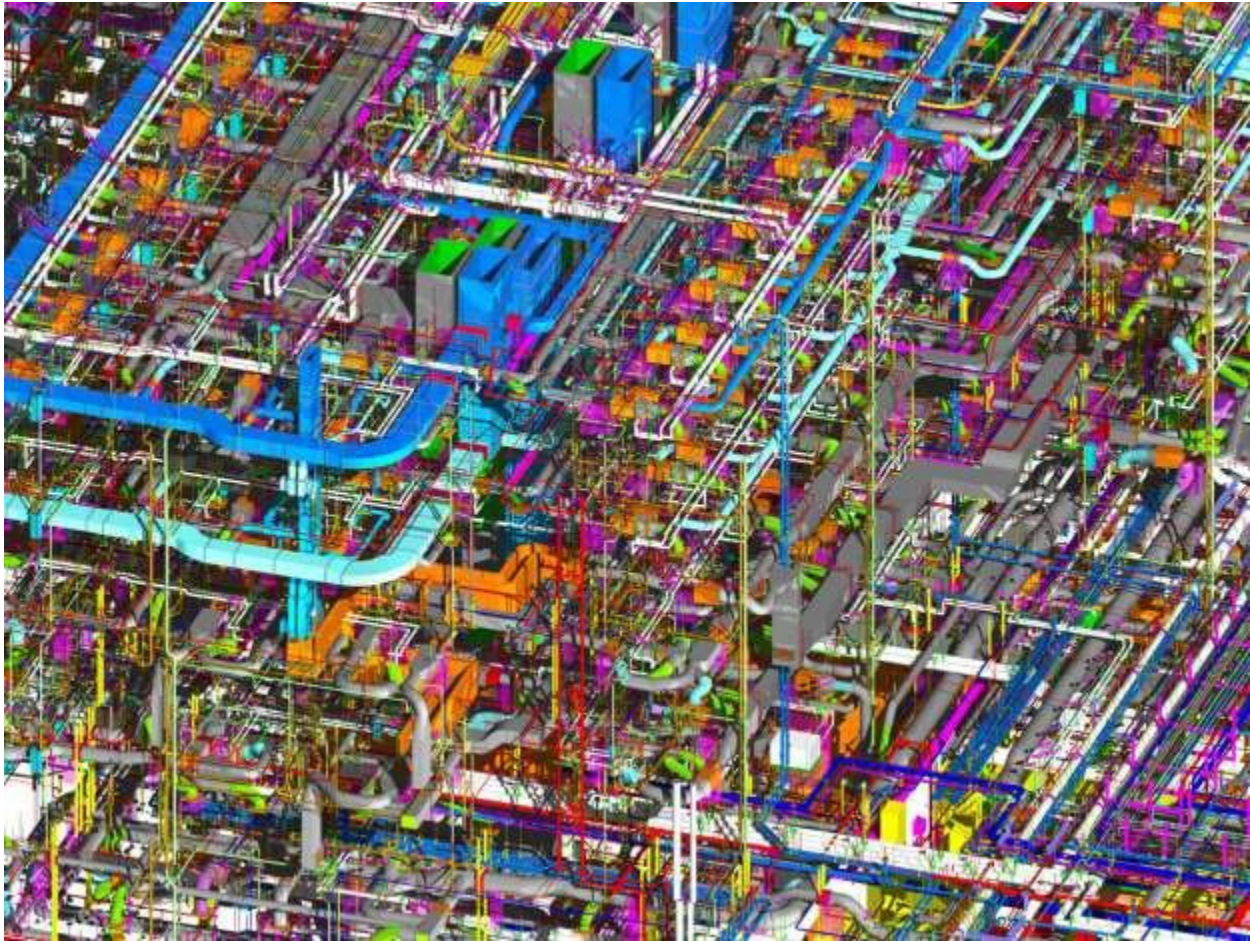
BIM Screenshots | Credit: DPR Construction

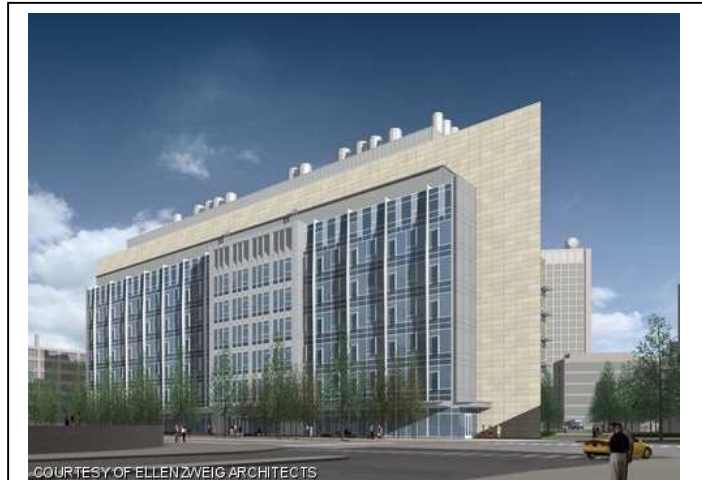
The David H. Koch Institute for Integrative Cancer Research at the Massachusetts Institute of Technology  
Photo: The Tech

Clash detection reporting generated by BIM enables the building team to make early changes, avoiding later, costly changes during the construction process. BIM also enables early coordination between disciplines and helps reduce time spent in the field. For example, the building team for the David H. Koch Institute for Integrative Cancer Research saved \$650,000 by utilizing BIM to identify where beam penetrations needed to be, so that they could be incorporated at the time of steel fabrication.

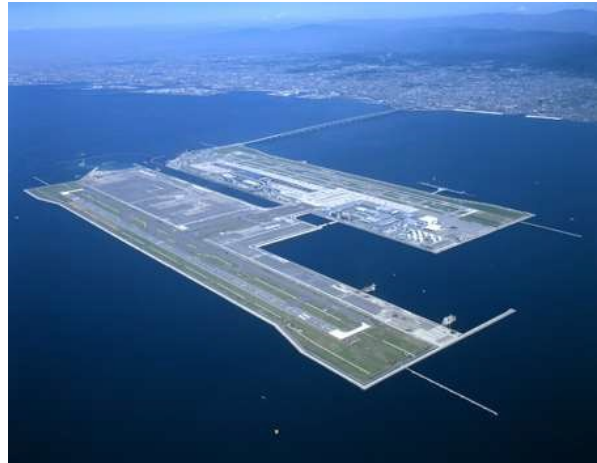
Better known as the "sinking airport," Kansai International Airport was built on an artificial island (reclaimed land). The excessive and continuous soil settlement caused huge cost overruns for the construction and maintenance of this island. A pilot study could have prevented this geotechnical engineering disaster.

The construction of this artificial island started in 1987. Three mountains were excavated to create a 98 ft layer of earth over the sea floor and inside the sea wall. The island had been predicted to sink 19 ft by the most optimistic estimate as the weight of the material used for construction compressed the seabed silts. However, the island had sunk 27 ft during the construction alone – much more than predicted. In 1991, the terminal construction commenced. To compensate for the ongoing sinking of the island, adjustable columns were designed to support the terminal building. They are extended by inserting thick metal plates at their bases.

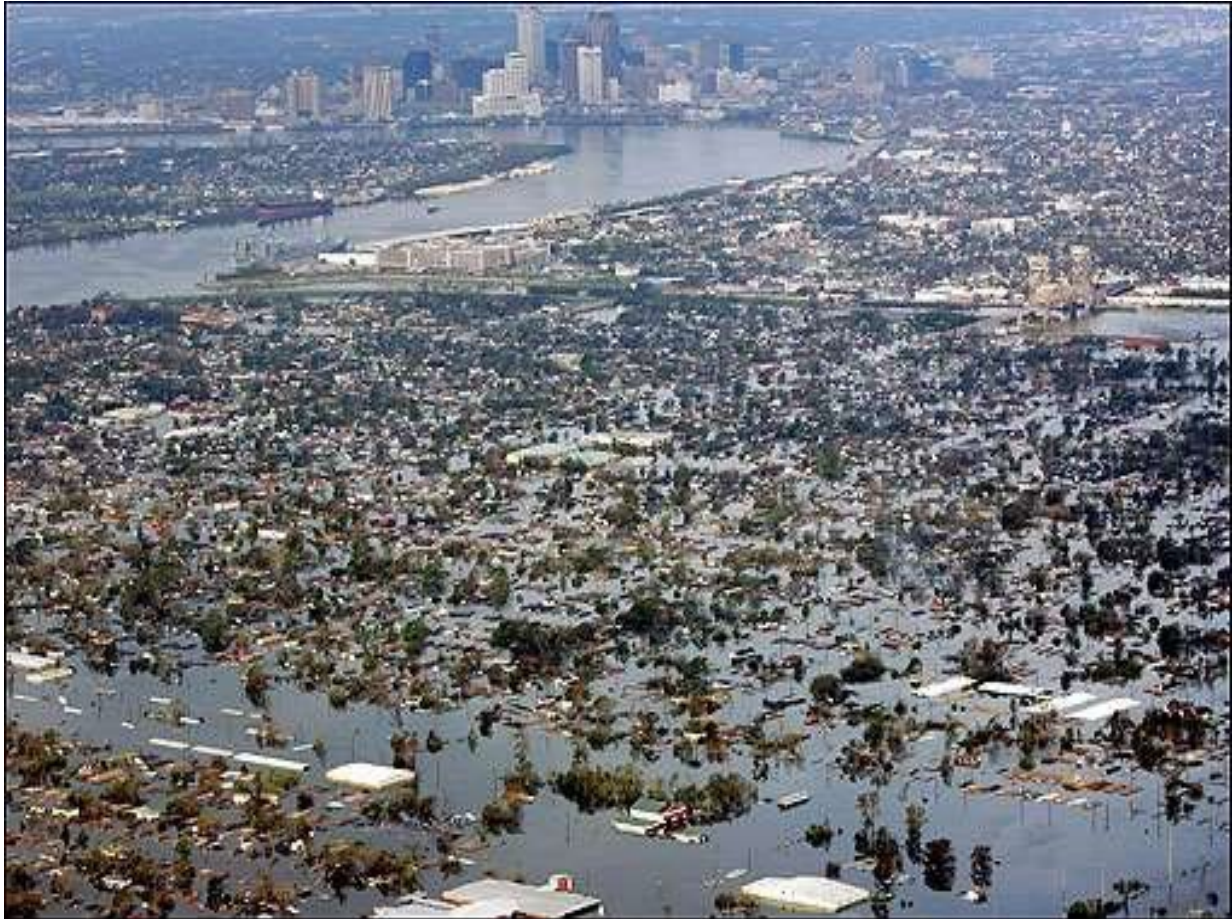
Many of you probably remember this image from your television. As Hurricane Katrina roared ashore in the summer of 2005, the long-ignored warnings about the inadequacy of New Orleans' defenses came shockingly, vividly alive. The flooding of New Orleans that followed was a tragic and appalling disaster. But it was not a natural disaster. Poor project planning, flawed project design, misplaced priorities, and the destruction of the city's natural flood protection – Louisiana's coastal wetlands, were the root causes of the city's ruin. Ultimately 80 percent of New Orleans and large portions of nearby parishes became flooded, and the floodwaters did not recede for weeks. After Katrina, organizations such as American Rivers have called for the adoption of natural flood protection and the abandonment of over-reliance on structural protection as a new approach to flood protection across the country.

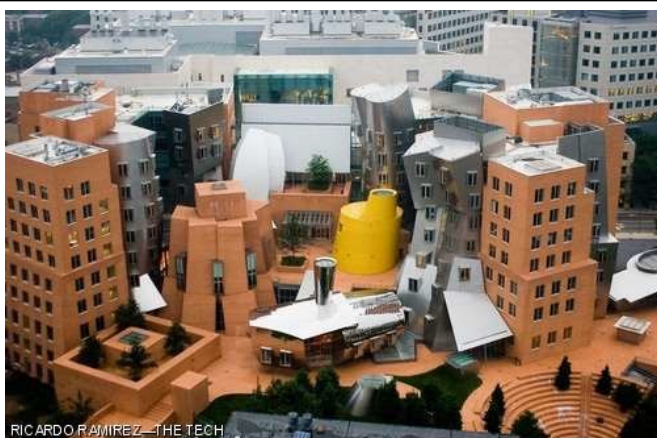
RICARDO RAMIREZ—THE TECH  
The Ray and Maria Stata Center at MIT defies some natural laws governing construction. Photo: The Tech

When the \$300 million Stata Center opened in 2004 at Massachusetts Institute of Technology (MIT), it got a lot of press, especially for its novel appearance featuring tilting towers, many-angled walls and whimsical shapes. However, the building soon suffered persistent leaks, blocked drainage and falling ice. As a result, MIT filed a lawsuit in 2007 against the design and construction teams.
