PDHonline Course M118 (3 PDH)

Introduction to Metallurgical Failure Analysis

Instructor: Semih Genculu, P.E.

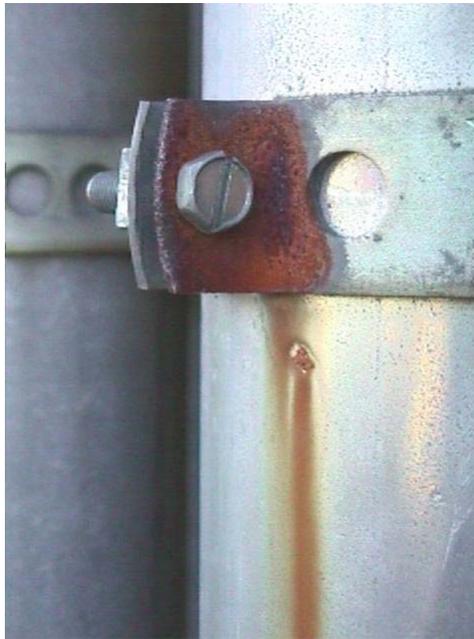
General Corrosion

Corrosion is an undesired chemical action that attacks materials in such a way as to degrade their properties or render them ineffective. General corrosion may result in excessive material loss that weakens a component until it either deforms or fractures under load. Majority of the corrosion failures do not involve fractures. The resulting failure may be in the form of a leak, such as in piping. Even the so-called corrosion resistant materials such as aluminum, stainless steels and titanium that obtain their resistance from a thin adherent oxide film that develops on their surfaces are susceptible to attack under certain conditions. When they are exposed to chemicals that can break down this passive oxide layer, corrosion initiates and progresses in a relatively short time.

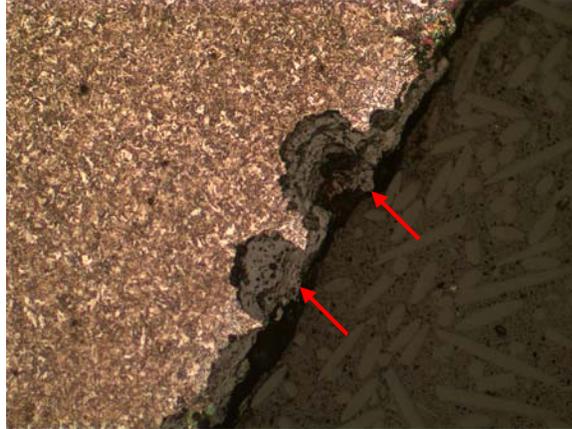
Pitting Corrosion

Pitting corrosion is a localized form by which attack can lead to perforations in the material. It is considered to be more dangerous than uniform corrosion because it may be difficult to detect and also design against. A small pit with insignificant overall metal loss can lead to the failure of a complex system. Pitting is usually initiated by the breakdown of a protective film (passive oxide layers or

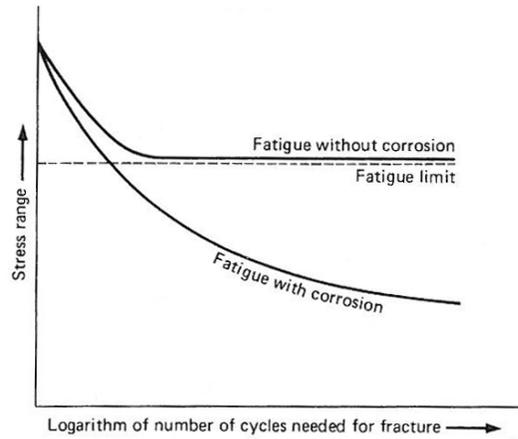
This is a mechanism where the combined effects of cyclic stress and corrosion are acting on a component. Preventative measures are to reduce the stress level and provide corrosion protection. The general effect of corrosion on fatigue failures may be illustrated as shown in the fatigue curve below. More detailed discussion of the S-N curve (stress versus number of cycles to failure) will be included in the fatigue section.

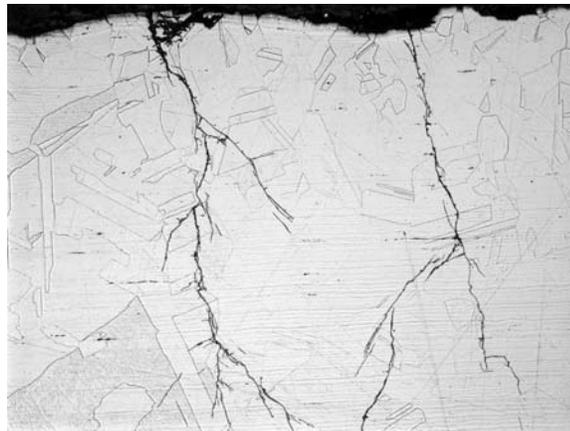
Micrograph showing transgranular SCC in Stainless Steel

SCC is the formation of cracks through the simultaneous action of stress and a corrosive environment. The stresses that lead to SCC may be external or residual stresses from processing. Certain materials are more susceptible to this type of attack when exposed to specific environments. Austenitic stainless steels or aluminum alloys in chloride containing environments and copper alloys in ammonia are a few detrimental alloys/environment combinations.

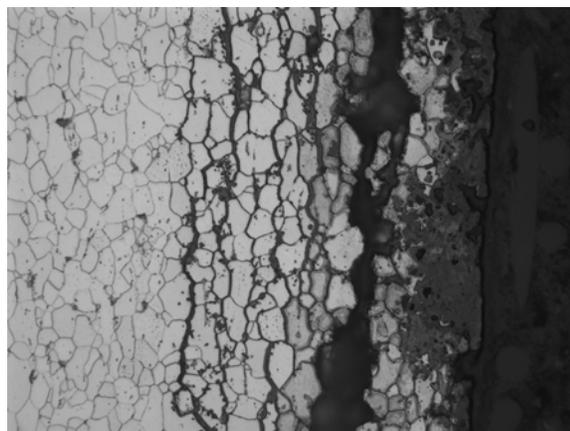
Micrograph showing intergranular attack

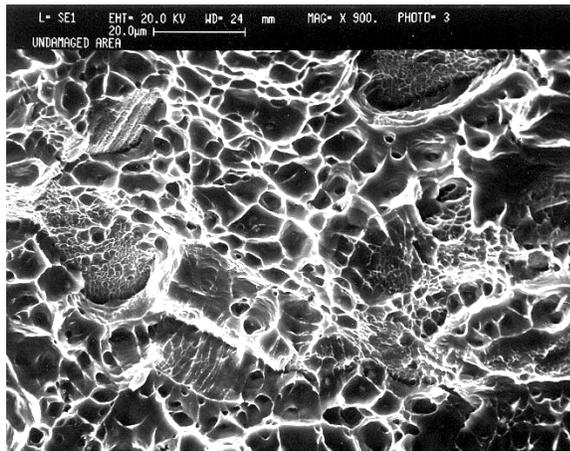
SEM micrograph showing undamaged area

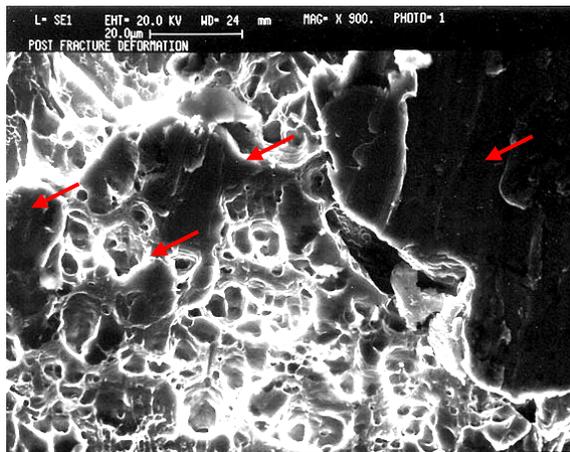
SEM micrograph showing post fracture damage due to smearing of the surfaces

Don't ever fit the two broken halves together, this will damage the surface features that can provide very useful information

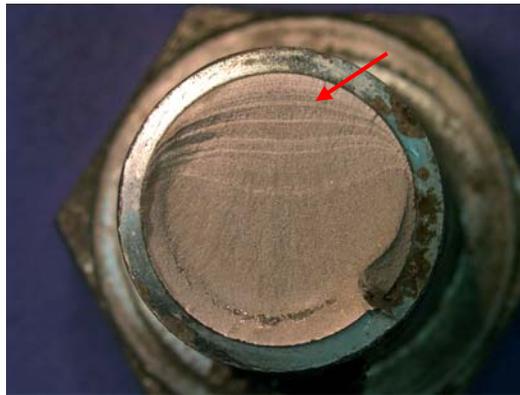
Bolt fracture surface

During receipt inspection, the analyst should verify the number of parts, note and photodocument the condition of the parts. As-received photo documentation is very useful especially once the parts are sectioned for testing. Documentation should be conducted throughout the analysis so that the information can later be shared with and described to all concerned parties. Color photography is recommended to illustrate the contaminants and show discoloration or temper marks. Macro examination using stereomicroscopy (5-50X) will allow determination of the failure origin, presence of stress concentrators, direction of crack propagation and other physical data. An example is shown below where a fatigue crack initiated in the fastener (arrow) and progressed until the remaining cross sectional area could no longer support the load and failure occurred via ductile overload.

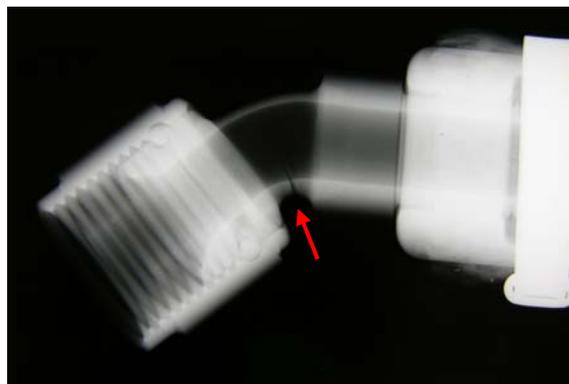
Radiography (x-ray) shows the crack location in tubing

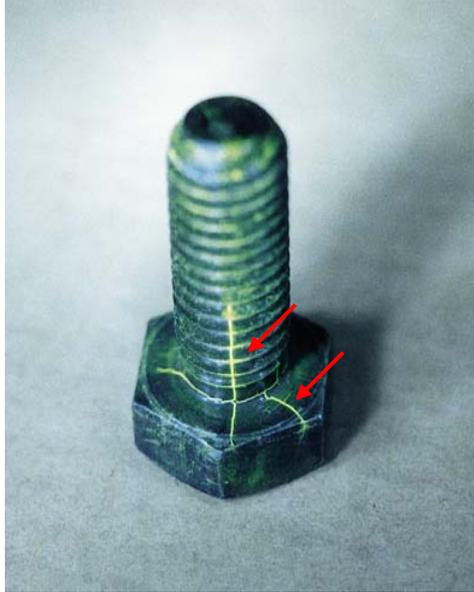
Magnetic particle testing reveals the quench cracks in this high strength steel bolt.

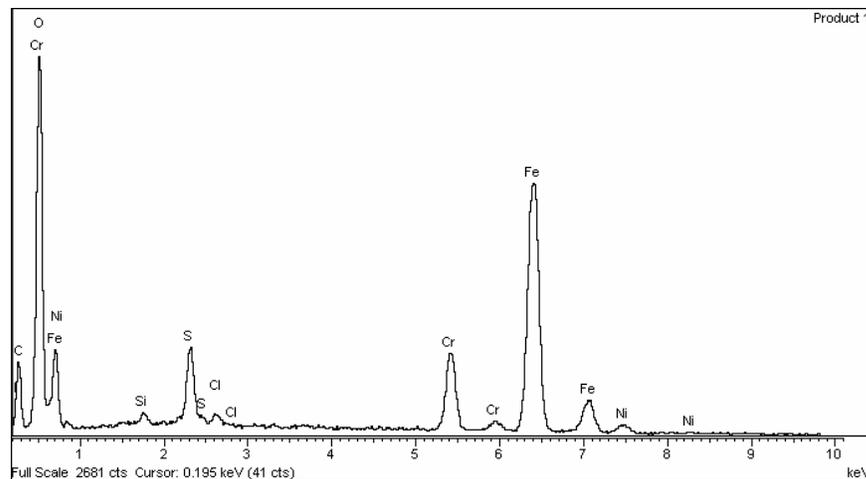
EDS spectrum showing the typical results of the technique, which can provide elemental make up information in a nondestructive manner on limited material or micron size particles. Chart shows presence of iron, chromium, nickel, sulfur and carbon.

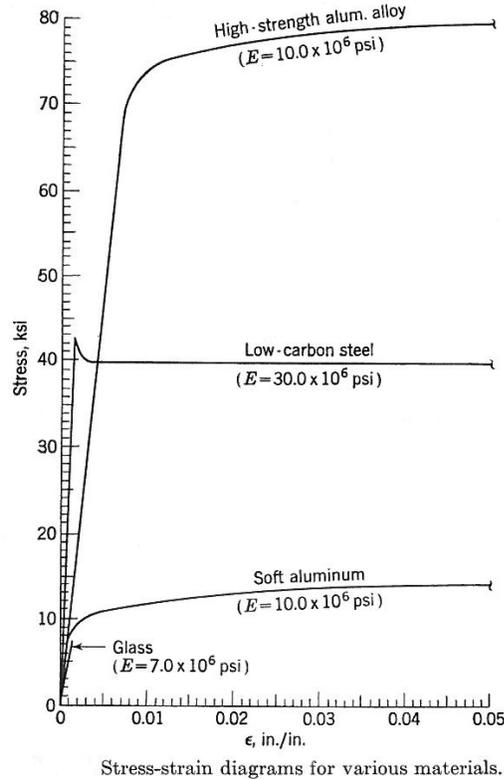
A stress-strain chart obtained through tensile testing can provide information regarding the ultimate tensile strength, yield strength, % elongation, and % reduction in area. The behavior of some common materials and their corresponding modulus of elasticity are shown below.

If the initial portion of the stress-strain graph is linear, as in the case of materials shown above, that is the strain is proportional to stress, then the material can be considered to have a modulus of elasticity (or Young's modulus, E). It is calculated as the ratio of stress to strain, and its unit is psi (pounds per square inch). A very rigid material will have a high E value.

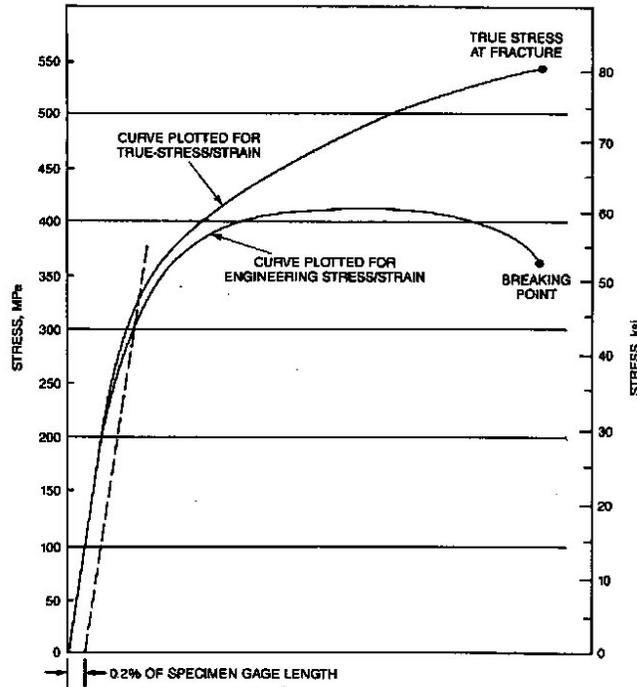
Stress strain diagram showing the behavior of a ductile material during a tensile test. The yield point (the transition from elastic to plastic range) is typically determined using the 0.2% offset method when there is not a sharp transition. Tensile strength corresponds to the break (fracture) point. Percent elongation is usually determined within a gage length (on a standard tensile specimen this is the 2 inch reduced section, which is put back together after the test and the amount of stretch within this gage length is determined as the %E). Reduction in area is another way of expressing the ductility of the material and is determined by comparing the final cross sectional area at the fracture site to the original stress area of the specimen.

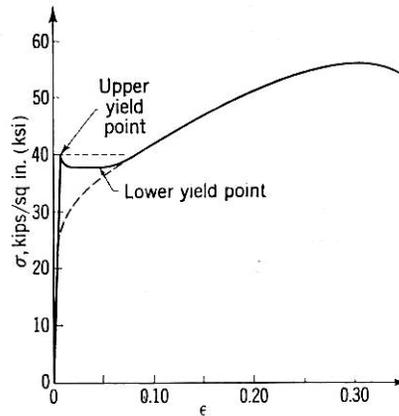
Most of the steels used for ordinary structures have carbon contents in the order of 0.25 percent and are often called low-carbon or mild steels. These steels typically display two yield points as shown above. The first yield point (upper yield point) is higher than the second and the yield drops dramatically after the upper yield point. There is practically no plastic strain up to this point, where certain internal restraining effects are abruptly released (e.g. dislocations generated by the initial elastic elongation) and plastic yielding begins, dropping the stress necessary for elongation. The deformation occurring throughout the yield-point elongating is heterogeneous in a way that discrete

localized bands of plastic deformation, often readily visible, appear on the specimen. These bands are generally at approximately 45° to the tensile axis. They are usually called Luder bands, Hartmann lines or stretcher strains. Coincident with the formation of the first band, the load drops to the lower yield point. The yield point gap is followed by plateau in stress-strain curve called yield point elongation when bands propagate along the length of the specimen. Further loading then causes increasing strain and the behavior displayed in the above graph is exhibited.

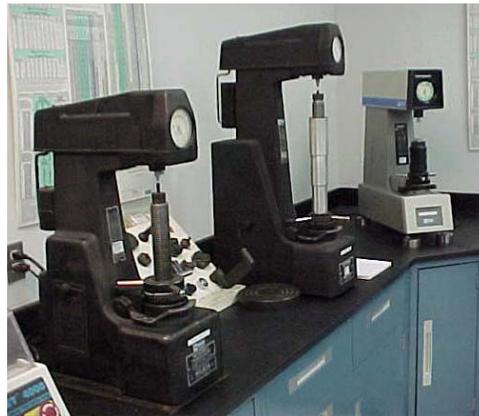
Rockwell hardness testers

The other most common test, especially if the component is too small and not suitable for tensile testing, is the hardness test. These results may also be used to estimate approximate tensile strengths. Typical methods include: Brinell, Rockwell (e.g. HRC, HRB, HRF), superficial Rockwell (e.g. HR30T, HR15N). These techniques employ various test load and indenter combinations. For hard materials the most common scale is the Rockwell C scale using a diamond tip and a 150 kg load. Softer materials may be tested using the Rockwell B scale (using a 1/16" diameter ball and 100 kg load). Brinell may be used for both hard and soft materials with either a 3,000kg or a 500kg load with a 10 mm carbide ball. This is the preferred scale for cast irons since the structure of the cast iron contains soft graphite (in the form of flakes or nodules) and a relatively hard matrix; the large indenter utilized in Brinell testing allows sort of an average hardness to be determined. Smaller tips or lighter loads may give inconsistent or nonuniform values. For extremely thin sections or case hardened parts Microhardness (e.g. Knoop, Vickers using diamond tips and typically loads around 500 grams) are utilized. Besides the small or very thin samples microhardness testing –which has to be conducted on polished specimens- is also used to determine case depths, evaluate cold working effects and properties of heat affected zones (HAZ) of weldments.

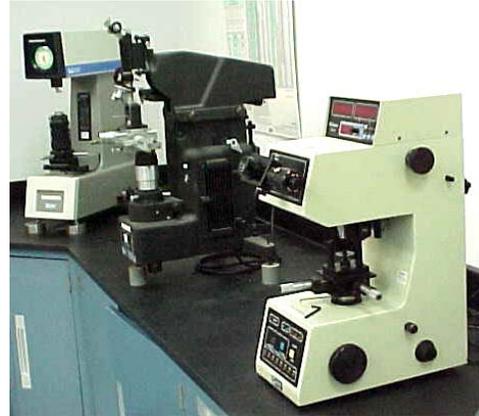
Microhardness testers

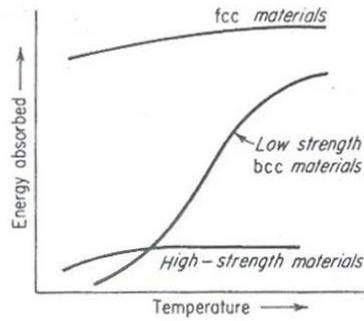
Charpy impact testing is one the most common ways of determining the toughness of a material. It is also one of the most revealing tests for detecting the low temperature brittleness in otherwise ductile materials. Charpy test uses a small specimen, typically with a v-notch in it. The specimen is supported horizontally at its ends in the impact machine and struck on the side opposite to the notch by a swinging pendulum type hammer. The energy dissipated by fracturing the specimen is measured in ft-lbs and can be plotted against the test temperature. As shown in the graph below carbon and alloy steels behave in a unique manner compared to other materials (e.g. aluminum or stainless steels) and can fail in a brittle manner when subjected to low temperatures. This ductile to brittle transition occurs abruptly when certain temperatures are reached.

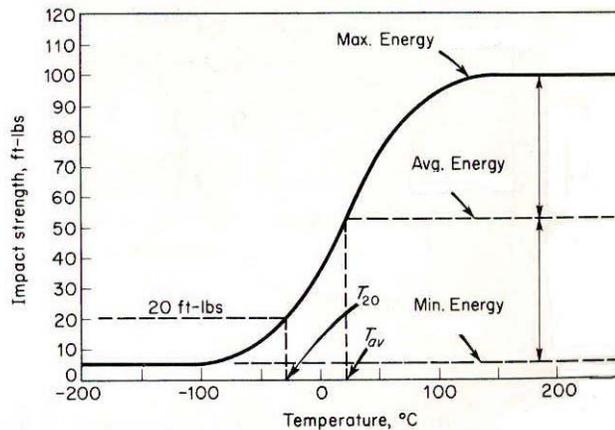
For some heats of steel this transition may take place at around ambient temperature. If the failure is determined to be brittle then the impact properties of the material at the expected service temperature should be determined. Series of Charpy impact tests may also be conducted over a temperature range to determine the ductile-to-brittle transition temperature. The graph below illustrates this phenomenon and the various ways of determining the transition temperature. The most common ways are either by establishing the temperature that corresponds to a minimum energy value such as 15 or 20 ft-lbs, or the mid-point (average energy) value between the lower and upper energy shelves of the energy curve that is developed by testing a series of impact specimens over a wide temperature range.

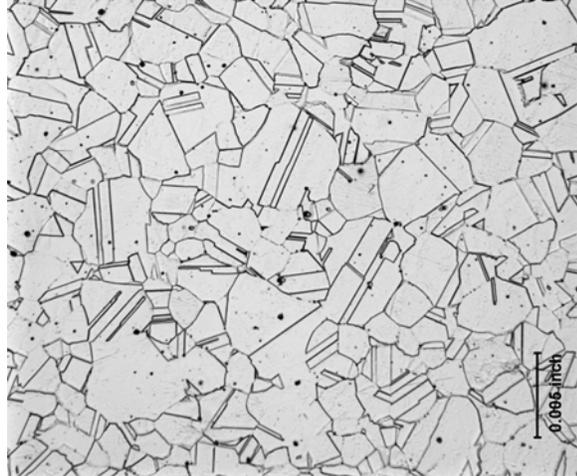
Micrograph showing annealed grains in a stainless steel part.

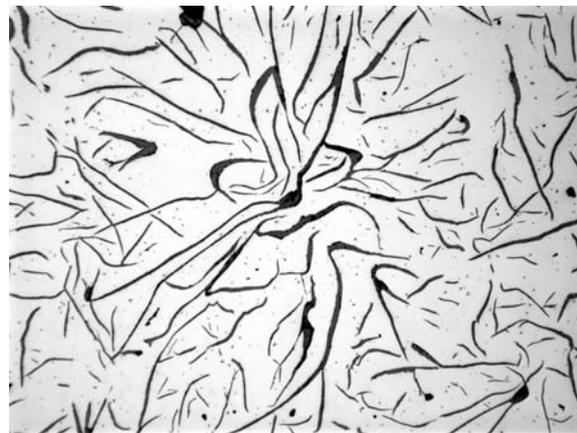
Micrograph showing the graphite flakes in a gray cast iron part (unetched condition)

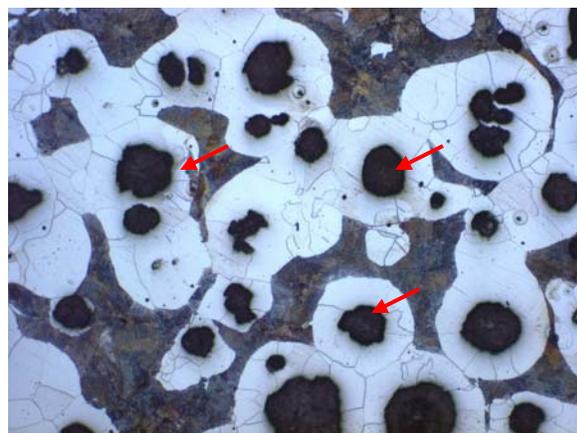
Micrograph showing the graphite nodules in a ductile cast iron part (etched condition)

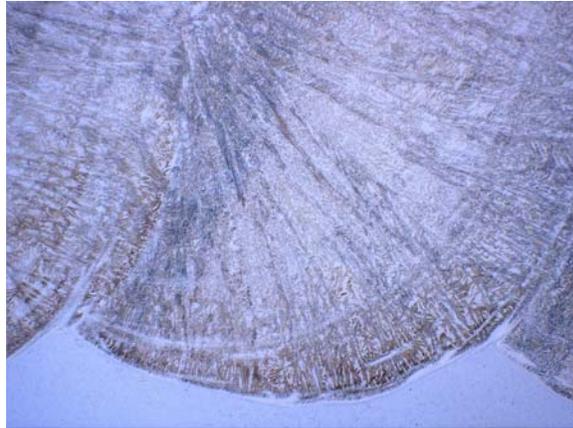
Micrograph showing the weld microstructure on a steel sample

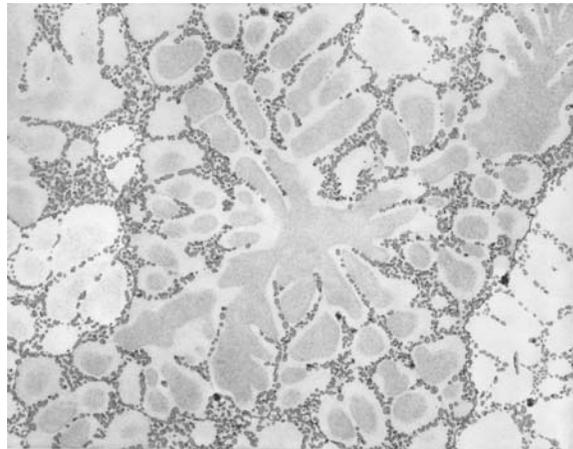
Micrograph showing the cast structure of a brass alloy

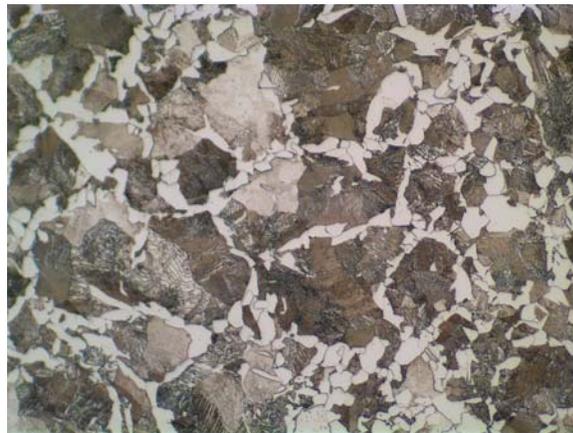
Micrograph showing the pearlitic (dark, carbon-rich) and ferritic (light, carbon-free) microstructure of a steel sample

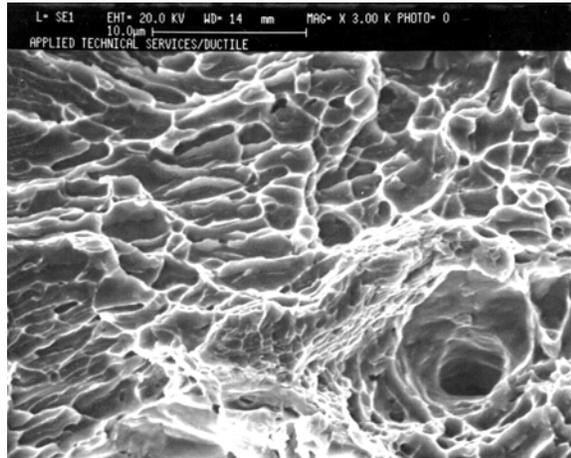
SEM micrograph showing typical ductile fracture features.

Ductile rupture: Typically the main difference between ductile and brittle fracture is the amount of plastic deformation that the material experiences before the fracture. Ductile materials exhibit significant amount of deformation while brittle materials show very little or no appreciable deformation before fracture. Ductile failures initiate with microvoids. When deformation continues and these microvoids enlarge to form a crack, the separation is said to have occurred due to microvoid coalescence.

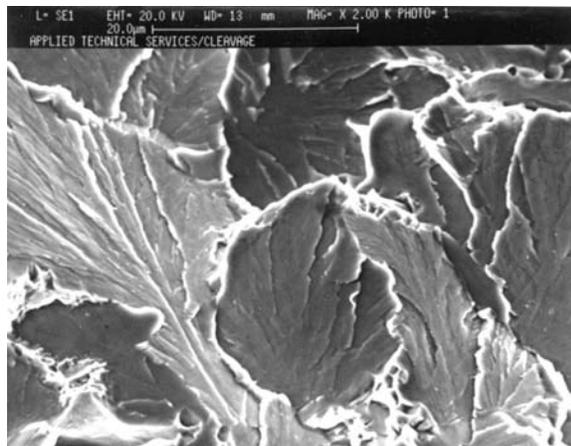
SEM micrograph showing typical brittle-cleavage fracture features.

Brittle fractures can occur in two distinct modes, transgranular cleavage and intergranular separation. Cleavage fracture progresses along crystallographic planes of a material and leaves ledges or steps behind. Some also include river patterns. Intergranular fracture, also known as "rock candy" in materials with coarse grain size (i.e. castings) is another form of low energy failure that usually indicates a service environment or processing problem. Typical causes are quench cracking, temper embrittlement, hydrogen embrittlement, liquid metal embrittlement, precipitation or transformation of detrimental phases due to high temperature exposures or stress corrosion cracking.

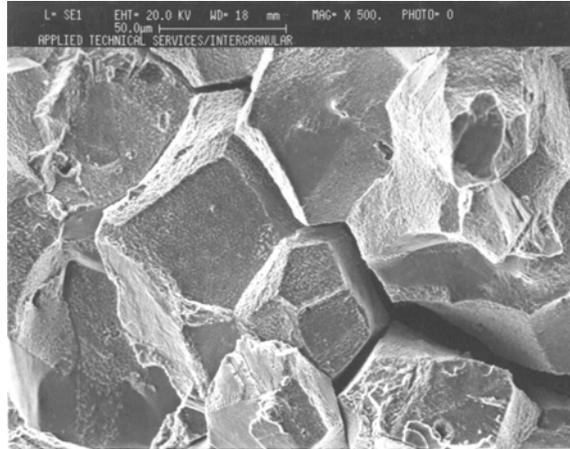
SEM micrograph showing intergranular fracture features.

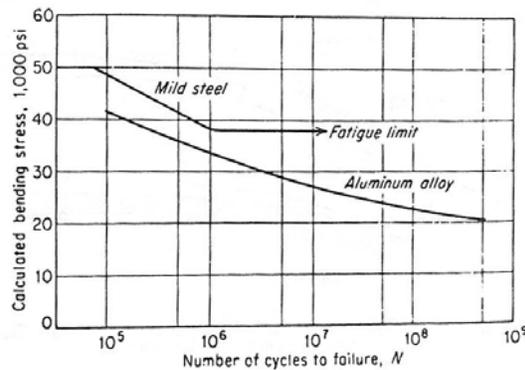
Typical bending fatigue curves comparing the fatigue characteristics of mild steel versus aluminum alloys

Note the lack of the “knee” for the aluminum alloy, compared to mild steel. Fatigue or Endurance limit is defined as this point on the curve where the number of cycles to failure becomes a straight line (infinite) at this stress level.

Fatigue fractures occur at stress levels below the yield stress of the material. They are produced by stresses repeated thousands or millions times (caused by cyclic loading). They are found in shafts, gear teeth, fasteners, vehicle frames, and various machine components. The crack propagates in a progressive manner due to fluctuating stresses. Cracks initiate at either metallurgical (e.g. porosity, inclusion, hard or soft spots) or geometrical (sharp change in cross section, toe of a weld, corrosion pits, etc.) stress concentration points. The fatigue process consists of the following stages: crack initiation, crack propagation and final sudden fracture of the remaining cross section. The maximum cyclic stress that can be applied indefinitely under fatigue conditions is called the endurance limit of the material as illustrated in the S-N curve below. For steels, the endurance limit is approximately 40% of the tensile strength.

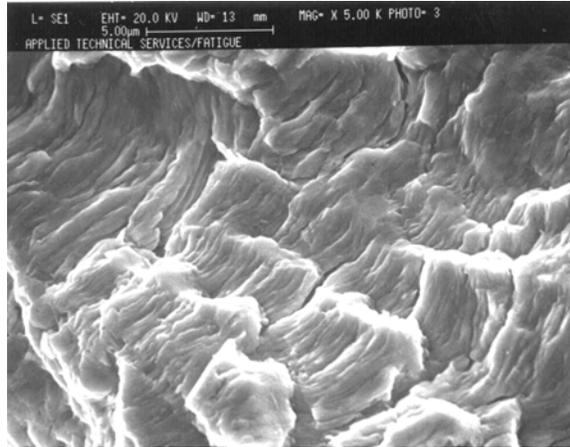
SEM micrograph showing fatigue striations.

Typical features that are observed on the fracture surfaces in most cases are "striations" which correspond to the growing crack with alternating load cycles. Fracture surfaces may also exhibit beach marks (sometimes referred to as clamshell marks), which are macroscopic fatigue features marking the interruption/succession cycles of the progressive crack front.

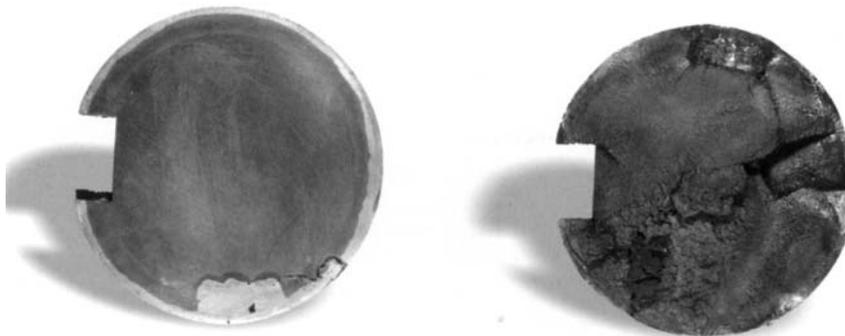
Analysis/Cause of Failure: SEM examination of the fracture surface revealed the fracture mode to consist mainly of fatigue. A metallurgical cross-section below the fracture plane revealed a weld overlay on the shaft with a weld metal filled original keyway. The interface between the weld metal and the shaft material in the keyway contained areas with porosity and lack of fusion. Microhardness measurements indicated that the heat-affected zone (HAZ) was much harder than either the weld metal or the base metal. These defects provided the initiation site for the fatigue crack that led to the failure of the shaft due to cyclic loading.

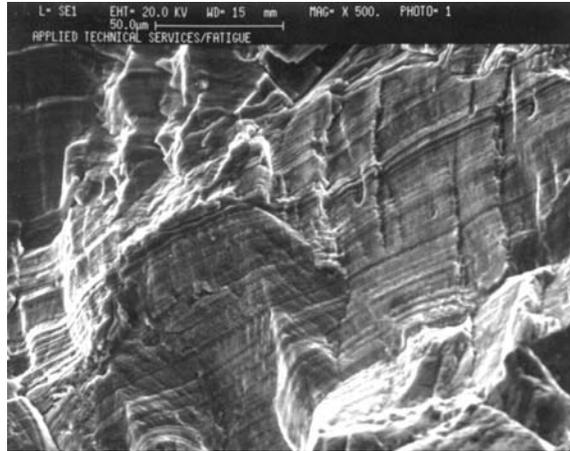
SEM showing fatigue striations

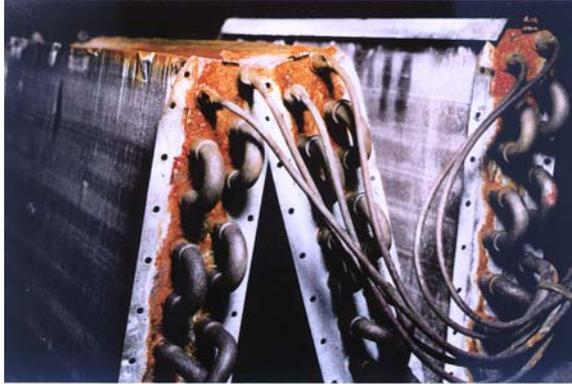
Overall view showing corrosion

Analysis/Cause of Failure: Pitting corrosion between the cooling fins and the copper tubing was determined to be the cause of failure. No evidence of corrosive species was found through EDS analysis. Metallographic examination of pits revealed features characteristic of formicary corrosion. Formicary, which is also known as ant-nest corrosion due to the unique appearance of the microscopic interconnected pits and cavities, mainly occurs in the HVAC industry. The residual organic drawing fluids used in fabrication decompose into acids when exposed to moisture and air during service and cause this type of corrosion. Thorough cleaning of the coils is required after fabrication to eliminate this type of attack in service.

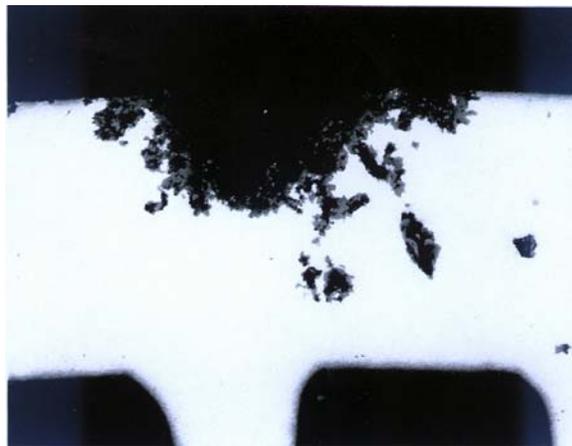
Micrograph showing pit "network"

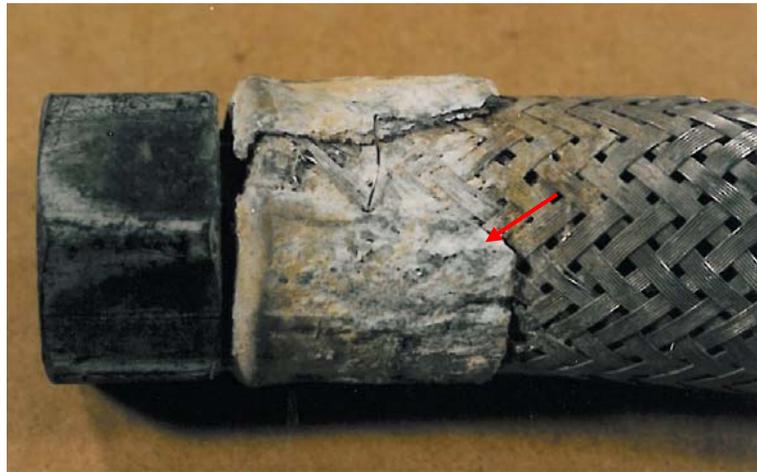
The corroded aluminum ferrule

Analysis/Cause of Failure: Evaluation of the two different types of hoses that were used in the system revealed that both types were experiencing corrosion as shown in the below photographs. However, the leaks were confined to the ones with aluminum ferrules not steel. Energy dispersive x-ray analysis (EDS) of the corrosion products did not show evidence of any corrosive species (i.e. chlorides) that were suspected to have leached out of the insulation and accelerated the attack. The corrosion appeared to be as a result of condensation and entrapment of moisture between the hose and the pipe insulation. Metallographic examination of the ferrules revealed attack on both the exterior and the interior surfaces of the aluminum ferrule that was in contact with the stainless steel braid.

The primary corrosion mechanism was determined to be galvanic attack between the ferrule and the braid due to dissimilar metals being in contact with each other. This condition, in the presence of an electrolyte (i.e. water) causes corrosion of the less noble metal, which was aluminum in this case. Assuming water/moisture cannot be avoided, replacing the aluminum ferrule with one made from the same type of stainless steel material as the braid is recommended to eliminate the galvanic corrosion.

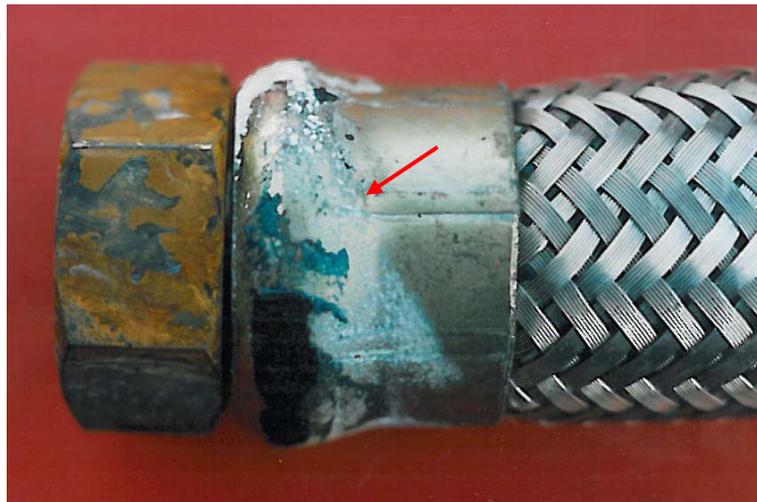
The corroded carbon steel ferrule
