Repair and Replacement of Historic Slate Roofs

29 Preservation Briefs

The Repair, Replacement & Maintenance of Historic Slate Roofs

Jeffrey S. Levine

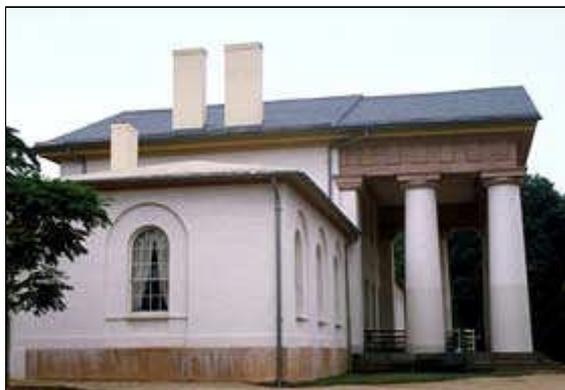
Although slate replacement roofs are expensive, the superiority of materials and craftsmanship will give years of continued service. If amortized over the life of the roof, the replacement cost can be very reasonable. Photo: NPS files.

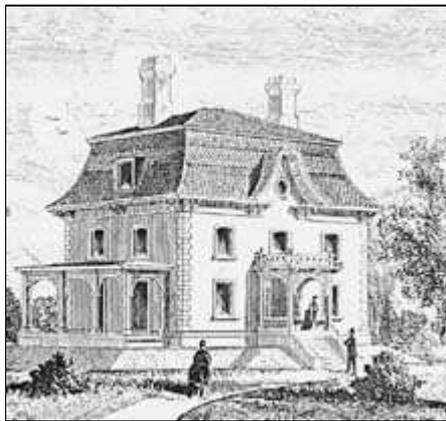
Architectural pattern books of the mid-19th century awakened Americans to the availability and quality of slate for roofing purposes. Drawing: Design XX, "A French Roof House," in A.J. Downing's Victorian Cottage Residences.

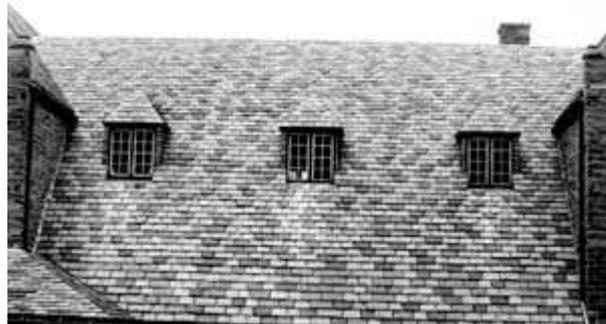
This graduated slate roof is composed of large, thick slates at the eave which are reduced in size and thickness as the slating progresses to the ridge. Photo: Jeffrey S. Levine.

Graduated slate roofs were frequently installed on large institutional and ecclesiastical structures. The slates were graduated according to thickness, size, and exposure, the thickest and largest slates being laid at the eaves and the thinnest and smallest at the ridge. Pleasing architectural effects were achieved by blending sizes and colors.

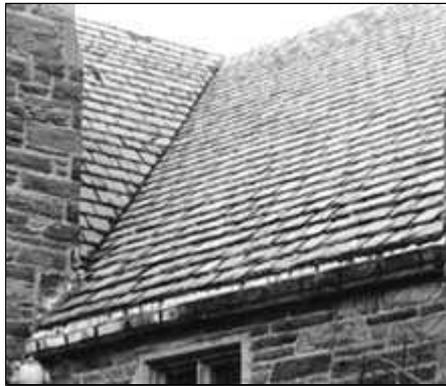
Valleys are formed at the internal angle of two roofing slopes. Flashing is often placed under the slate to increase moisture protection at this vulnerable joint. Photo: Jeffrey S. Levine.

Two types of valleys were traditionally employed, the **open valley** and the **closed valley**. The open valley is lined with metal over which slates lap only at the sides. Closed valleys are covered with slate and have either a continuous metal lining or metal flashing built in with each course. Open valleys are easier to install and maintain, and are generally more watertight than closed valleys. Round valleys are a type of closed valley with a concave rather than Vshaped section. Given the broader sweep of the round valley, it was not uncommon for roofers to interweave asphalt saturated felts rather than copper sheet in the coursing in order to cut costs.

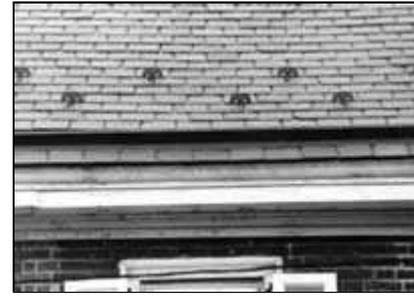
Eave details include snow guards, snow boards, and gutter treatments. Snow guards are generally used in areas where the ice and snow accumulate to avoid dangerous slides from the roof.
Photo: Jeffrey S. Levine.

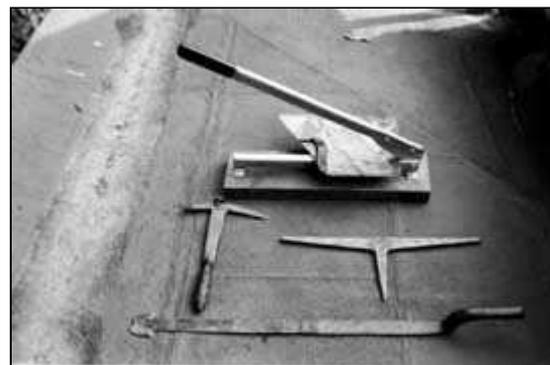
These traditional slater's tools are used to cut and trim, hammer, measure, and rip out nails.
Photo: Jeffrey S. Levine.

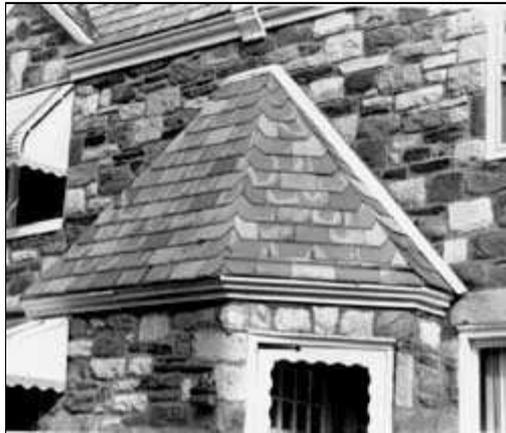
The white blotches on these Pennsylvania Soft-Vein slates indicate areas where gypsum is leaching out onto the surfaces of the slates. Photo: Jeffrey S. Levine.

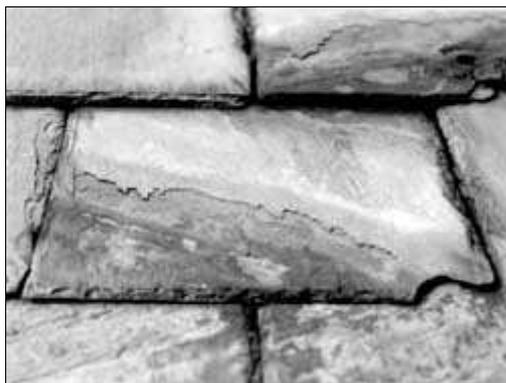
Paper thin lamination can be seen flaking off this weathered, 120 year piece of Pennsylvania Hard-Vein slate. Photo: Jeffrey S. Levine.

The natural weathering of roofing slate manifests itself as a slow process of chipping and scaling along the cleavage planes. Paper thin laminations flake off the surface of the slate and the slate becomes soft and spongy as the inner layers begin to come apart, or delaminate. The nature of the sound given off by a slate when tapped with one's knuckles or slating hammer is a fair indication of its condition.

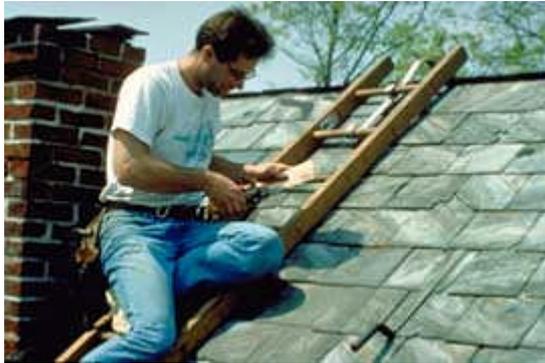
After removing the deteriorated slate and sliding the new slate into place, it is secured with a copper nail. A copper bib (shown here) is formed to protect the newly created nail hole. Finally, a slate hammer is used to push the bib in place over the nail head. Photo: Jeffrey S. Levine.

To prevent water penetration through the newly created nail hole, a piece of copper with a friction fit, measuring roughly 3" (7.5 cm) in width and 8" (20 cm) in length, is slid lengthwise under the joint between the two slates located directly above the new slate and over the nail. Alternate methods for securing the replacement slate include the use of metal hooks, clips, and straps that are bent over the tail end of the slate. The application of roofing mastic or sealants to damaged slates should not be considered a viable repair alternative because these materials, though effective at first, will eventually harden and crack, thereby allowing water to enter.

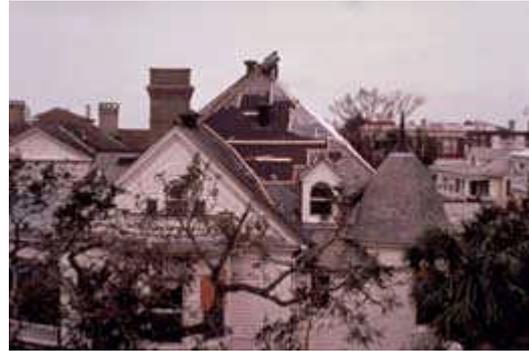
After a hurricane or other natural disaster, it may be necessary to stabilize a roof temporarily until materials can be obtained and a qualified roofing contractor hired. Significant slate roofs should not be stripped off and replaced with asphalt shingles. Photo: NPS files.

process to begin. Heavy gauge plastic and vinyl tarpaulins are often used for this purpose, though they are difficult to secure in place and can be blown off in high winds. Roll roofing, carefully stitched in to areas of the remaining roof, is a somewhat more functional solution that will allow sufficient time to document the existing roof conditions, plan repairs, and order materials.

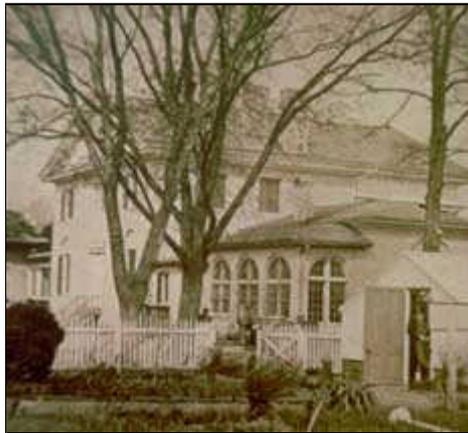
Prior to a replacing a roof, historical documentation is gathered (such as photo documentation) to determine the roof configuration. Photo: NPS files.

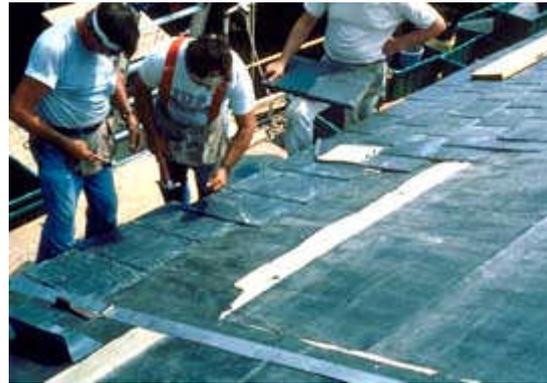
Roofing felt is being installed over the decking; a rubberized membrane is used selectively at the eaves and under some flashing. Photo: NPS files.
