**PDHonline Course M399 (4 PDH)**

# **Plastics Fundamentals: Properties and Causes of Failures**

*Instructor: Semih Genculu, P.E.*

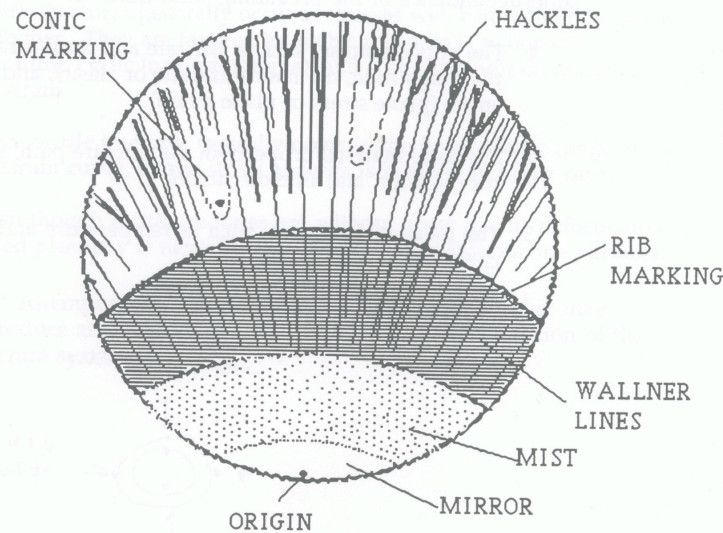
### ***Characteristic fracture zones of a brittle failure***

Brittle fractures in plastics exhibit characteristic features, several of which are macroscopically visible. These may include a mirror zone at the origin, mist region, and rib marks. The mirror zone is a smooth, flat, featureless region surrounding the origin and associated with the slow crack growth phase of fracture. In many polymers the mirror zone is the remnant of a ruptured craze. The size of the mirror zone depends both on the prevailing stress at the time of the fracture and the fracture toughness of the material. The mist region is located immediately adjacent to the mirror zone and displays a misty appearance. This is a transition zone from slow to fast crack growth. Rib marks are semi-elliptical lines resembling beach marks. Regions of the fracture surface containing hackle lines are typically rough in appearance. The hackles consist of divergent lines radiating outwards from the fracture origin. They are perhaps the most reliable features to use to locate the fracture origin by back tracing along the path of crack growth. Hackled regions are associated with high-energy dissipation due to localized plastic deformation on the fracture surface. They are regions of violent activities involving high crack velocity, rapid changes in the stress field, and non co-planar fracture paths. Hackles are commonly observed in the regions subjected to bending where the stresses change from compression to tension.

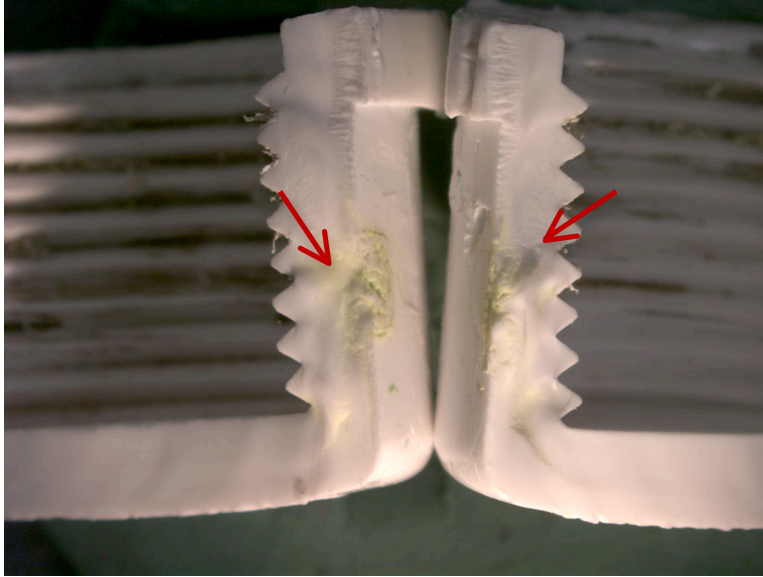
A view of the side opposite the ridge side revealed the features of a weld line failure. This weld line was where the initial failure occurred. A weak weld line would result from processing conditions (melt mold and/or core temperature too low). The crack initiated here and progressed up this side and across the top of the cap.

In this part the mold design had the gate on the side. The melt entering from the side split around and over the core rejoining at the weld line. The figure above shows the side with shear ridges before contrasting "coating" was applied to the surface to reveal fracture features. The gate location is visible (arrows).

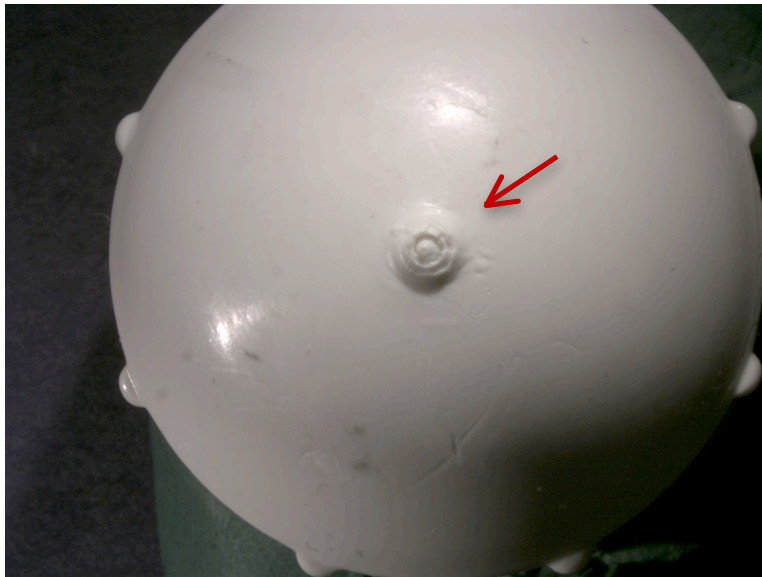
There was evidence of severe tool marks on the cap's exterior surface at the initiation point where the weld line was located. The installation practice and the undesirable location of the weld line combined to cause the failure under water pressure.

Photograph of an exemplar end cap showing an alternate mold design where the injection gate is located at the top instead of the side. With this design there would not be a weld line. The melt would enter at the top and flow down the sides of the part ending at the bottom without forming a weld line.

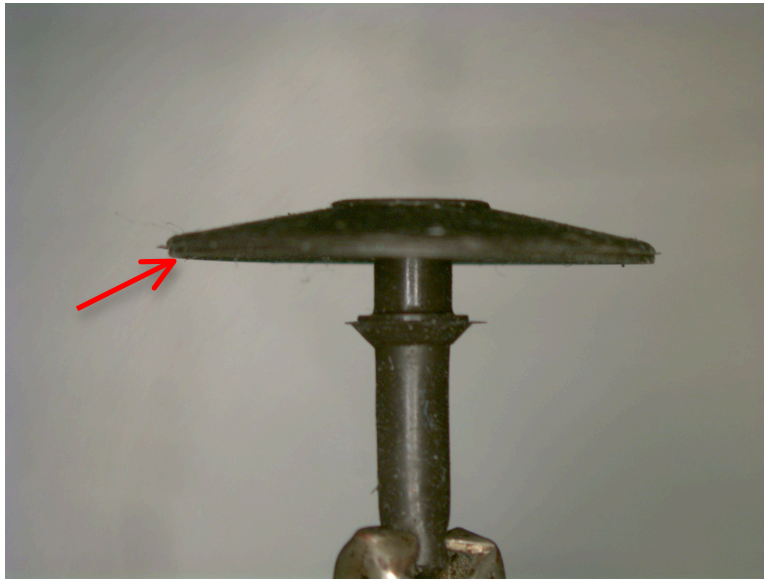
Photograph showing the mushroom shaped flapper head (arrow), anchor stem, and anchor rib. The anchor stem and anchor rib inserted into one end of the anchor hole in the valve head.

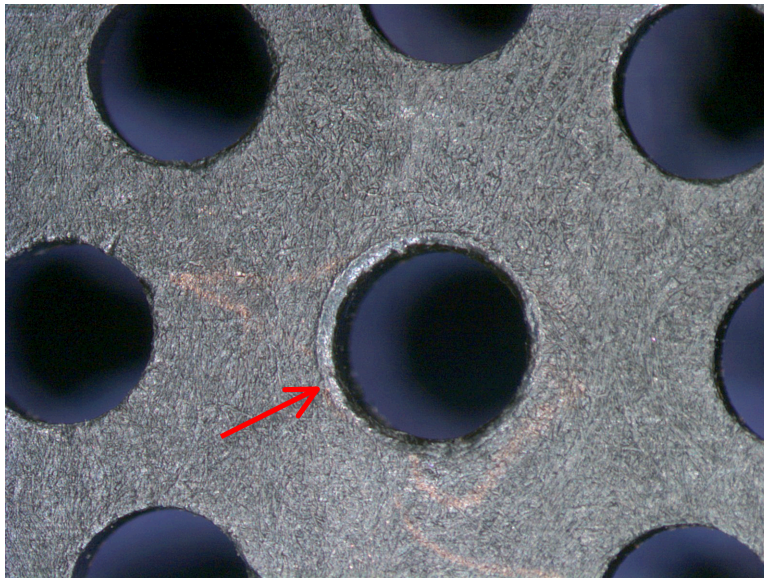
Compressor valve head with anchor hole (arrow) for the flapper surrounded by the air holes. Compressed air would lift the flapper to allow flow in one direction only.

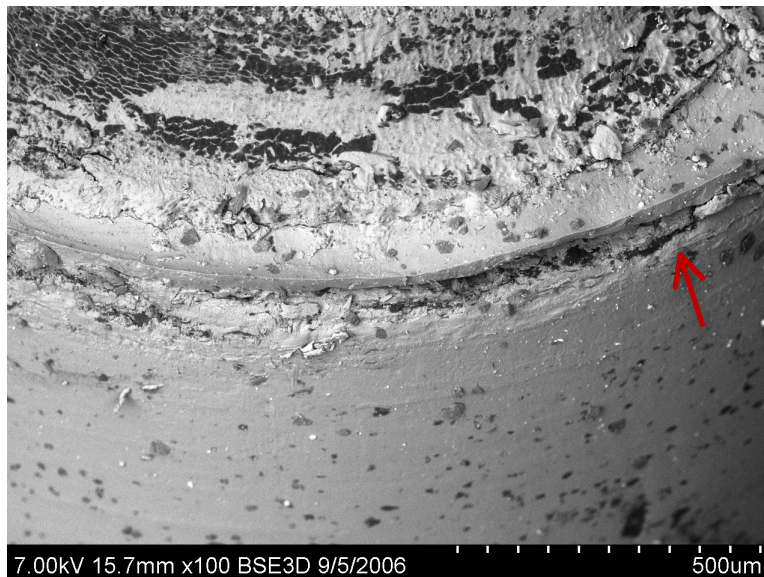
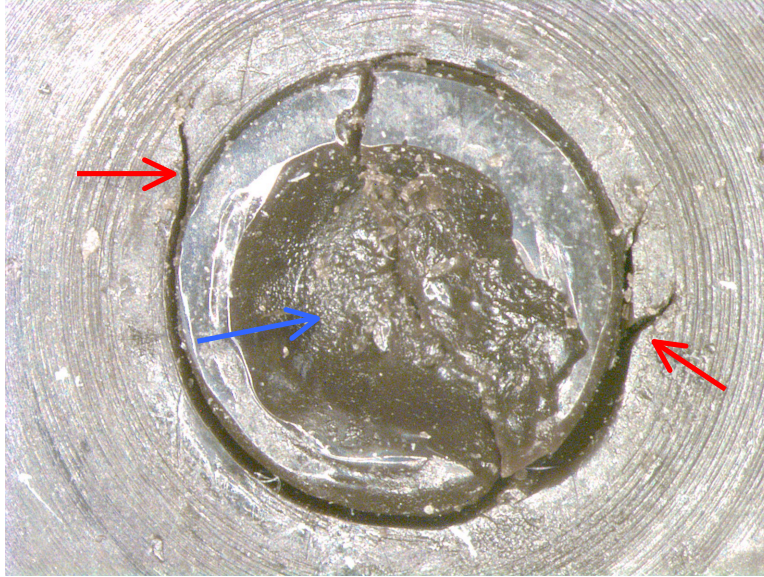
Examination of the fracture area with a Scanning Electron Microscope (SEM), revealed secondary cracks as shown below (arrow). These appeared to originate within rings of abrasion suggesting rubbing against the edge of the anchor hole.

Macro photograph showing bottom of flapper where the stem separated. Primary failure (blue arrow) followed contour of step ring where it joined the stem. Secondary cracks (red arrows) developed following the contour where the step ring connected to the flapper.

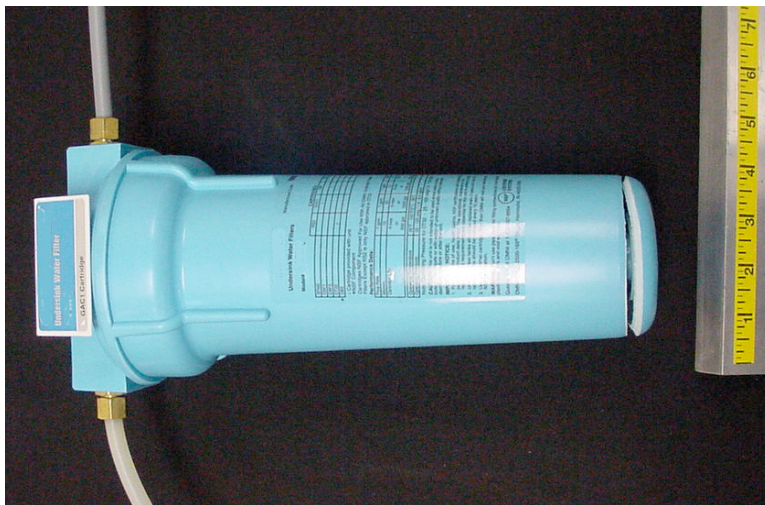
The filter housing failure most likely occurred in a progressive mode. The crack initiated at the high stress area at the bottom of the housing at a stress concentration point and propagated over time until final separation. Considering that the failure was related to the geometry of the part and the stress levels generated during normal use, the filter failure was attributed to inadequate design.

***Photograph showing overall view of the cracked filter housing***

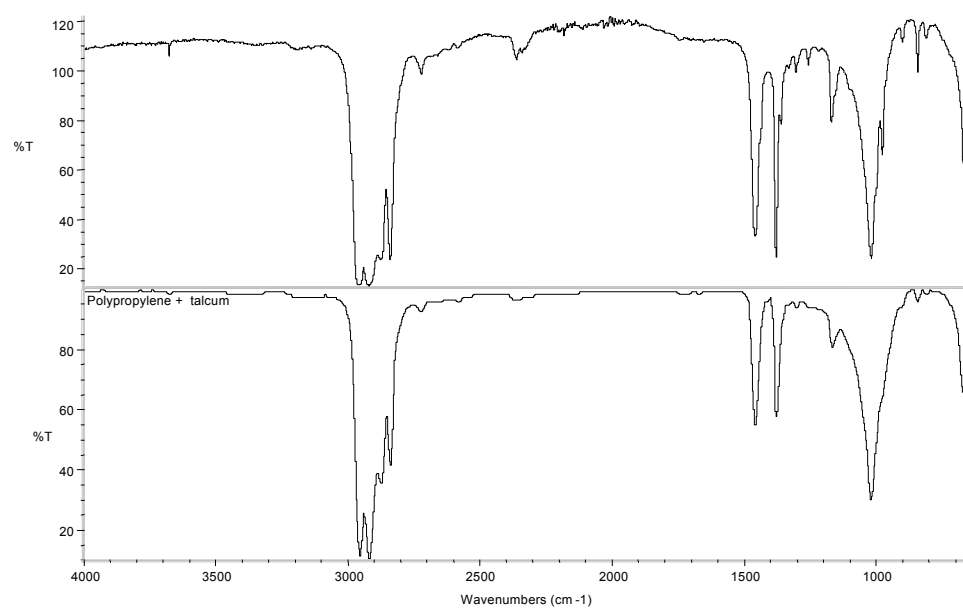
A small shaving was removed from an area away from the crack and analyzed using Fourier Transmission Infrared techniques (FT-IR) to determine the material type of the housing. As shown in the spectra below, the material was determined to be polypropylene with talc filler.

***FT-IR spectra showing the housing material and matching reference standard***

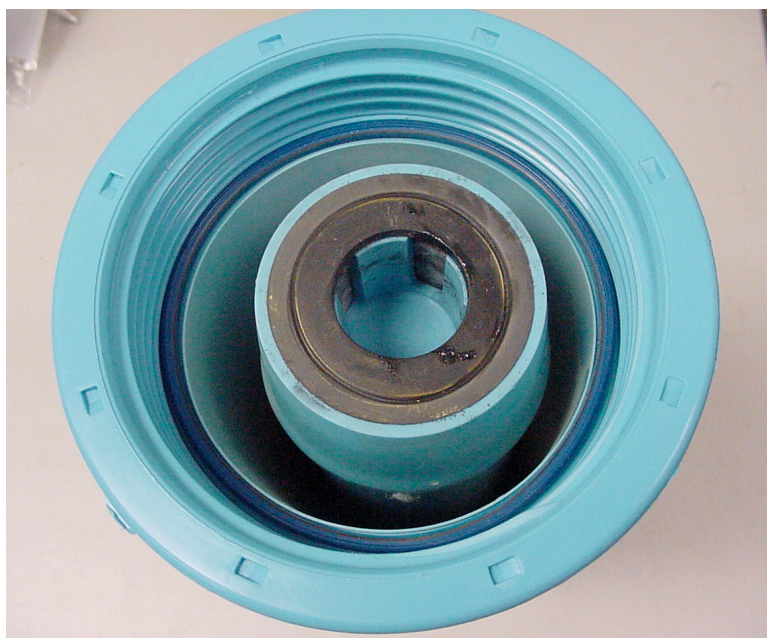
The cap was removed to inspect the condition of the housing interior and the filter cartridge. No unusual conditions were observed upon disassembly. The o-rings on the cartridge sealing surface and the cap were found to be in position.

***Photograph showing the cartridge and the housing interior after removing the cap***

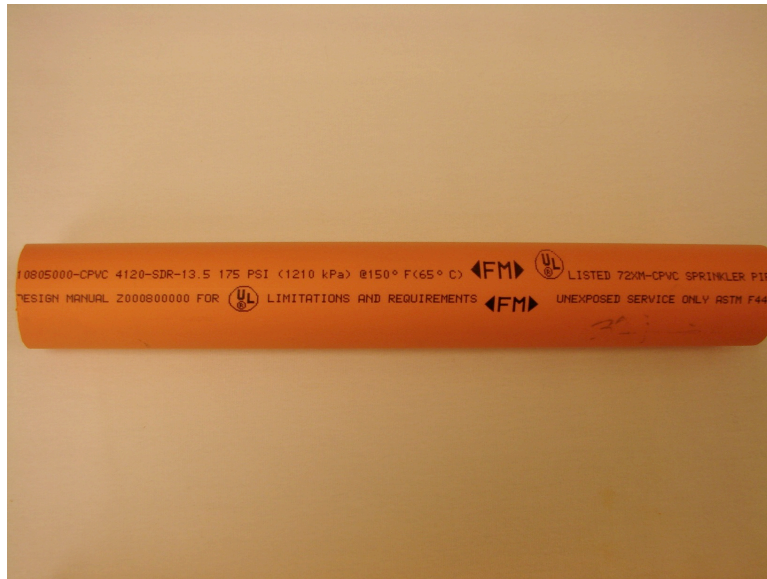
***Photograph showing the “failed” sample***

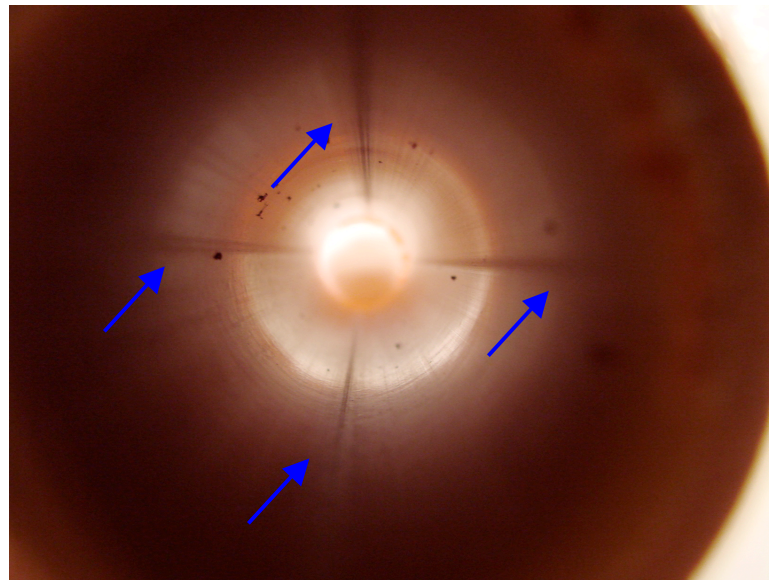
***A representative macrograph showing the extrusion knit lines (arrows) in one of the unfailed samples***

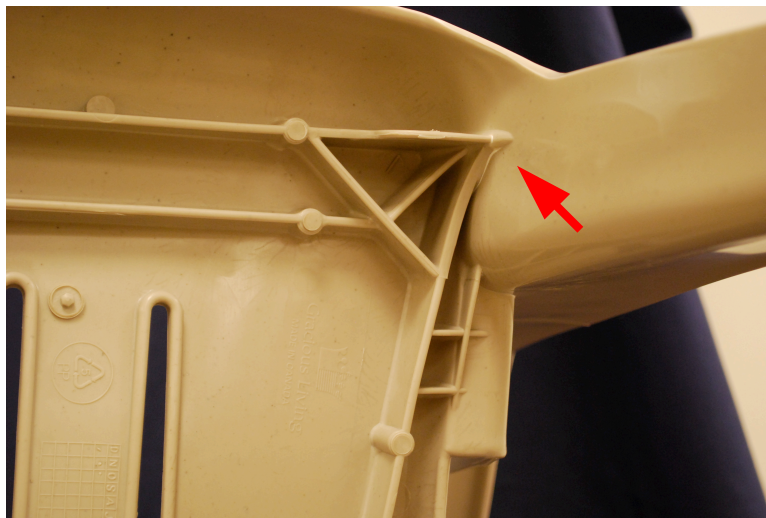
***Photograph showing the left front leg, opposite the failed one. Arrow points to the high stress area where stress whitening has occurred.***

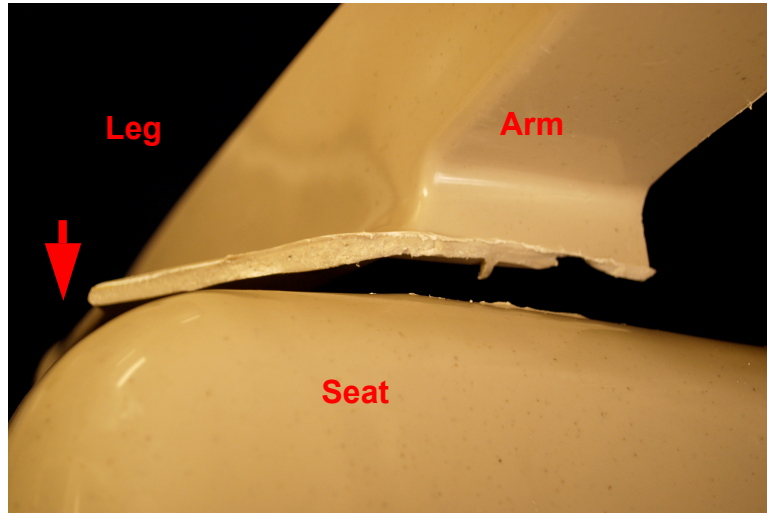
*Photograph showing the fracture area*

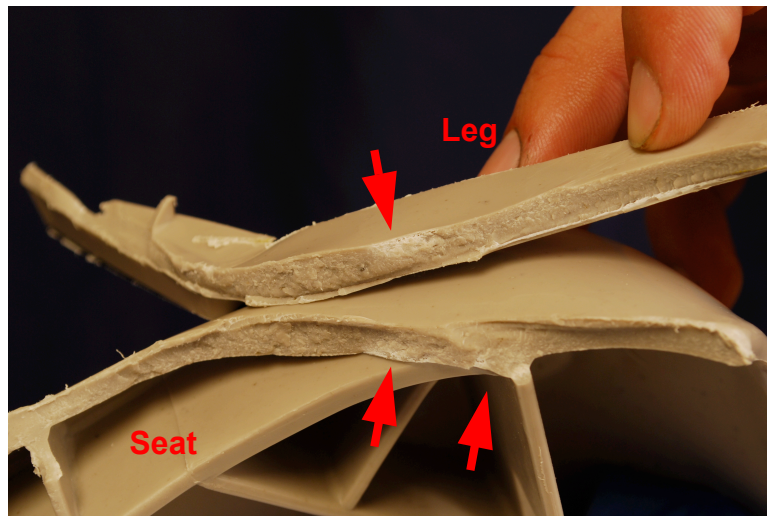
*Photograph showing a close-up view of the fracture area after the sectioning.  
Arrows point to areas where defects were observed.*

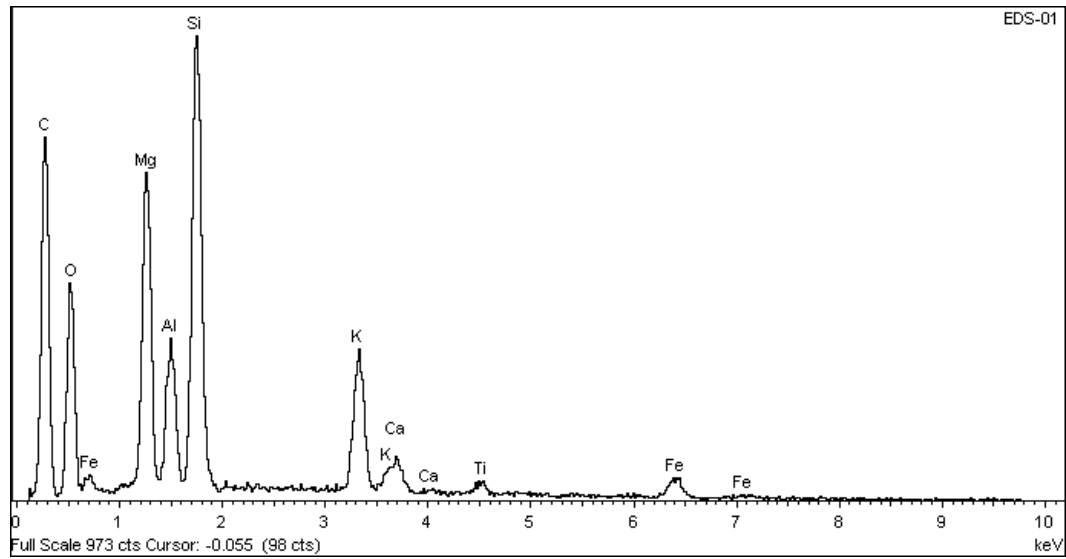
***EDS spectrum showing the elements detected in one of the large platelets near the fracture initiation site; the composition was consistent with mica.***

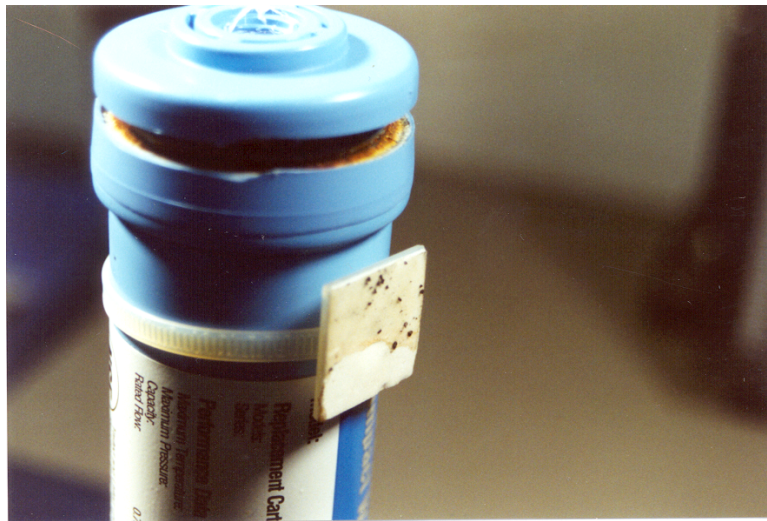
In this case the metal particles experienced corrosion due to exposure to water and the volume expansion of the corrosion products caused high stresses to develop in the radiused area of the cap causing it to fracture.

***Photograph showing the fractured cap area of the filter***

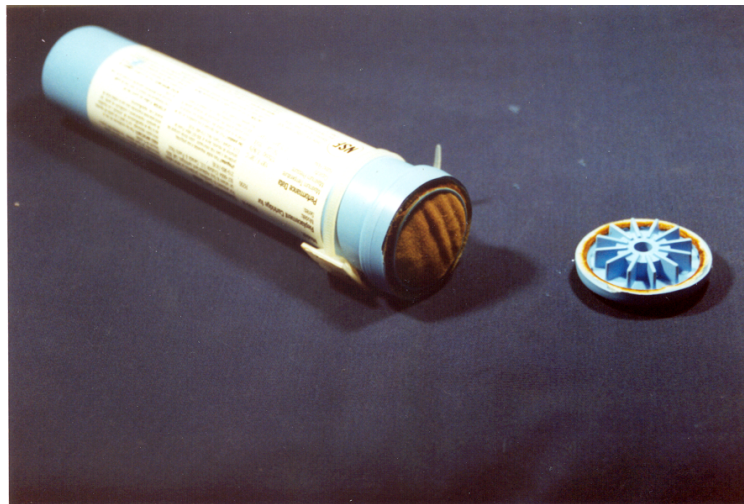
***Photograph showing the filter body after the cap was separated for analysis***

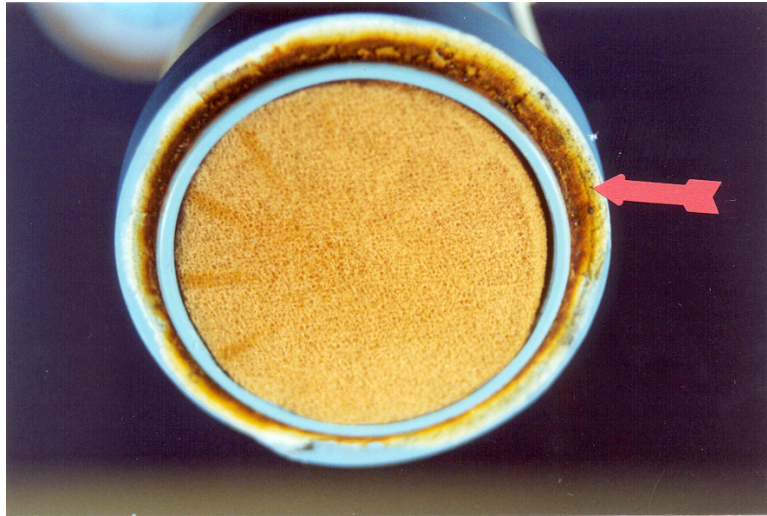
***Photograph showing the fracture; note the corrosion products (arrow)***

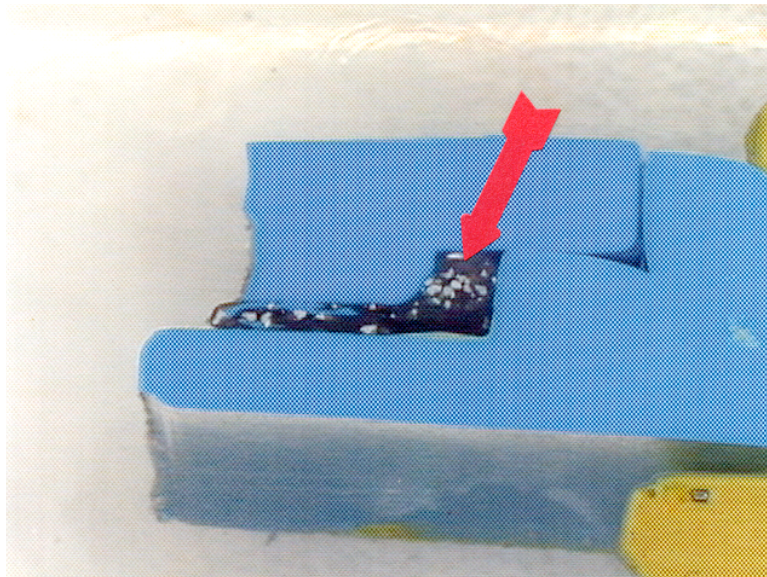
***Cross sectional view showing the weld joint made using ferromagnetic particles***

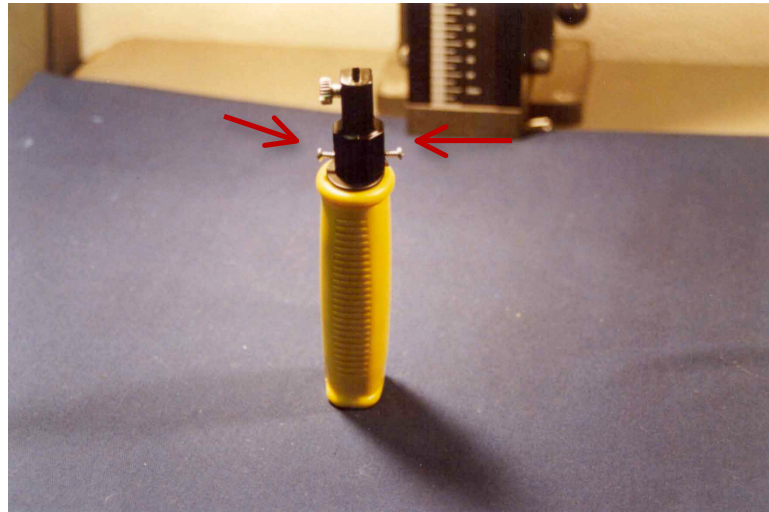
Molded ABS (Acrylonitrile Butadiene Styrene) insert for a Vinyl saw handle experienced delayed failures after assembly upon shipment to customers. Examination revealed that the metal component that holds the saw blade is secured in place with two screws as shown in the below figure. These screws extended into the handle causing deformation of the plastic. The cracks originated in these highly stressed areas.

***Photograph showing the assembly; arrows point to the two screws that secured the metallic piece, which held the blade in place.***

After reviewing the details of the assembly process, it was discovered that the inserts were immersed in a surfactant before assembly to make them slip into the vinyl handles easier. It is known that plastics can fail under very low stress, when they are in contact with particular chemical agents. This phenomenon is called environmental stress cracking (ESC). ABS is a co-polymer that is widely used in a variety of fields owing to its favorable cost/performance ratio, luster and resistance to impact. However, it is well documented in the literature through previous studies that certain kinds of chemical agents such as organic solvents and surfactants cause ESC of ABS. Laboratory ESC testing illustrated that a different type of surfactant, used at a much lower dilution ratio, could be utilized during assembly without causing any failures.

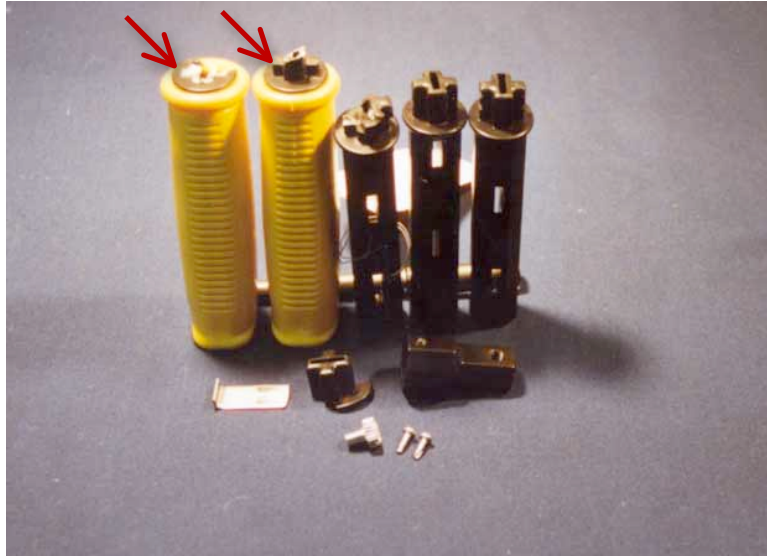
*Photograph showing the black inserts, with the yellow handles. Arrows point to the failures.*

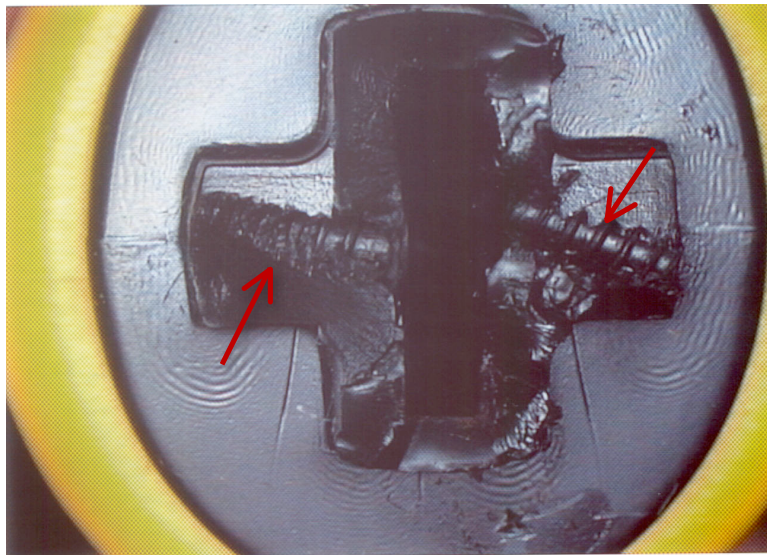
*Photograph showing the screws that secured the metallic piece in place*

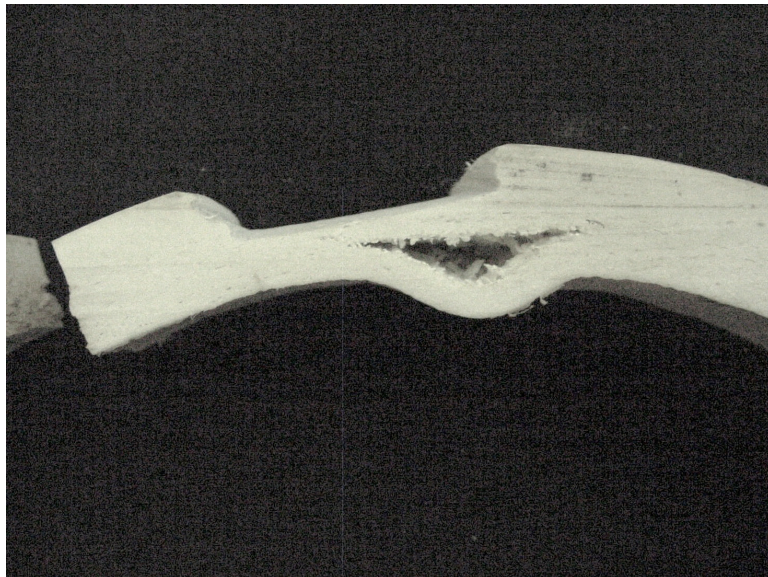
An acetone immersion test, per ASTM D2152, Method for Adequacy of Fusion of Extruded PVC Pipe and Molded Fittings by Acetone immersion, was performed on the pipe to determine the presence of manufacturing defects. A cross section of pipe was taken and cut into pieces to fit in the acetone immersion tank. Although the smooth outer surface of the pipe was unaffected by acetone, the inner wall and sanded portions were severely affected by the acetone and exhibited peeling and flaking.

*Pipe section before acetone immersion*

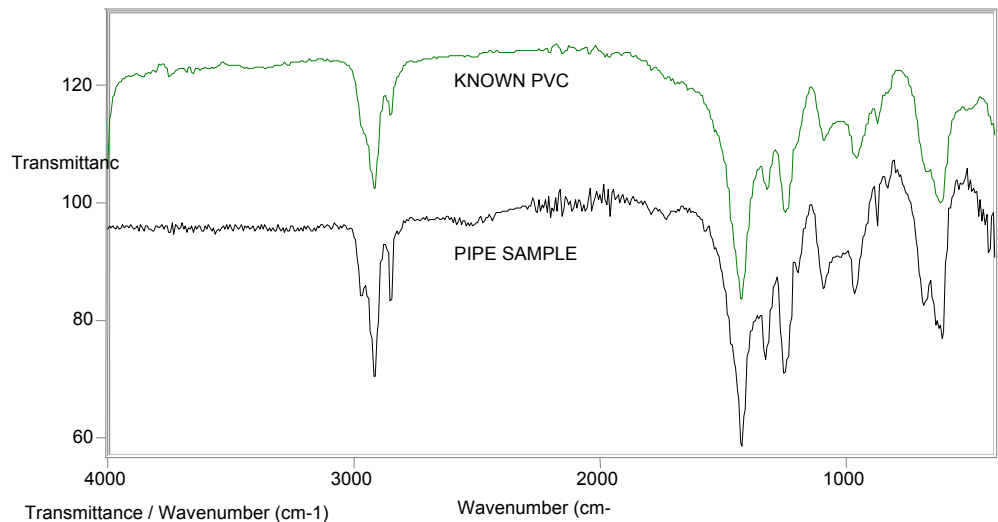
FT-IR was performed on the pipe material to confirm it was PVC. The sample, removed from the rough fracture surface, where contamination would have been most likely was found to be consistent with PVC without phthalate plasticizers.

***FT-IR spectrum of sample removed from pipe fracture surface.  
The pipe sample is consistent with PVC without phthalates***

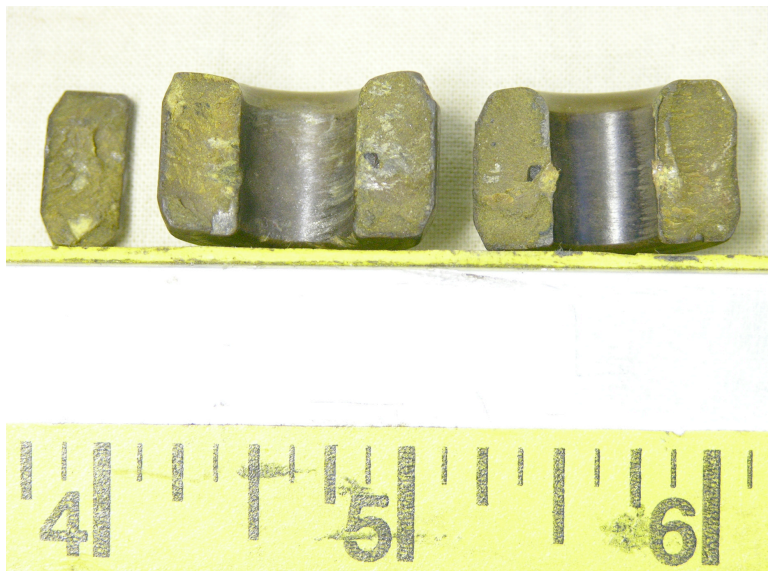
Stereomicroscopic examinations of the roller revealed that the failure originated at the inner diameter of the part, near an inclusion. Although post-fracture mechanical damage in the vicinity of the inclusion prevented determination of the exact origin, it was clear that the fracture occurred on the same plane as the inclusion, indicating it was the primary cause of failure. The fracture on the surface opposite of the inclusion side propagated down through the height of the roller with no obvious fracture origin.

***Photograph showing the fracture surfaces of the roller***

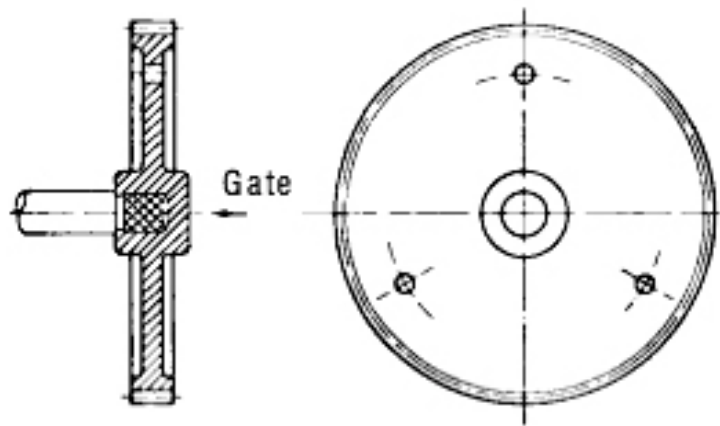
The disk failed through a combination of manufacturing and service related factors. The part was subjected to a temperature that exceeded its recommended operating temperature, which then caused a failure at a weak point in the part. In this case, the weak point was a weld line created during injection molding. Design and gating can have significant influence on a part's performance. In a similar situation, almost identical gears molded onto knurled shafts behaved differently in service. The gear shown below was center gated and did not create a problem.

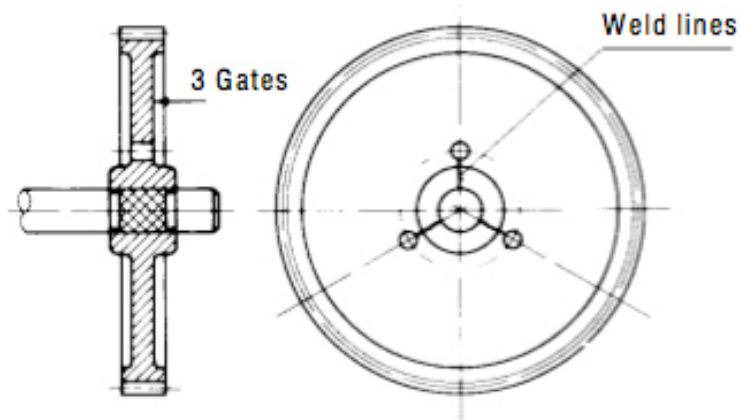
However, the gear shown in the below figure was filled through 3 pinpoint gates in the web. In addition, the three holes provided for attaching a metal disc were placed close to the hub. As a result, the thicker hub section was poorly filled and the three weld lines created weak spots, unable to withstand the stresses created by the metal insert and the sharp edges of the knurled surface.

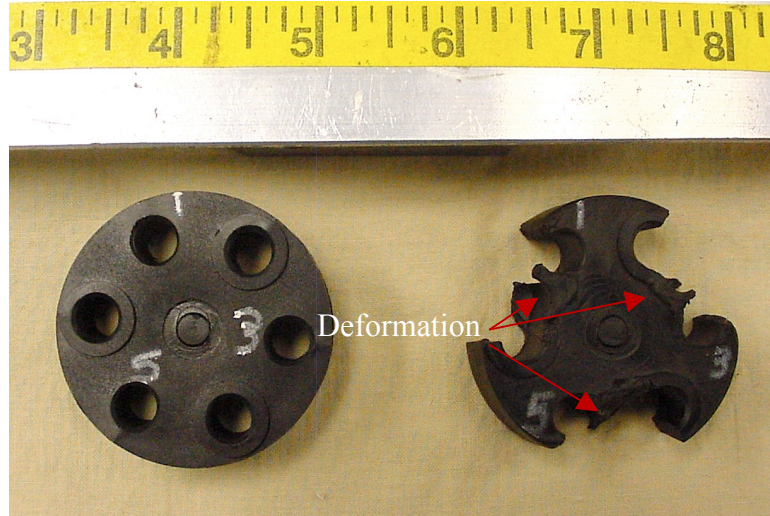
The initial inspection of the part showed extensive plastic deformation and significant thermal damage to the disk. Examination of the good part revealed weld lines running down through the disk at each pinhole. The weld lines coincided with the fractures in the failed part. The good part was sectioned to allow for examination of these areas. The good and failed parts were also submitted to Differential Scanning Calorimetry and glass content analysis, to verify the filler content and presence of any contaminants.

***Photograph showing the failed and unused disks***

While eliminating the weld lines through modifying molding parameters is expected to improve the part's performance, it was also recommended that the customer conduct further studies to determine the cause of the overheating of the disk.

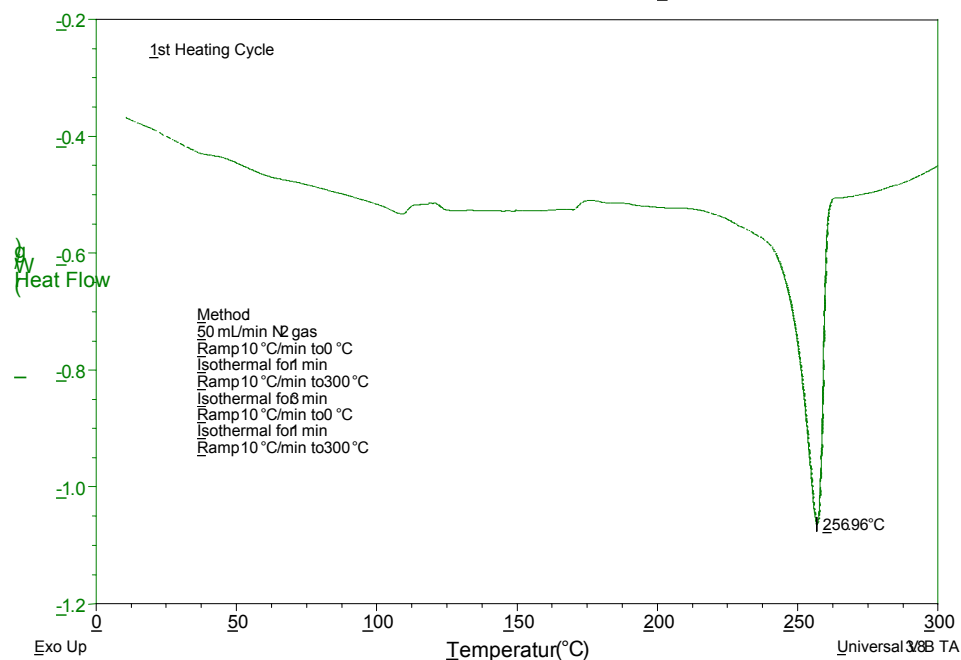
In the first heat, the scan of the failed part showed two distinct melting peaks, one for the PA6 component and one for the PA66 component, in the appropriate areas for each component of the blend. The first heat of the good part, however, showed only one melting peak. After the second heat, both showed two melting peaks, one for each component. The double peak seen in the first heat of the failed part occurred because it was subjected to heat sufficient to cause annealing of the part, which would have changed the physical properties of the part. Considering the normal service temperature of the part is mostly within the range of acceptable use for the material, the results indicated that the failed part was subjected to a higher temperature sufficient to soften one component of the material.

**DSC Thermogram of 1<sup>st</sup> heating cycle of Good part showing a single endotherm**

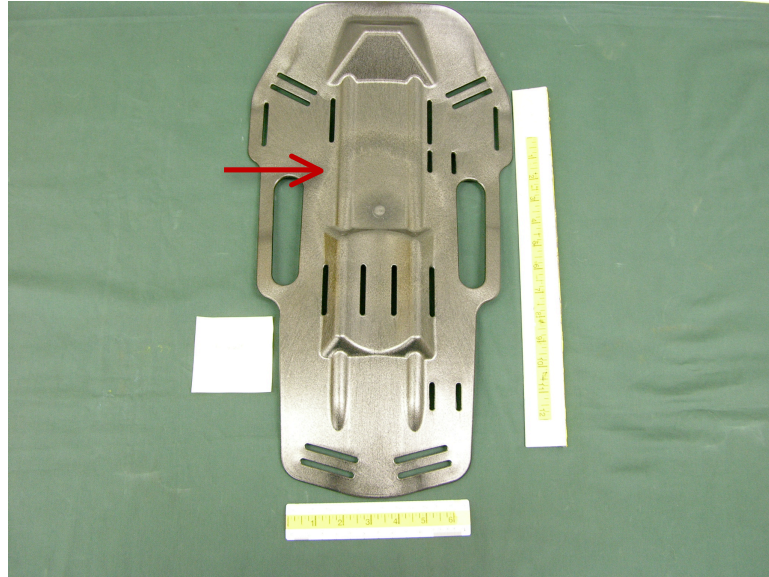
The 'halo' effect observed on the unused part could have been caused by a several different factors. An excessively high melt temperature could cause some degradation of the material, which would show up as streaks flowing from the injection point. In the case of this part, with a central injection point, the streaks would radiate from the gate, creating a halo. The streaks could also have been caused by the presence of water vapor. Polycarbonate is hygroscopic, meaning it can absorb water from the atmosphere. If the material was not properly dried, water vapor could be released during molding. This water vapor can also cause degradation of the polycarbonate, decreasing the strength of the part. It should be noted that the halo/streaking effect was not noticed on all of the examined parts.

***Photograph of Unused part with halo visible***

The molded-in stress can be relieved through changes in the molding process or the mold itself. One solution would be to increase the mold temperature, allowing the polymer to cool at a slower rate. Polycarbonate typically needs a mold temperature between 80 and 120°C to minimize stress. Another solution would be to add a second injection point into the part so that the part can be filled from two directions.

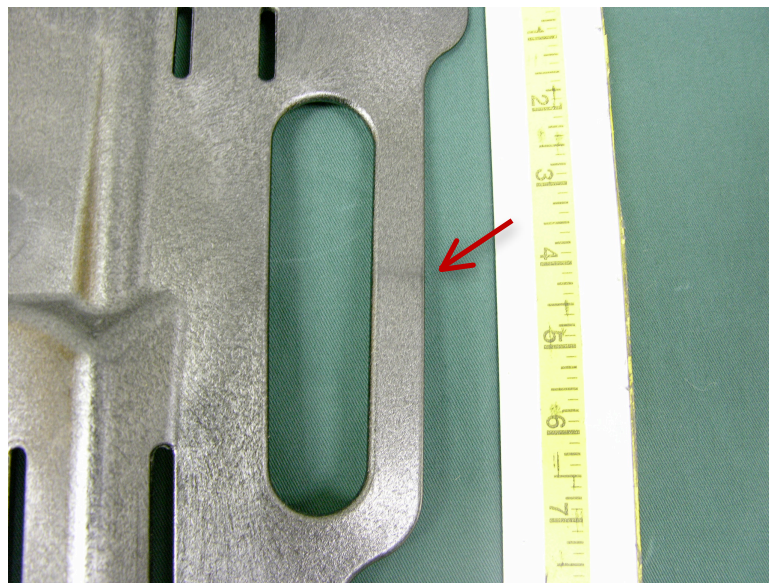
***Photograph showing the weld line***

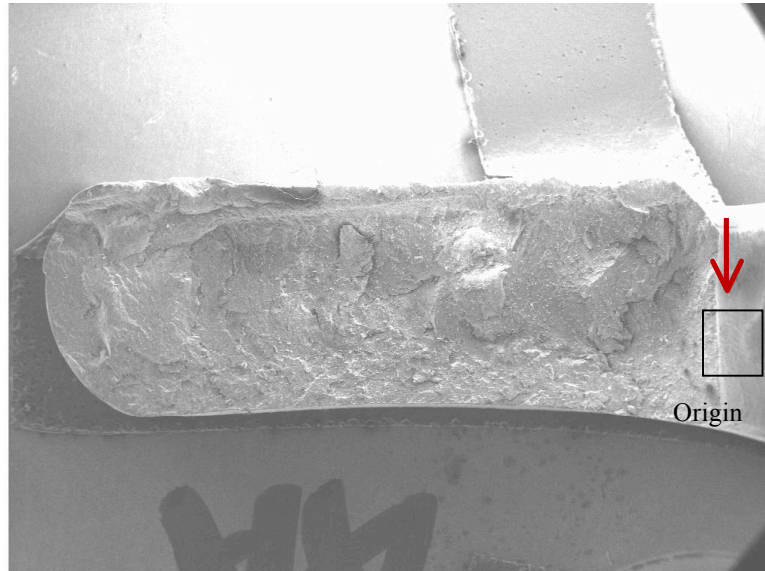
Visual examination of the parts revealed extensive cracking, mostly at the radii of the strapping slots. A 'halo' was also observed on the unused part, centered around the injection gate. The parts were then examined with a stereomicroscope to look for evidence of chemical attack or any chemical residue. None was found. Failures were observed to have occurred near the geometric transitions, in the vicinity of punch out marks, flow fronts or weld lines. The glass fibers were found to be randomly oriented; on the SEM images the holes visible were fibers perpendicular to the fracture surface, while the grooves visible were fibers parallel to the fracture surface. The glass fibers were all in intimate contact with the polycarbonate, as shown by the feathered pattern of cracks coming from the edges of the glass fibers, which indicated that the bonding was adequate. The fracture progression was rapid in nature, as indicated by the Wallner lines observed on many of the fracture surfaces.

***Fracture surface of one of the cracks, origin on right***

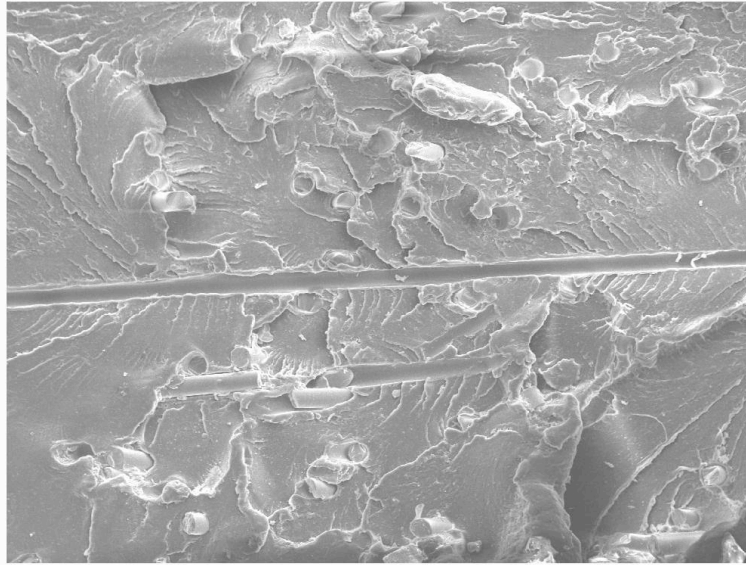
**SEM image showing fiber pullouts (parallel to fracture surface)**

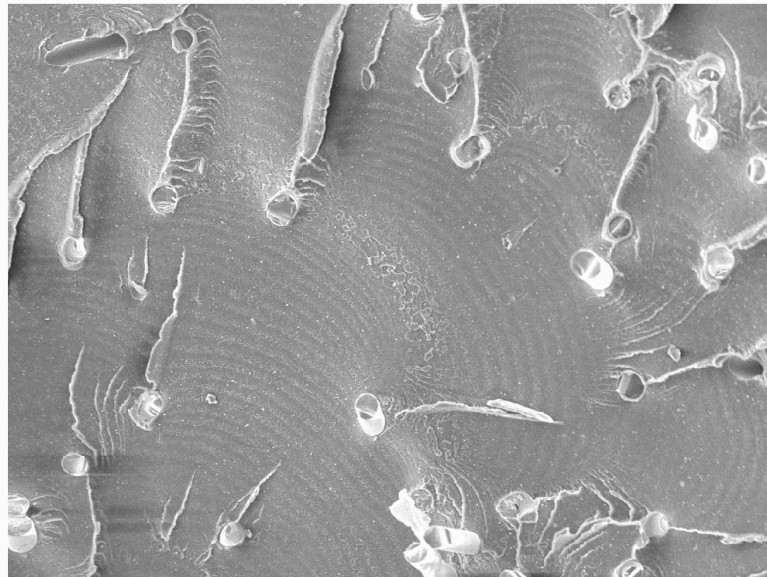
**SEM image showing Wallner lines (fibers are perpendicular to fracture surface)**

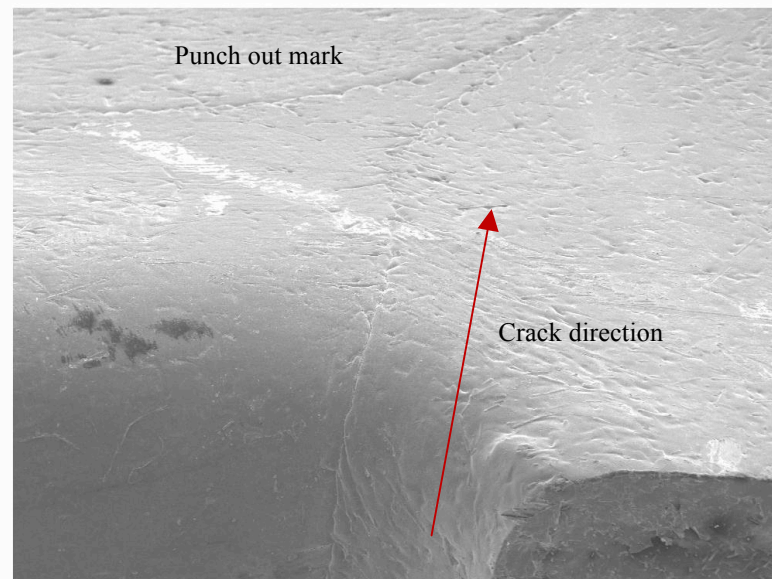
***Fracture near geometric transition and punch out***

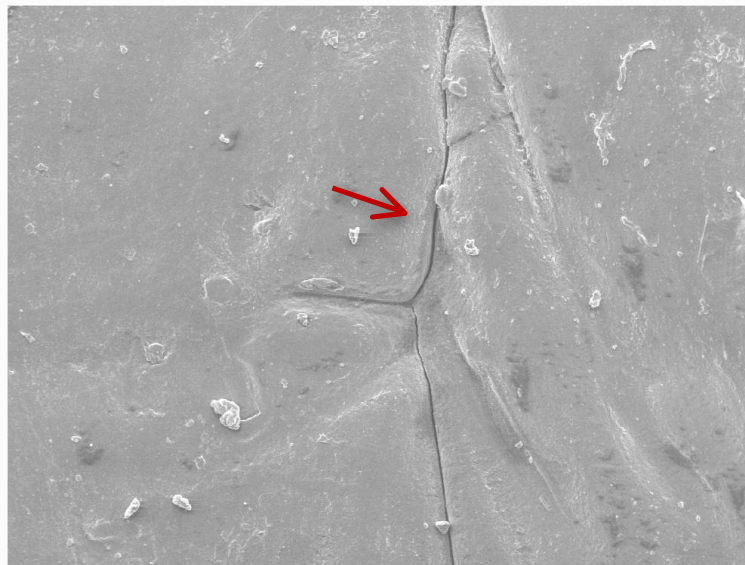
***Surface crack observed near fracture***

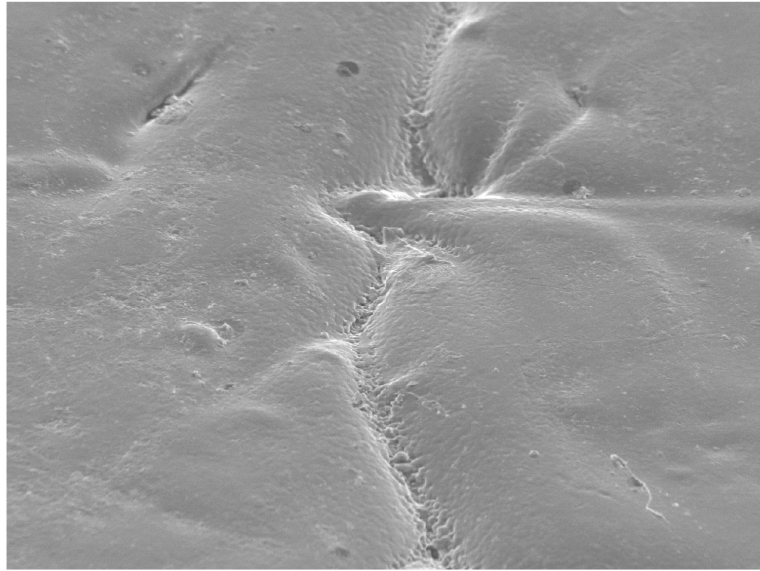
***Surface defect observed near one of the fractures***
