Preserving Historic Glazed Architectural Terra-Cotta

7 Preservation Briefs

The Preservation of Historic Glazed Architectural Terra-Cotta

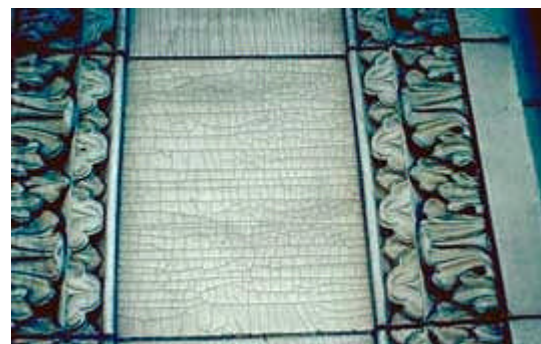
Water and air-borne moisture entering the glazed architectural terra-cotta causes expansion of the porous clay body, increasing its volume. This upsets the "fit" of the glaze and makes its surface shatter, which is commonly called "crazing." Photo: NPS files.

Crazing, or the formation of small random cracks in the glaze, is a common form of water-related deterioration in glazed architectural terra-cotta. When the new terra-cotta unit first comes from the kiln after firing, it has shrunk (dried) to its smallest possible size. With the passage of time, however, it expands as it absorbs moisture from the air, a process which may continue for many years. The glaze then goes into tension because it has a lesser capacity for expansion than the porous tile body; it no longer "fits" the expanding unit onto which it was originally fired. If the strength of the glaze is exceeded, it will crack (craze). Crazing is a process not unlike the random hairline cracking on the surface of an old oil painting. Both may occur as a normal process in the aging of the material. Unless the cracks visibly extend into the porous tile body beneath the glaze, crazing should not be regarded as highly serious material failure. It does, however, tend to increase the water absorption capability of the glazed architectural terra-cotta unit.

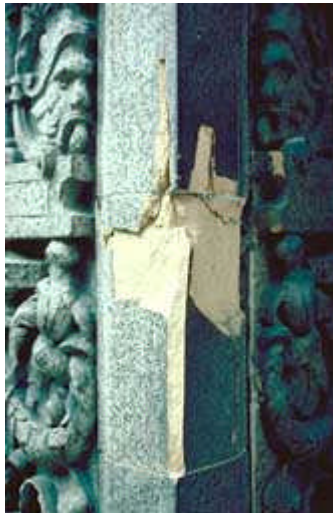
The damage shown here is the result of direct live load on a mid-rise building. The steel frame has settled and shifted the weight onto the exterior terra-cotta cladding, resulting in rupturing of the material. Photo: NPS files.

Stress-related deterioration: Stress-related deterioration of glazed architectural terra-cotta frequently occurs in high rise buildings. The evolution of stress relieving details (flexible joints, shelf angles, etc.) occurred late in the development of American building construction. Consequently, most early continuously clad High Rise buildings (c.1900-1920s) had little or no provisions for normal material and building movement in their original design.

The development of large stress-related cracks or wholesale material deterioration is often caused by unaccommodated building-frame shortening under load, thermal expansion and contraction of the facade and moisture expansion of the glazed architectural terra-cotta units themselves. Cracks running through many units or stories or large areas of material deterioration often indicate stress-related problems. This sort of deterioration, in turn, permits significant water entry into the terra-cotta system.

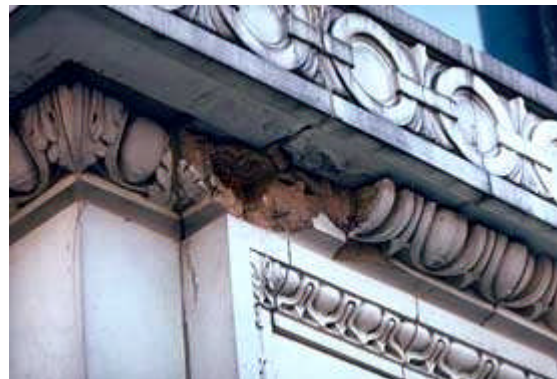
Material spalling is the result of excessive expansion of the porous tile body caused by water and freezing temperatures. This is a serious condition, often difficult to repair. Photo: NPS files.

Material spalling is a particularly severe situation. Not only is the visual integrity of the detailing impaired, but a large area of the porous underbody, webbing and metal anchoring is exposed to the destructive effects of further water entry and deterioration. Both glaze and material

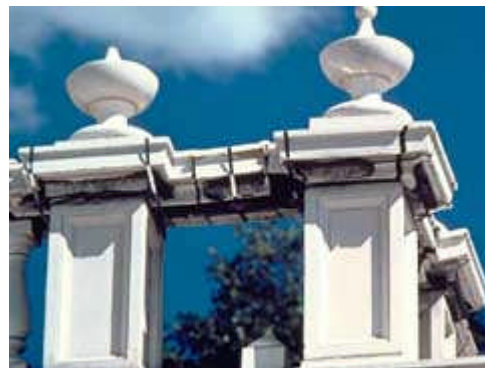
Exposed or freestanding terra-cotta detailing (parapets, urns, balusters, etc.) have traditionally been subjected to the most severe vicissitudes of deterioration as a result of freezing temperatures and water. Photo: NPS files.

spalling must be dealt with as soon as possible. Missing units is a serious situation which particularly plagues architectural terra-cotta systems. Unlike brick or stone, damaged glazed architectural terra-cotta is exceedingly difficult to replace. New production is extremely limited. Missing units create gaps which increase the structural load on the remaining pieces and also permit water to enter the system. Exposed or freestanding glazed architectural terra-cotta detailing (balusters, urns, parapet walls, etc.) are particularly susceptible to extensive loss of material.

These elements face the most severe vicissitudes of water and temperature-related deterioration in direct proportion to the extent of their exposure. The replacement of missing units should be a high priority work item in the rehabilitation of glazed architectural terra-cotta.

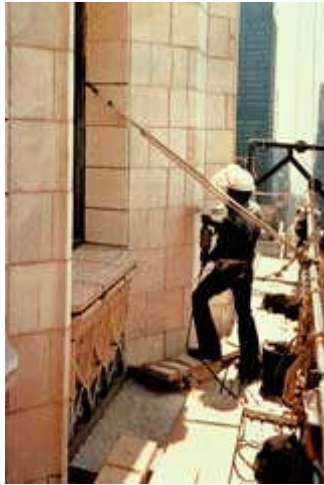
A worker cleans out mortar joints in preparation for repointing the architectural terra-cotta Photo: NPS files.

Repointing: Repointing of mortar which is severely deteriorated or improperly or infrequently maintained is one of the most useful preservation activities that can be performed on historic glazed architectural terra-cotta buildings. Ongoing and cyclical repointing guarantees the long life of this material. Repointing should always be carried out with a mortar which has a compressive strength (measured in p.s.i.) *lower* than the adjacent masonry unit. Hard (Portland

cement) or coarsely screened mortars may cause point loading and/or prevent the outward migration of the water through the mortar joints, both of which ultimately damage the terra-cotta unit. Repointing with waterproof caulking compounds or similar waterproof materials should never be undertaken because, like waterproof coatings, they impede the normal outward migration of moisture through the masonry joints. Moisture then may build sufficient pressure behind the waterproof caulk and the glaze on the terra-cotta to cause damage to the unit itself.
