FHWA Bridge Inspector's Manual Section 6--Timber Superstructures

Section 6 Inspection and Evaluation of Common Timber Superstructures

Topic 6.1 Solid Sawn Timber Bridges

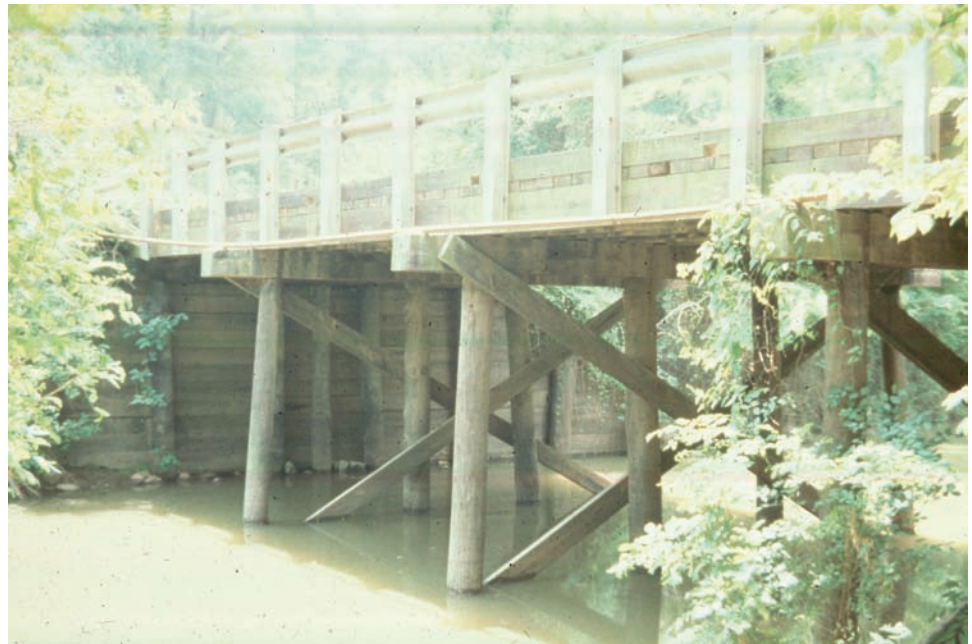
Timber bridges are gaining a resurgence in popularity throughout the United States. There are two basic classifications in timber construction: solid sawn and glued-laminated (glulam). A solid sawn beam is a section of tree cut to the desired size at a saw mill. Solid sawn multi-beam bridges are the simplest type of timber bridge (see Figure 6.1.1).

Figure 6.1.1 Elevation View of a Solid Sawn Multi-Beam Bridge

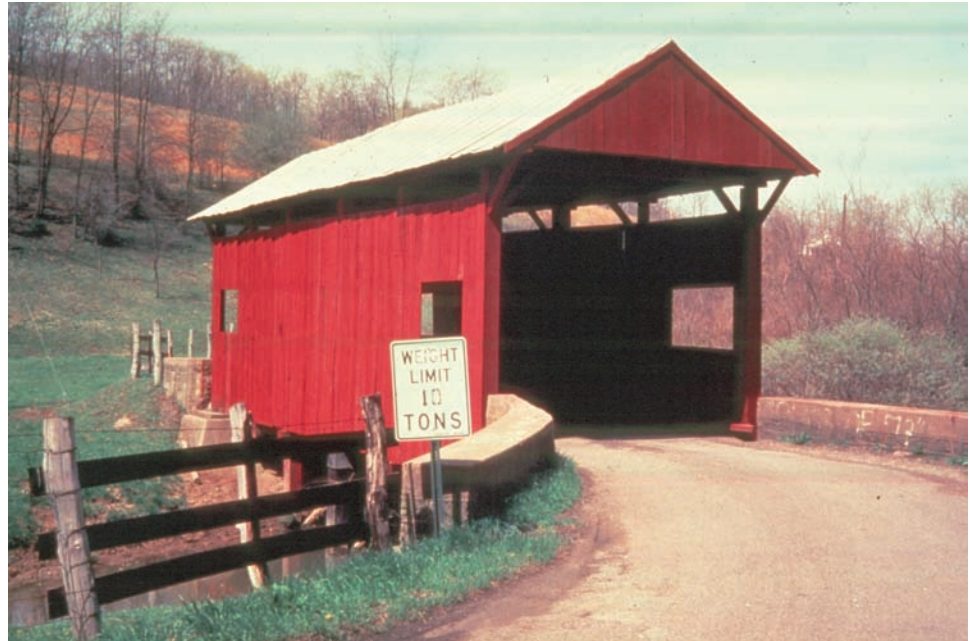
Covered bridges are generally found along rural roads and get their name from the walls and roof which protect the bridge superstructure (see Figures 6.1.3 and 6.1.4). Covered bridges are usually owned by local municipalities, although some are owned by states or private individuals. Some still carry highway traffic, but many are only open to pedestrians or light weight vehicles. While most covered bridges were built during the 1800's and early 1900's, there are a number of covered bridges being built today as historic reconstruction projects.

Figure 6.1.3 Elevation View of Covered Bridge

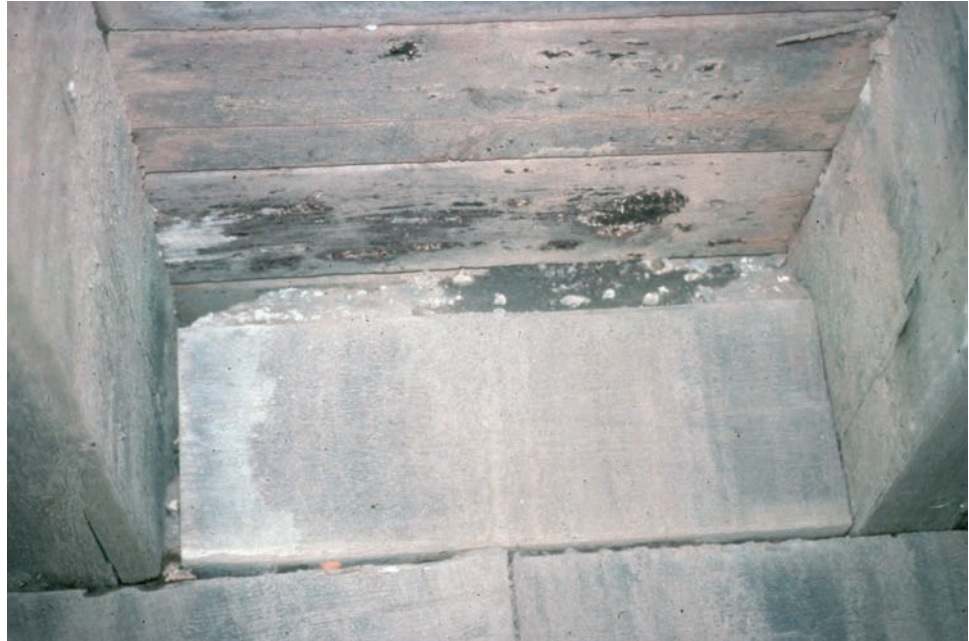
Inspect bracing members for decay and fire damage. Examine connections of bracing to beams for tightness, cracked or split members, and corroded, loose, or missing fasteners (see Figure 6.1.14). Deteriorated secondary members may indicate problems in the primary members.

Figure 6.1.14 Typical Timber End Diaphragm

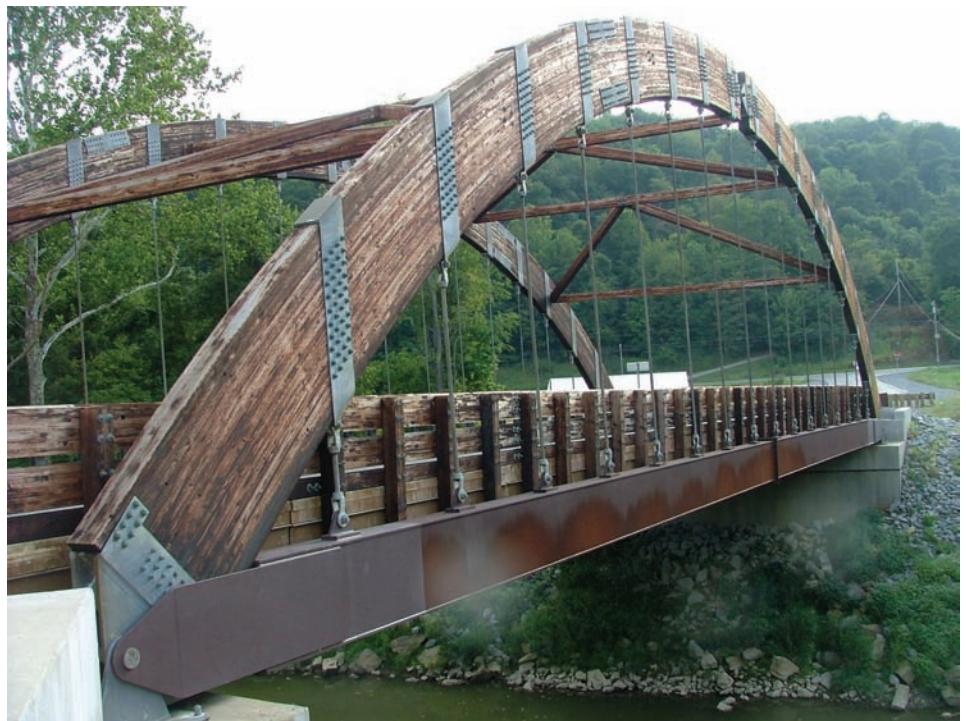
Glulam arch bridges usually consist of two- or three-hinged deck arches, which support a glulam deck and floor system (see Figures 6.2.6 and 6.2.7). Glulam arches are practical for spans of up to about 91 m (300 feet). Although they are not widely used for highway bridges, they are frequently used for pedestrian overpasses and in locations such as parks where aesthetics is important.

Figure 6.2.7 Glulam Arch Bridge (West Virginia)

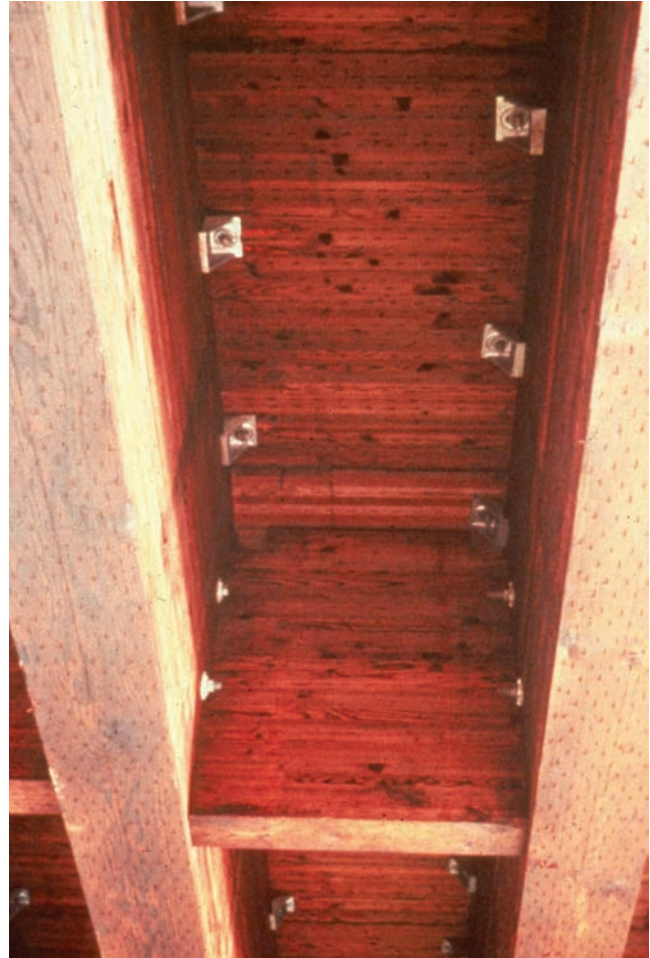
The primary members of glulam multi-beam bridges are the beams, and the secondary members are the diaphragms or cross bracing (see Figure 6.2.8). Due to the larger depth of the glulam beams, diaphragms or cross bracing should always be present. Diaphragms are usually constructed of short glulam members, and cross bracing is usually constructed of steel angles.

Figure 6.2.8 Typical Glulam Diaphragm

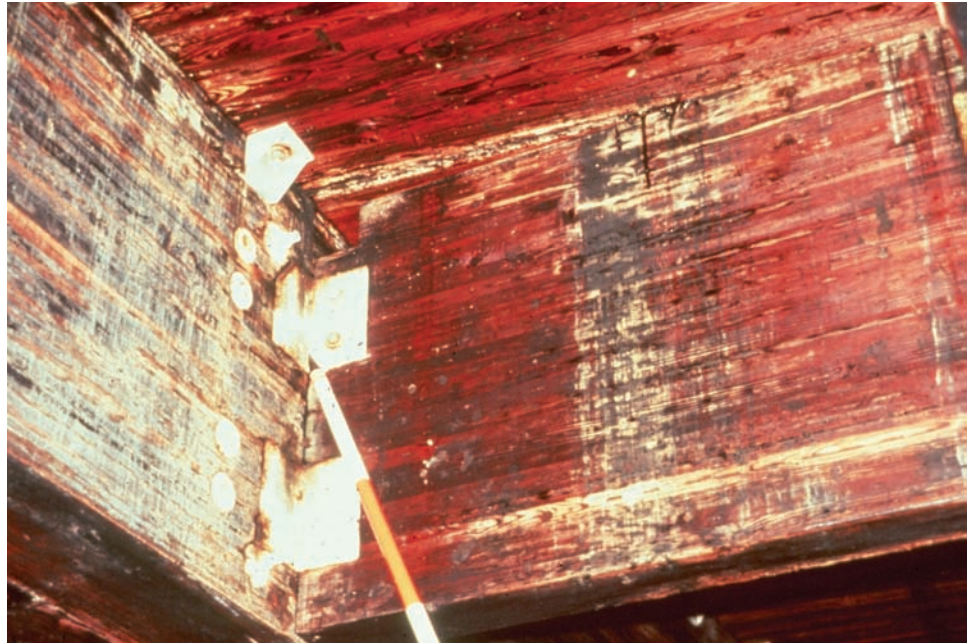
Examine diaphragms for decay, fire damage, and insect damage (see Figure 6.2.13). Check steel cross bracing for corrosion, bowing, or buckling (see Figure

Figure 6.2.13 Typical Diaphragm for a Glulam Multi-beam Bridge

Inspect all fasteners for corrosion, tightness, and missing parts (see Figure 6.2.13).

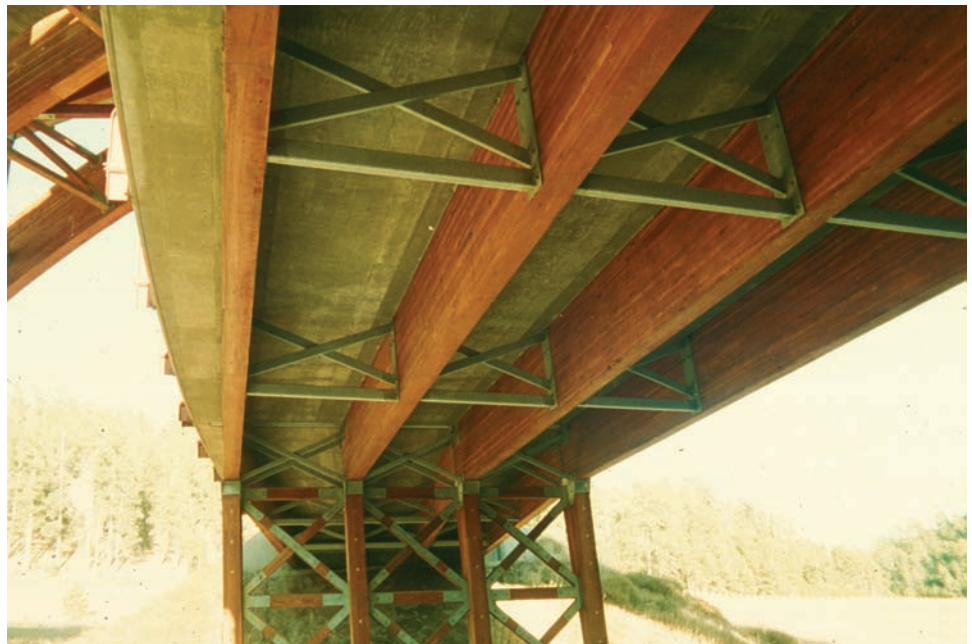
6.2.14). Examine connections for tightness, cracks and splits, and corroded, loose, or missing fasteners. Deteriorated secondary members may indicate problems in the primary members.

Figure 6.2.14 Glulam Beams with Numerous Fastener Locations

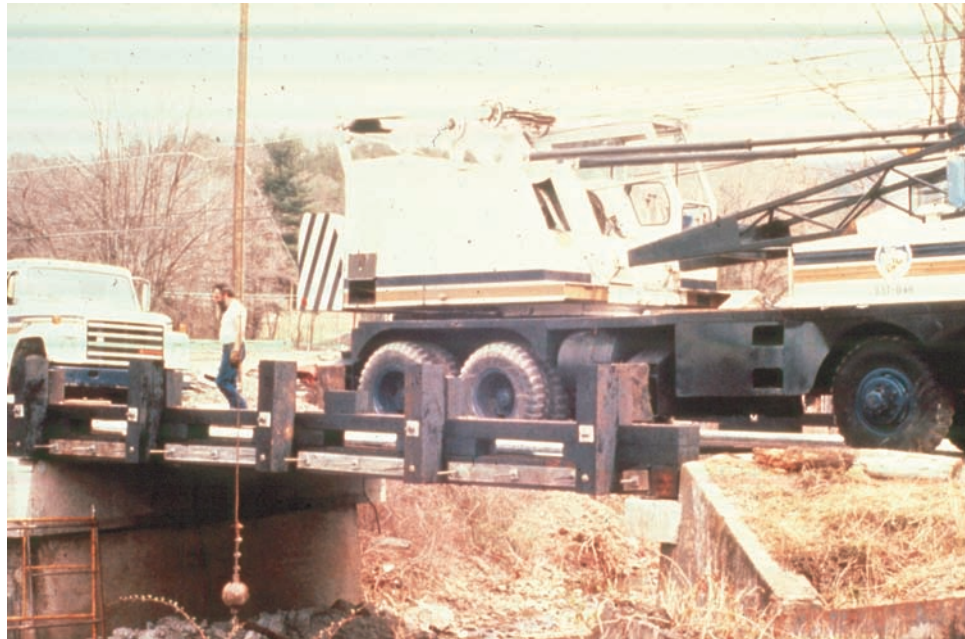
Stress-laminated timber slab bridges can be used for simple spans of up to 15 m (50 feet) and are capable of carrying modern highway loadings (see Figures 6.3.1 and 6.3.3). Stressed deck bridges have also been constructed using glulam members. Combining glulam technology with stress-lamination increases practical span lengths to 19 m (63 feet) (see Figure 6.3.4).

Figure 6.3.3 Stress-Laminated Timber Slab Bridge
