**PDHonline Course C748 (6 PDH)**

## **Chinese Drywall**

# Chinese Drywall

## Module A. Introduction

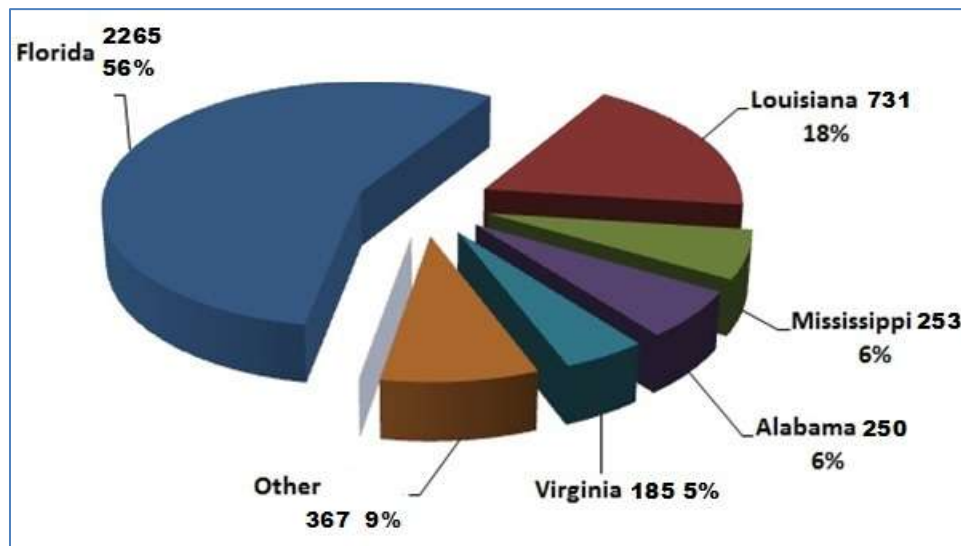
### Five States contain 91% of all reported cases

In the United States, most complaints have come from states in the Southeast, where a warm and humid climate seems to encourage the emissions. Florida may have been the most heavily affected by the drywall.

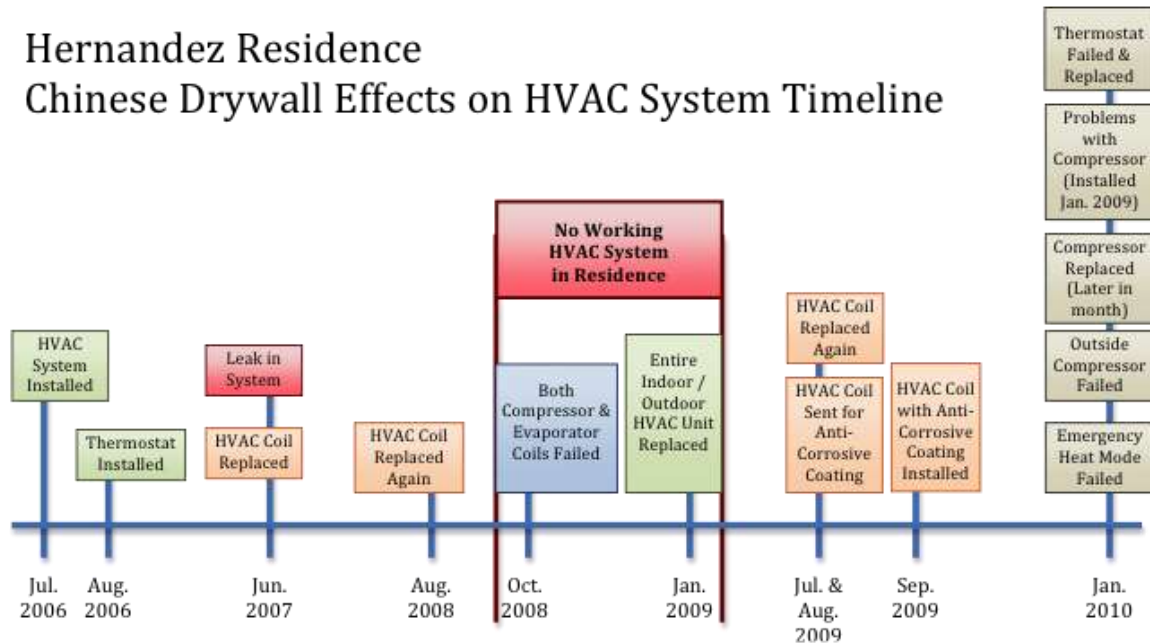
## Hernandez Residence

### Chinese Drywall Effects on HVAC System Timeline

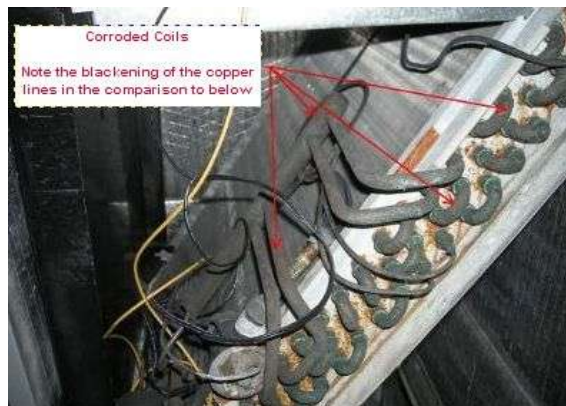
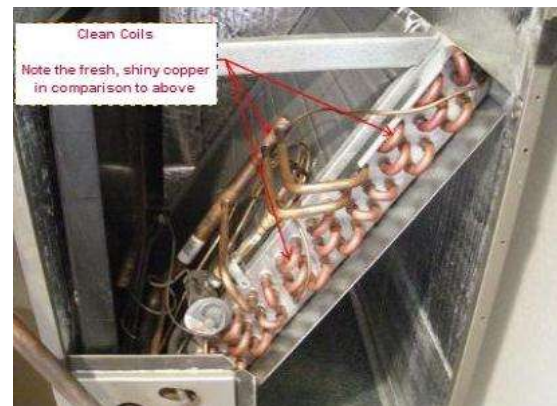
The coils below on the left unit appears to be dirty with debris and or a black ashy substance on the copper tubing. Coils with no damage on the right exhibit clean copper.

2. Observed corrosion of air conditioner evaporator coil exemplified by black corrosion on copper tubing components. The corrosion can result in refrigerant leakage making it impossible to cool the home requiring coil replacement. Coil failures indicative of this problem typically occur every 6-14 months
3. Observed metal corrosion, indicated by blackening of **one or more** of the following:
  - copper wires, ground wires, and electrical connectors
  - un-insulated and un-coated copper pipes and fittings
  - chrome-plated bathroom fixtures
  - silver and copper jewelry
  - mirror backing in bathrooms

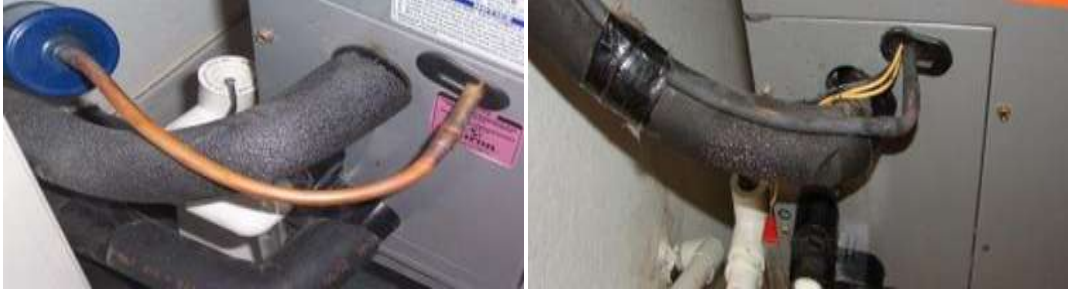
The pictures below show normal copper tubing (left) and corroded copper tubing (right)

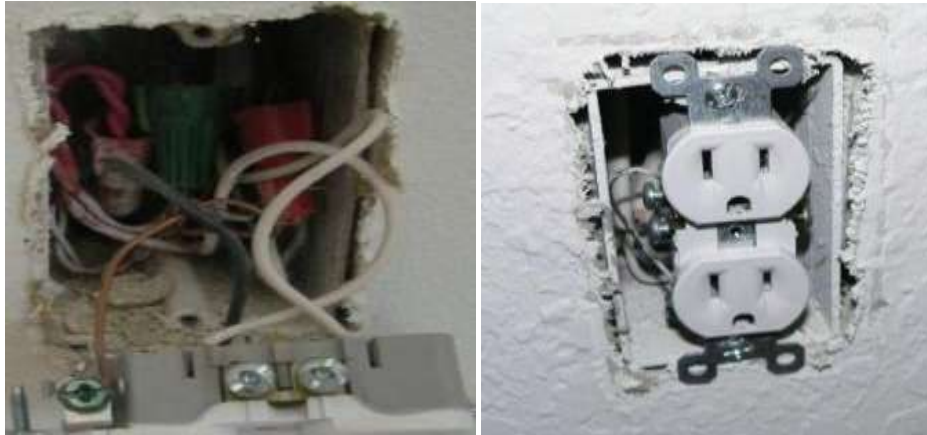
Chinese drywall corrodes electrical wiring. Check the electrical receptacles in your walls to see if the wires are blackened. Pull off the electrical plate and look inside.

The pictures below show some potential locations of electrical corrosion from Chinese drywall.

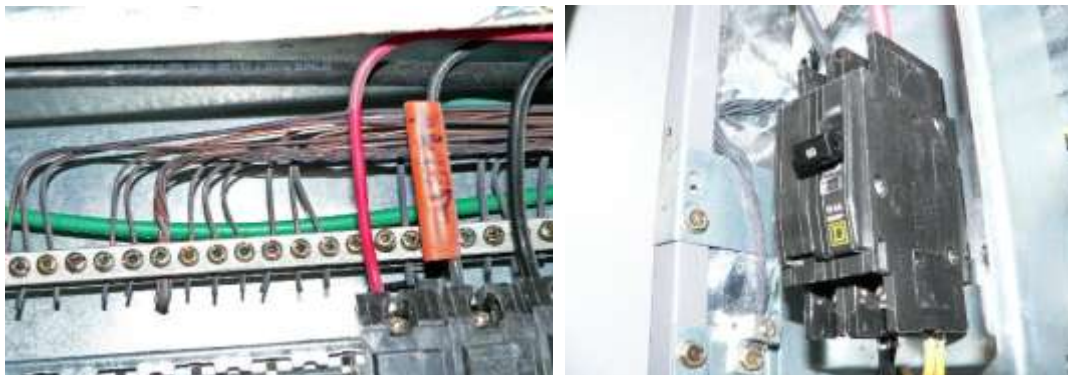
Corrosion can be a real electrical problem if not addressed.

7. The corrosion on metals caused by the sulfur gases emitted by Chinese drywall poses a fire risk. The corrosion increases resistance in the circuitry of appliances and electronics. Increased resistance increases heat in appliances and electronics. This increased resistance can cause excessive heating of the connection when energized. Complete failure of a switch can lead to fires or other life safety problems, depending on the intended function of the switch.

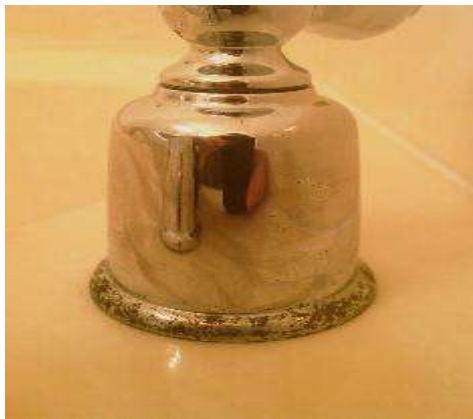
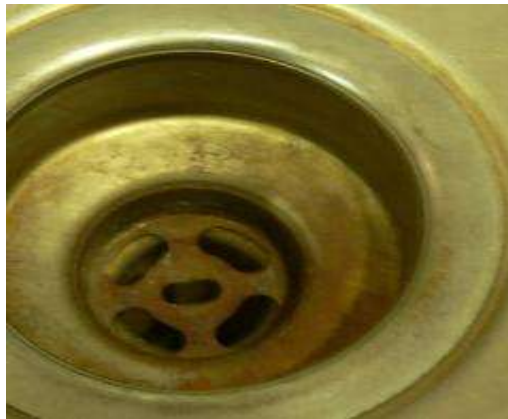
### **Corrosion to Plumbing fixtures**

The plumbing fixtures below have been damaged from off gassing of Chinese drywall
