PDHonline Course S110 (3 PDH)

Durability Design of Corrugated Steel Pipes

Instructor: John C. Huang, Ph.D., PE

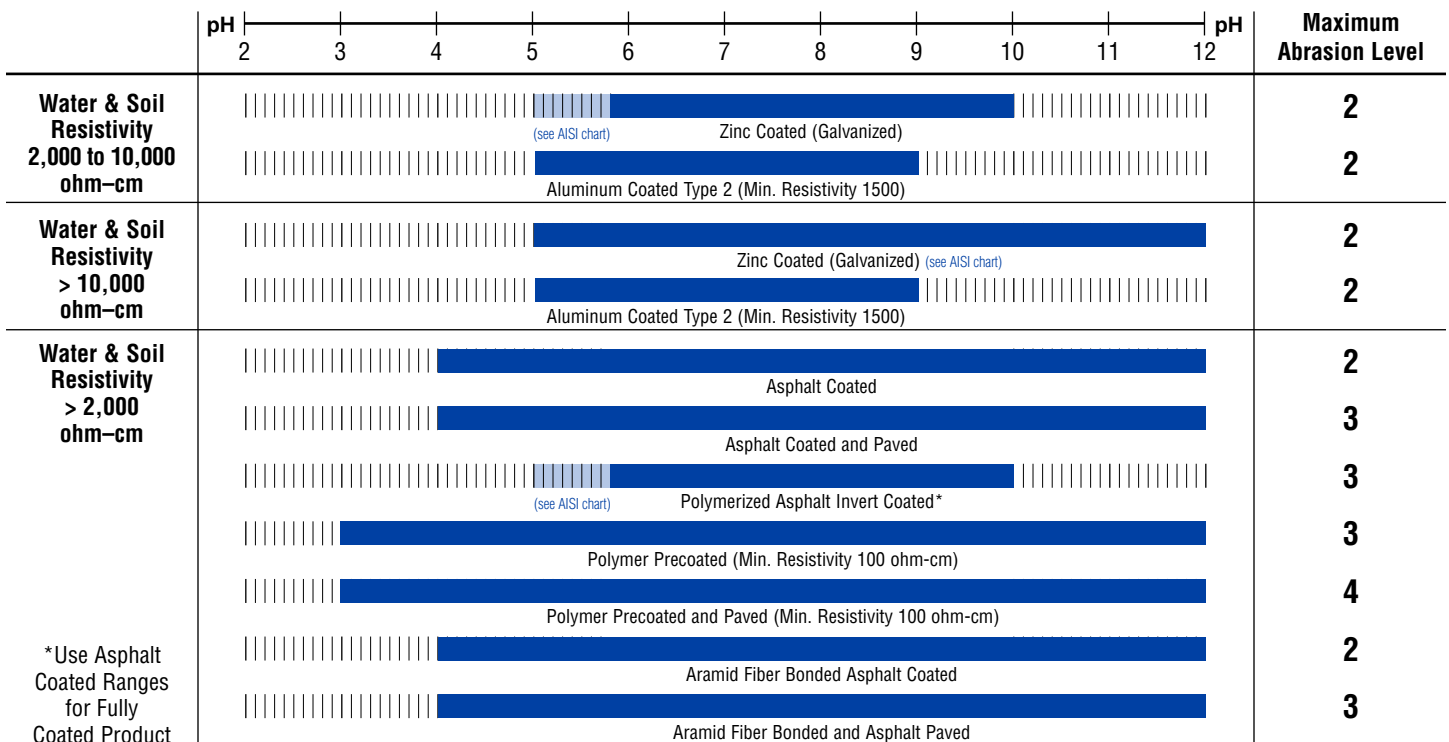
Environmental Guidelines for Corrugated Steel Pipe

ENVIRONMENTAL RANGES:

- **Normal Conditions:** pH = 5.8 – 8.0 (for R > 2000 ohm-cm)
- **Mildly Corrosive:** pH = 5.0 – 5.8 and/or for R = 1500 to 2000 ohm-cm
- **Corrosive:** pH < 5.0 (for R < 1500 ohm-cm)

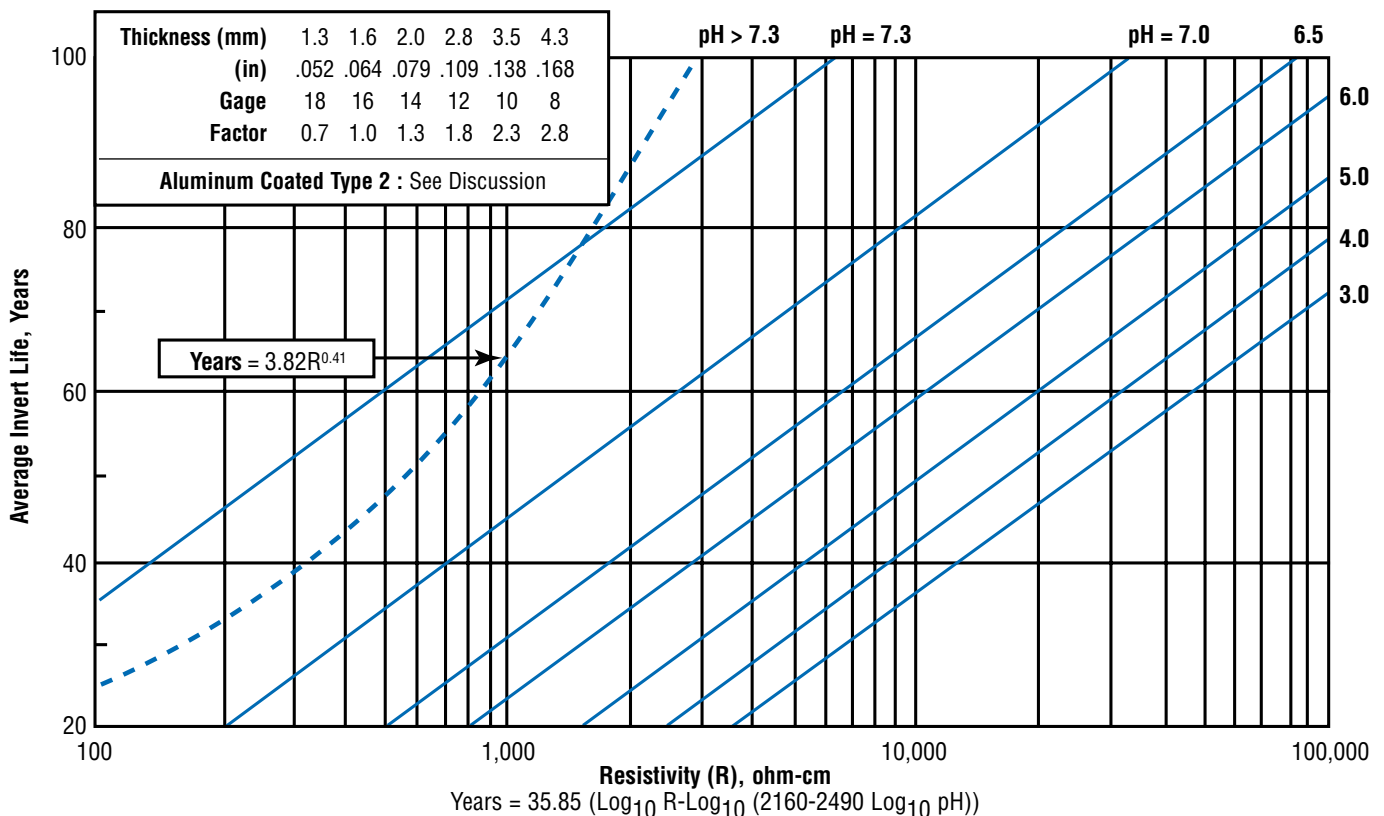
AISI Chart for Estimating Average Invert Life for Galvanized CSP

The service life of CSP can be reasonably predicted based on the environmental conditions, the thickness of the steel, and life of the coating. The most practical method of predicting the service life of the invert is with the AISI (American Iron and Steel Institute) chart shown on page 4.⁹ This chart is based on 16 gage galvanized CSP with a 610 g/m² (2 oz/ft²) coating and can be applied to other thicknesses with the appropriate factor. See discussion above for estimating the service life of aluminum coated type 2.

The AISI chart, which gives service life in terms of resistivity and pH, was developed from a chart originally prepared by the California Department of Transportation (Caltrans).¹⁰ The Caltrans study of durability was based on life to first perforation in culverts that had not received any special maintenance treatment. The results included the combined effects of soil-side and interior corrosion, as well as the average effects of abrasion. For pipes where the pH was greater than 7.3, soil-side corrosion controlled and life could be predicted by resistivity. For pipes where the pH was less than 7.3, the interior invert corrosion generally controlled and both resistivity and pH were important. In the field inspection of 7000 culverts in California for Caltrans, Richard Stratfull, Lead Project

Investigator, states he "has no memory of a corrosion perforation being initially found other than in the invert." At least 70 percent of the pipes were expected to last longer than the chart prediction.
