## **PDHonline Course A111 (1 PDH)**

# **Conserving Energy in Historic Buildings**

>Conserving Energy in Historic Buildings

#### Baird M. Smith, AIA

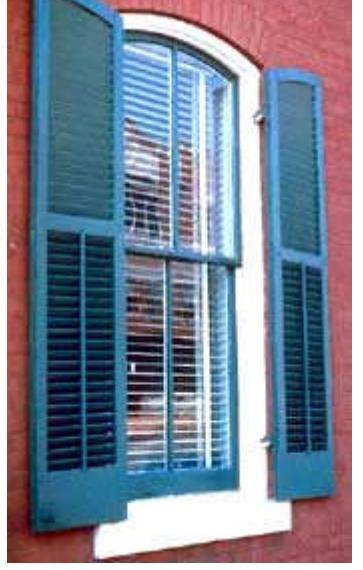
Shutters can be used to minimize the problem of summer heat gain by shading the windows. Photo: NPS files.

Early builders and architects dealt with the poor thermal properties of windows in two ways. First, the number of windows in a building was kept to only those necessary to provide adequate light and ventilation. This differs from the approach in many modern buildings where the percentage of windows in a wall can be nearly 100%. Historic buildings where the ratio of glass to wall is often less than 20%, are better energy conservers than most new buildings. Secondly, to minimize the heat gain or loss from windows, historic buildings often include interior or exterior shutters,

interior venetian blinds, curtains and drapes, or exterior awnings. Thus, a historic window could remain an energy efficient component of a building.

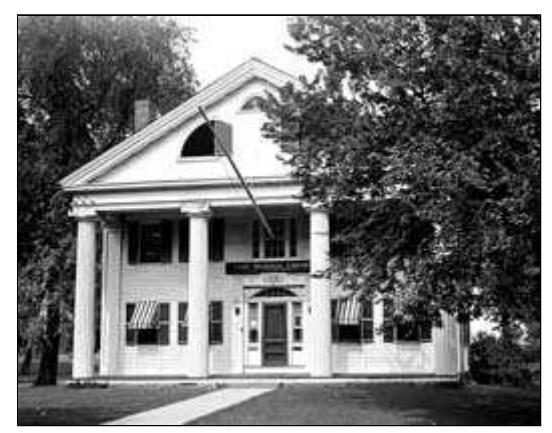
This 19th c. building in Massachusetts employed several energy-conserving features in its historic design, including shade trees, roof overhangs, awnings and shutters. Photo: HABS collection, NPS.

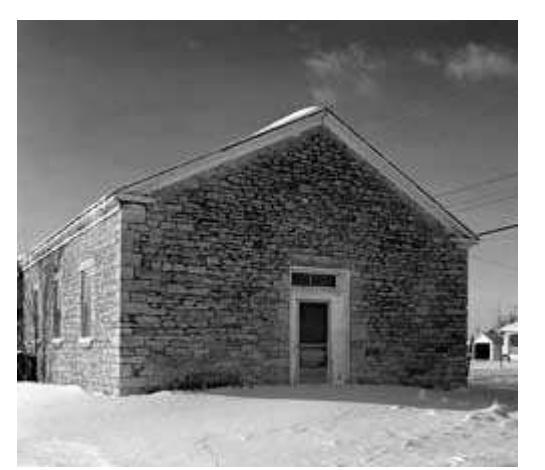
Heavy masonry walls and few windows serve to maximize warmth inside. Photo: HABS collection, NPS.

Winter heat loss from buildings in the northern climates was reduced by using heavy masonry walls, minimizing the number and size of

windows, and often using dark paint colors for the exterior walls. The heavy masonry walls used so typically in the late 19th century and early 20th century, exhibit characteristics that improve their thermal performance beyond that formerly recognized. It has been determined that walls of large mass and weight (thick brick or stone) have the advantage of high thermal inertia, also known as the "M factor." This inertia modifies the thermal resistance (R factor) (1) of the wall by lengthening the time scale of heat transmission. For instance, a wall with high thermal inertia, subjected to solar radiation for an hour, will absorb the heat at its outside surface, but transfer it to the interior over a period as long as 6 hours. Conversely, a wall having the same R factor, but low thermal inertia, will transfer the heat in perhaps 2 hours.

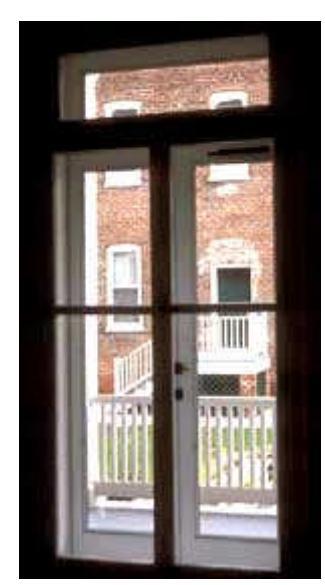
Storm doors have been added on the inside of this historic building as an energy-conserving device. Photo: NPS files.

A storm door would improve the thermal performance of the historic door; however, recent studies indicate that installing a storm door is not normally cost effective in residential settings. The costs are high compared to the anticipated savings. Therefore, storm doors should only be added to buildings in cold climates, and added in such a way to minimize the visual impact on the building's appearance. The storm door design should be compatible with the architectural character of the building and may be painted to match the colors of the historic door.

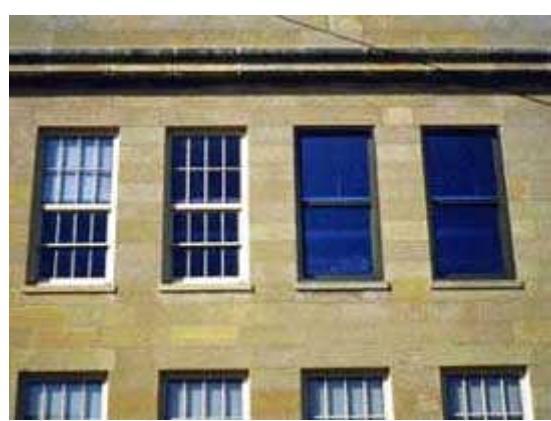
Tinted glazing has jeopardized the character of this historic office building and is, thus, not a recommended approach. Photo: Mike Jackson.

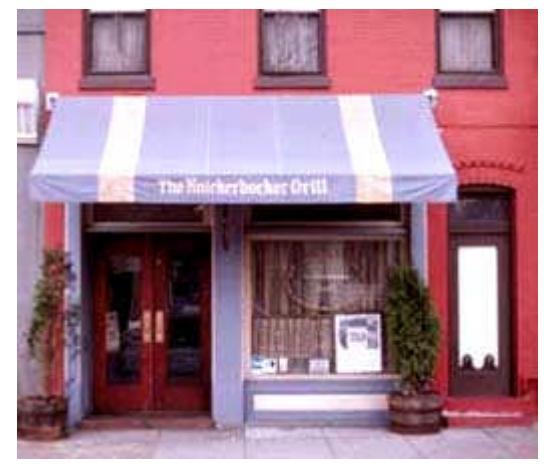
Awnings reduce heat gain in the summer and, when they are raised in the winter, radiant heat from the sun provides free

supplementary heat. Photo: NPS files.

Awnings and Shading Devices: In the past, awnings and trees were used extensively to provide shade to keep buildings cooler in the summer. If awnings or trees are in place, keep them in good condition, and take advantage of their energy-saving contribution. Building owners may consider adding awnings or trees if the summer cooling load is substantial. If awnings are added, assure that they are installed without damaging the building or visually impairing its architectural character. If trees are added, select deciduous trees that provide shade in the summer but, after dropping their leaves, would allow the sun to warm the building in the winter. When planting trees, assure that they are no closer than 10 feet to the building to avoid damage to the
