# **The Effect of Traffic Calming Measures on Pedestrian and Motorist Behavior**

# The Effects of Traffic Calming Measures on Pedestrian and Motorist Behavior

REPORT NO. FHWA-RD-00-104

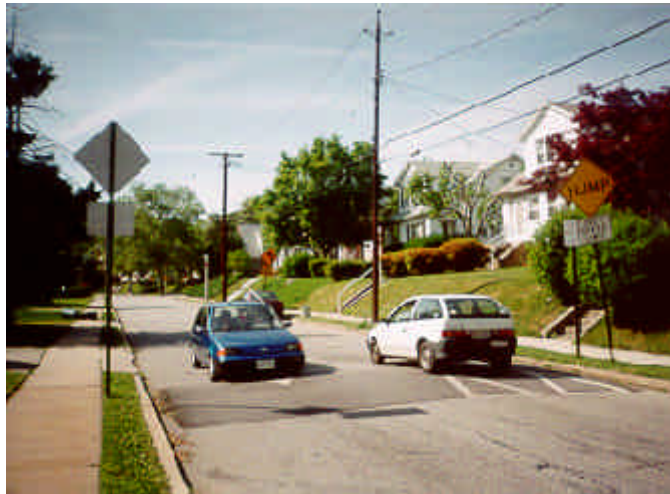
**Figure 1. Two vehicles slow down as they pass over a speed hump.**

Also known as road humps, undulations, or "sleeping policemen," the purpose of speed humps is to promote the smooth flow of traffic at slow speeds of about 32 to 40 km/h (20 to 25 mi/h). The speed hump is an elongated hump with a circular-arc cross-section (round-top) or flat-top, rising to a height of 76 mm (3 in) above the normal pavement surface and having a length of 3.7 m to 6.7 m (12 ft to 22 ft) in the direction of vehicular travel (Figure 1). Speed humps usually extend the full width of the road, excluding the gutter to allow for drainage (1).

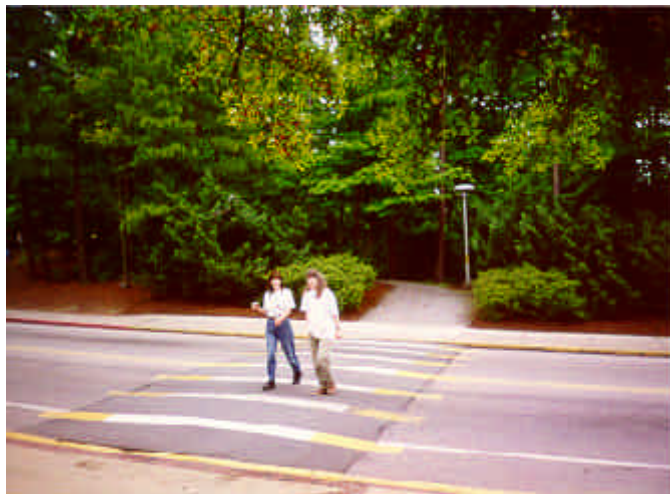
**Figure 2. Pedestrians using a raised crosswalk.**

Raised crosswalks are flat-top speed humps with crosswalk markings painted on the top (Figure 2). Raised crosswalks elevate pedestrians above the surface of the roadway and can make them more visible to motorists. Raised crosswalks cause motorists to slow at the most critical location, where pedestrians cross. They are generally designed to keep pedestrians at one level so that there is no need for curb ramps. Drainage is accommodated by pipes along the gutter or other design features.

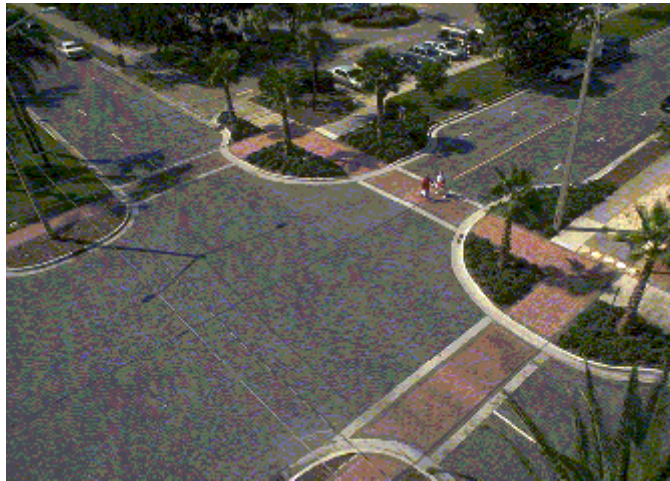
**Figure 3. Bulbouts shorten crossing distances for pedestrians, improve sight distances, and may slow vehicle speeds.**

The purpose of a bulbout (also known as a choker, curb bulb, neckdown, nub, or gateway) is to reduce the width of vehicle travel way at an intersection or a mid-block pedestrian crossing. Bulbouts shorten the street crossing distance for pedestrians, may slow vehicle speeds, and provide pedestrians and motorists with an improved view of one another, thereby reducing the risk of a motor vehicle-pedestrian collision (Figure 3).

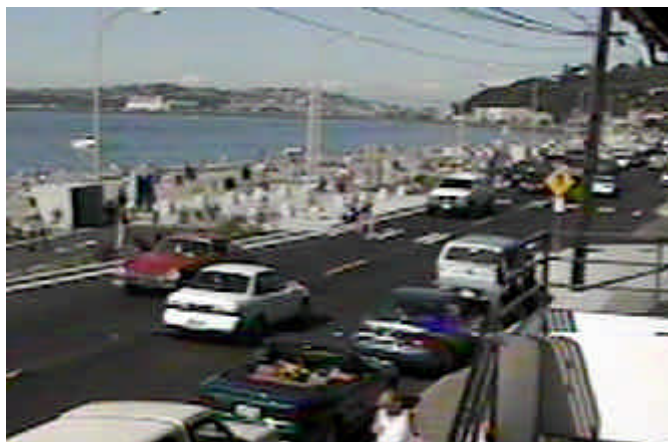
**Figure 4. A motorist yielding to pedestrians, Alki at 59<sup>th</sup>, Seattle.**

By constricting the roadway, bulbouts are intended to slow vehicles down and increase the likelihood that motorists will see pedestrians sooner than they would otherwise. Therefore, it was hypothesized that bulbouts would increase the number of pedestrians for whom motorists yielded. In other words, more pedestrians would have the benefit of motorists yielding to them (Figure 4).

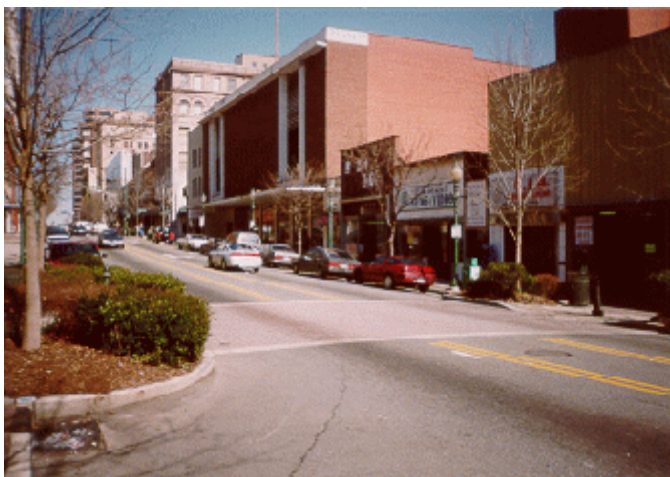
**Figure 5. Bulbout and textured crosswalk, Greensboro, North Carolina.**

Elm Street in Greensboro is the main north-south downtown arterial. Both bulbouts and the control site between Market Street and Friendly Avenue are downtown. The control site at Martin Luther King Jr. Drive is on the southern edge of downtown. Elm Street is generally two-way, with one lane in each direction. There is usually parking on both sides. The crosswalks are made of textured pavement. Elm Street is lined with shops, offices, and several vacant buildings (Figure 5).

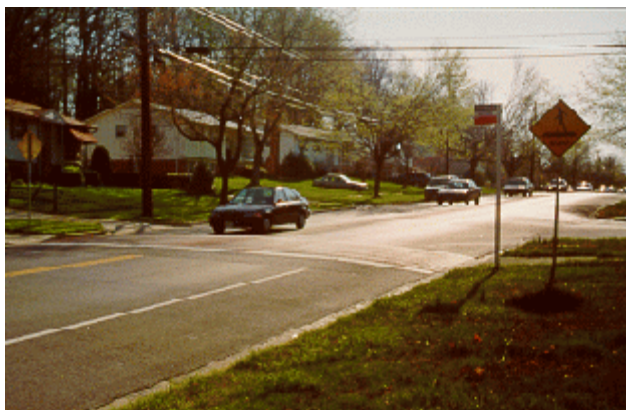
**Figure 7. Raised crosswalk, Bel Pre Road at Merton Road, Montgomery County, Maryland.**

Bel Pre Road at Merton Road is in a residential area just outside of Rockville, MD. Bel Pre is a northwest-southeast collector, with one lane of traffic in each direction and parking lanes on both sides. Merton Road is a local street that approaches from the southwest and forms a T-intersection with Bel Pre Road. The raised crosswalk is on the northwest leg of the intersection, and the control site is on the southeast leg of the same intersection (Figure 7).

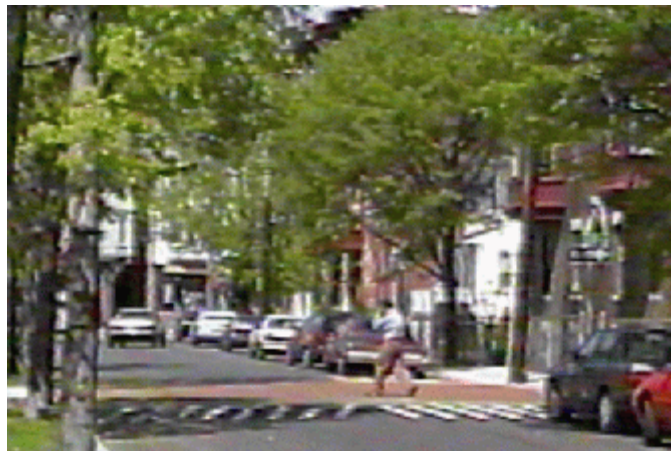
**Figure 8. Raised intersection, Berkshire Street and Marcella Street, Cambridge, Massachusetts.**

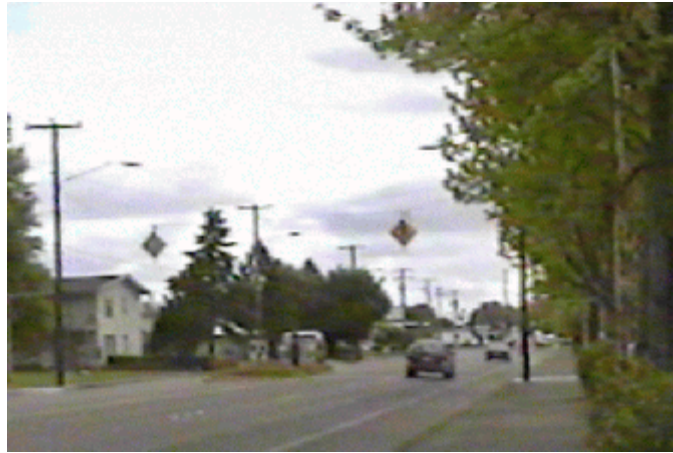
**Figure 9. Refuge island, Circle Boulevard, Corvallis, Oregon.**

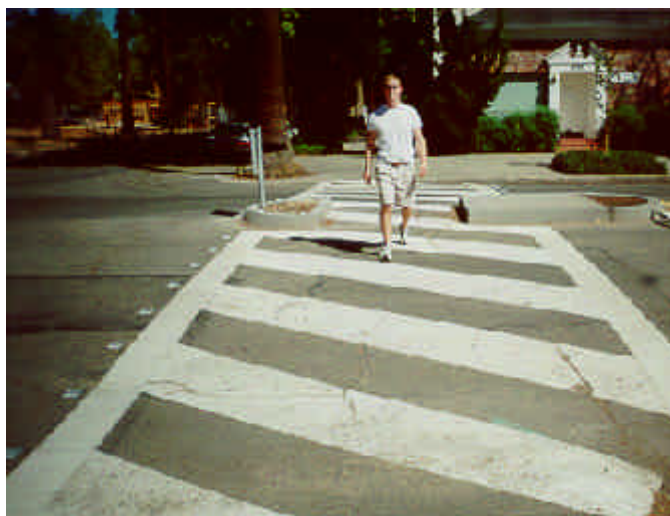
**Figure 10. Pedestrian in crosswalk with refuge island, Sacramento, California.**
