# FHWA Bridge Inspector's Manual Section 10.1 - Abutments and Wingwalls

# SECTION 10: Inspection and Evaluation of Substructures TOPIC 10.1: Abutments and Wingwalls

# **Topic 10.1Abutments and Wingwalls**

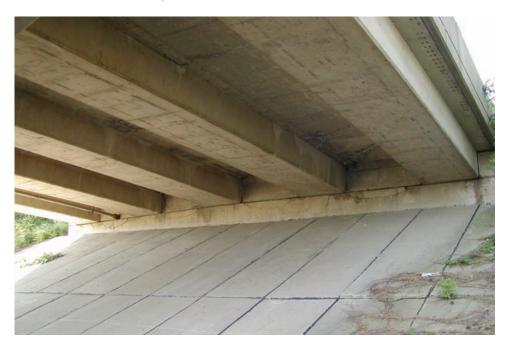
Figure 10.1.4 Stub Abutment

Full height abutments are used when shorter spans are desired or if there are Right-of-Way or terrain issues. This reduces the initial superstructure costs. Stub abutments may be used when it is desirable to keep the abutments away from the underlying roadway or waterway. Longer spans are required when stub abutments are used. Using stub abutments reduces the cost of the substructure but increases the cost of the superstructure.

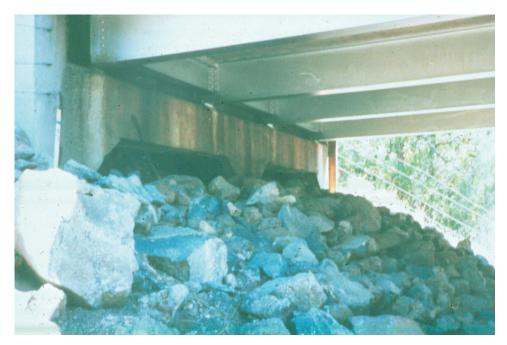
Figure 10.1.5 Open Abutment

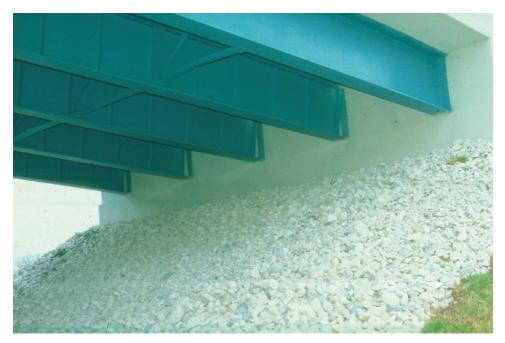
Figure 10.1.7 Integral Abutment

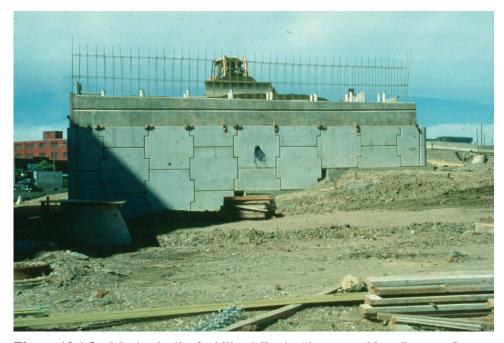
**Figure 10.1.8** Mechanically Stabilized Earth Abutment (Note Precast Concrete Panels)

Precast concrete panels are erected first, followed by the placement and compaction of a layer of backfill. The layers of backfill are sometimes referred to as "lifts." Soil reinforcement is then placed and bolted into the panels and covered with more backfill (see Figure 10.1.9). This process, which allows the wall to remain stable during construction, is repeated until the designed height is attained.

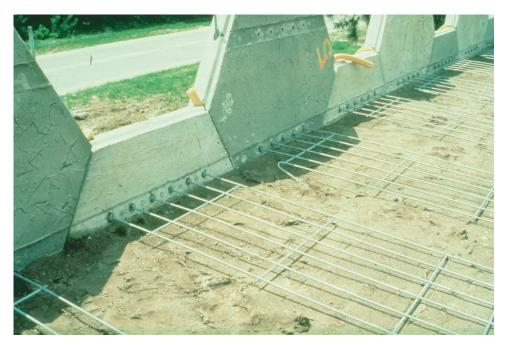
Figure 10.1.9 Mechanically Stabilized Earth Wall Under Construction

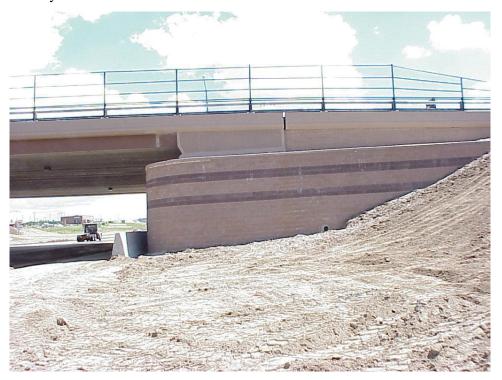
**Figure 10.1.11** View of the Founders/Meadows Bridge Supported by GRS Abutments

Another less common, fairly new type of abutment is the geosynthetic reinforced soil (GRS) abutment, developed by the Federal Highway Administration. GRS abutments are basically constructed on a level surface starting with a base structure of common, but high quality, cinder blocks. Fill is then placed and compacted with a sheet of geosynthetic reinforcement, which can be a series of polymer sheets or grids. These materials are layered until the designed height is attained. GRS abutments, which are internally supported, use friction to hold the blocks together and obtain their strength through proper spacing of the layers of reinforcement. Advantages of GRS abutments are their simplicity to construct, their durability, and their aesthetic appearance. GRS technology works well with simple overpasses; however, they are not ideal where severe flooding could occur (see Figures 10.1.10 and 10.1.11).

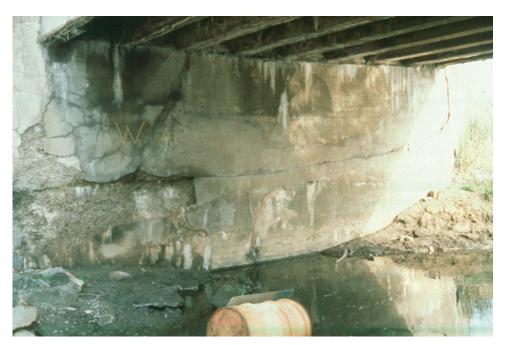
Figure 10.1.12 Plain Unreinforced Concrete Gravity Abutment

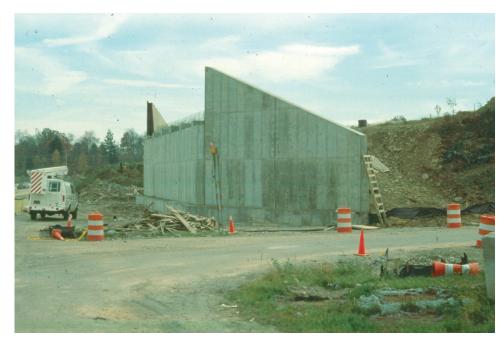
Figure 10.1.13 Reinforced Concrete Cantilever Abutment

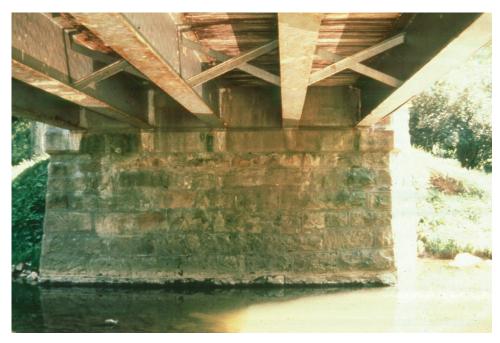
Figure 10.1.14 Stone Masonry Gravity Abutment

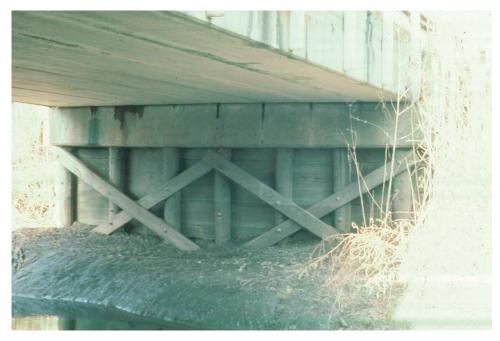
**Figure 10.1.15** Combination: Timber Pile Bent Abutment with Reinforced Concrete Cap

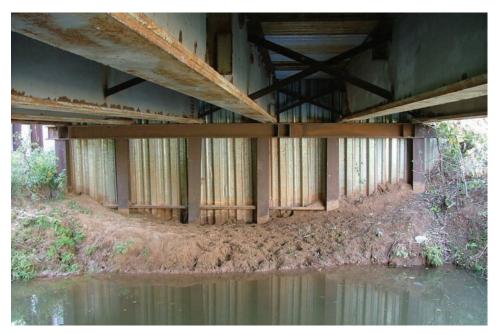
Figure 10.1.16 Steel Abutment

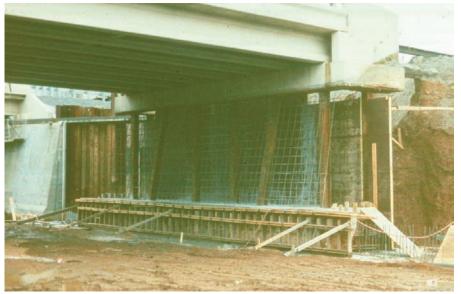
Figure 10.1.21 Stub Abutment on Piles with Piles Exposed

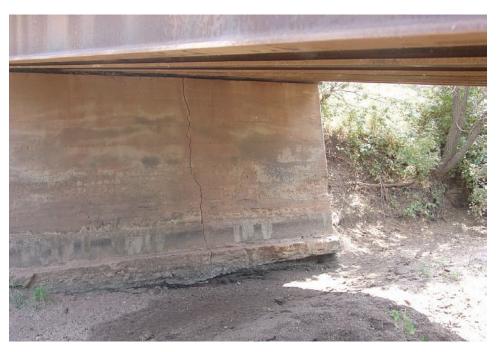
Figure 10.1.24 Crack in Abutment due to Settlement

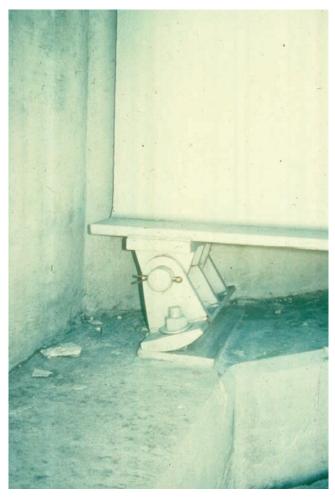
**Figure 10.1.26** Excessive Rocker Bearing Displacement Indicating Possible Lateral Displacement of Abutment

- Inspect the general alignment of the abutment.
- Check the bearings for evidence of lateral displacement (see Figure 10.1.26).
- Examine the opening in the construction joint between the wingwall and the abutment.
- Investigate the joint opening between the deck and the approach slab (see Figure 10.1.27).
- Check the approach roadway for settlement.
- Check the distance between the end of the superstructure and the backwall.
- Examine for clogged drains (approach roadway, weep holes, and substructure drainage).
- Inspect for erosion, scour or undermining of the embankment material in front of the abutment (see Figure 10.1.28).

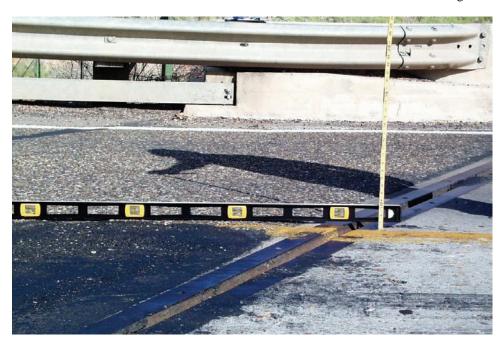
Figure 10.1.27 Depressed Approach Slab due to Rotating Abutment

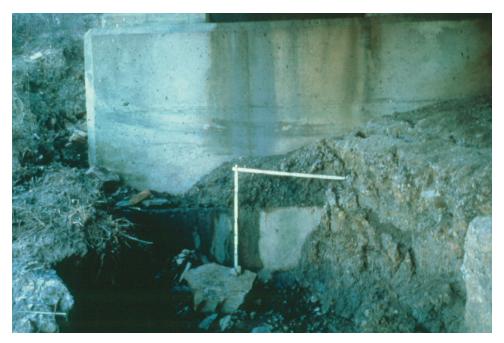
Figure 10.1.28 Erosion at Abutment Exposing Footing

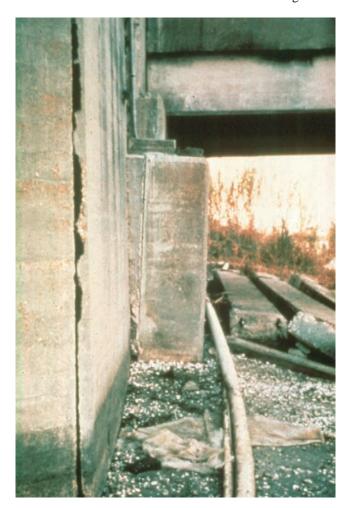
Figure 10.1.30 Rotational Movement at Abutment

- Check the vertical alignment of the abutment using a plumb bob or level; keep in mind that some abutments are constructed with a battered or sloped front face (see Figures 10.1.30 and 10.1.31).
- Examine the clearance between the beams and the backwall.
- Inspect for clogged drains or weep holes.
- Investigate for unusual cracks or spalls.
- Check for scour or undermining around the abutment footing. See Topic 11.2 for a detailed description of scour and undermining. See Topic 11.3 for a detailed description of underwater inspection.

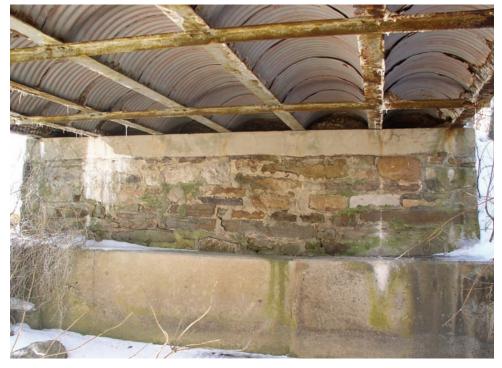
Figure 10.1.32 Cracking in Bearing Seat of Concrete and Stone Abutment

- Examine the bearing seats for cracking and spalling, particularly near the edges; this is particularly critical where concrete beams bear directly on the abutment seat (see Figure 10.1.32).
- Inspect for the presence of debris and standing water on the bearing seats.
- Investigate for deteriorated concrete in areas that are exposed to roadway drainage, particularly below the joint between the backwall and the deck (see Figure 10.1.33).
- > Check the backwall for cracking and possible movement.
- Examine the construction joint between the backwall and the abutment stem.
- Inspect stone masonry for mortar cracks or loss of mortar in the joints (see Figure 10.1.34).
- Examine stone masonry for vegetation, water seepage through cracks, loose or missing stones, weathering, split, spalled, loose or missing blocks.

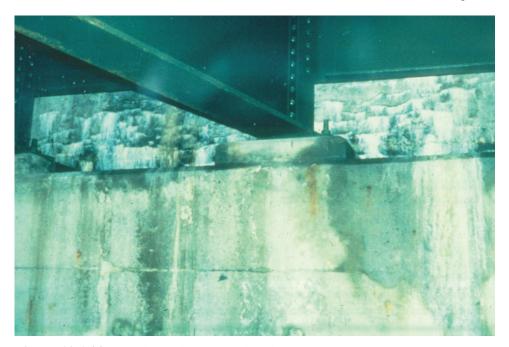
Figure 10.1.33 Deteriorated Concrete in Abutment Backwall

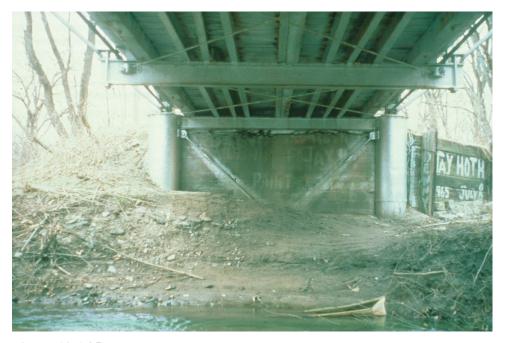
Figure 10.1.35 Steel Abutment

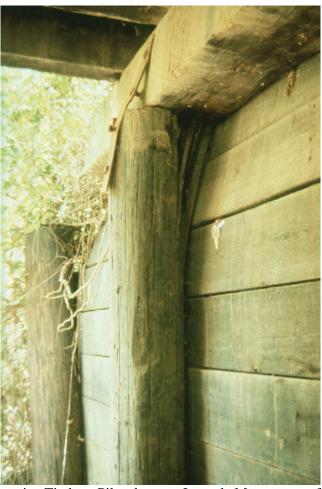
Figure 10.1.36 Local Failure in Timber Pile due to Lateral Movement of Abutment

- Examine bearing seat for accumulated dirt and debris and prolonged exposure to moisture.
- Inspect for decay, insect damage, and crushing of the cap beam.
- Investigate for local failures in lagging or piles due to lateral movement (see Figure 10.1.36).
- Check crib timbers, timber lagging, and piles for splits, cracks, decay, insect damage, fire damage, and chemical attack (see Figure 10.1.37).
- Inspect for scour around the piles (see Figure 10.1.38).
- Examine piles very closely for decay at or near the ground line or

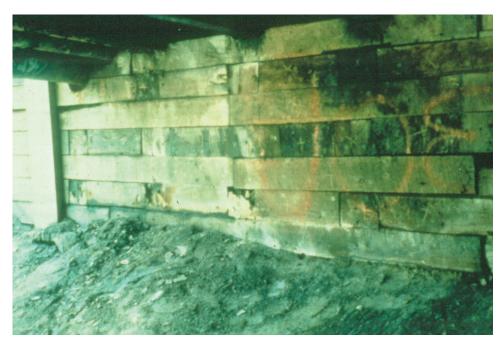
Figure 10.1.37 Decay in Lagging of Timber Crib Abutment

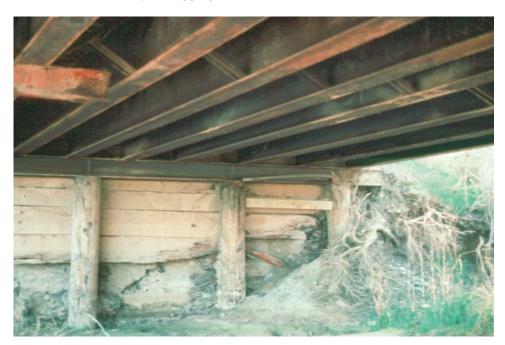
Figure 10.1.38 Decayed Lagging and Scour at a Timber Pile Bent Abutment

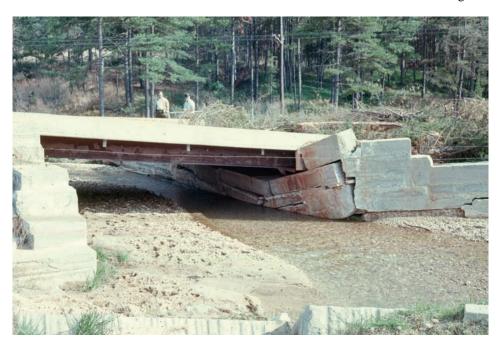
Figure 10.1.39 Abutment with Undermining due to Scour

Scour is the removal of material from a streambed as a result of the erosive action of running water (see Figure 10.1.39). Scour can cause undermining or the removal of supporting foundation material from beneath the abutments when streams or rivers flow adjacent to them. Refer to Topic 11.2 for a more detailed description of scour and undermining.

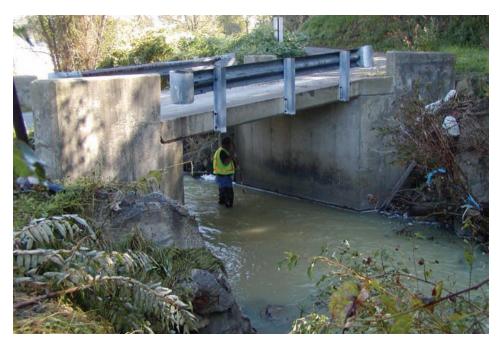
Figure 10.1.40 Inspector Checking for Scour

Inspection for scour should include probing around the abutment footing for signs of undermining (see Figure 10.1.40). Sometimes silt loosely fills in a scour hole and offers no protection or bearing capacity for the abutment footing.

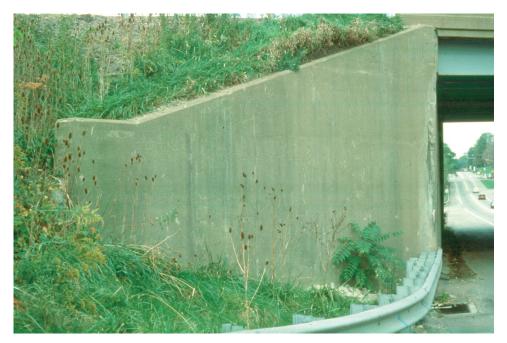
Figure 10.1.41 Typical Wingwall

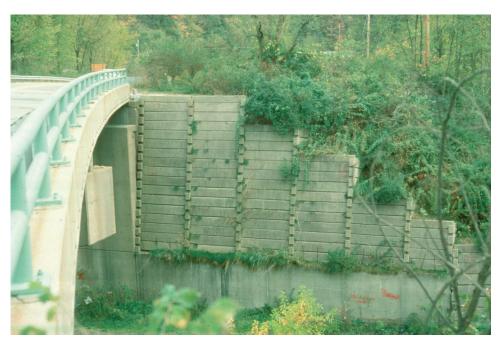
Figure 10.1.42 Straight Wingwall

- Straight extensions of the abutment wall (see Figure 10.1.42)
- Flared form an acute angle with the bridge roadway (see Figure 10.1.43)
- **U-wings** parallel to the bridge roadway (see Figure 10.1.44)

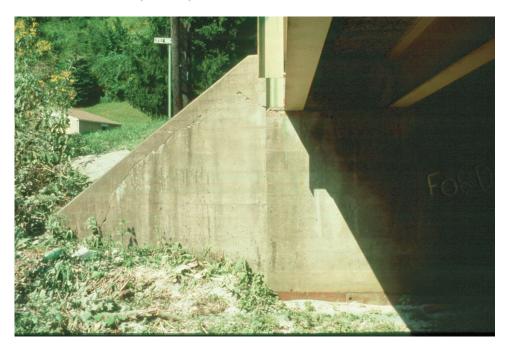
Figure 10.1.43 Flared Wingwall

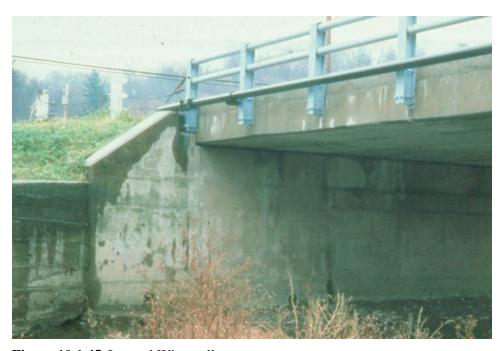
Figure 10.1.45 Integral Wingwall

- Integral constructed monolithically with the abutment (see Figure 10.1.45) normally cast-in-place concrete
- ➤ **Independent** constructed separately from the abutment; usually an expansion or mortar joint separates them from the abutment stem (see Figure 10.1.46)

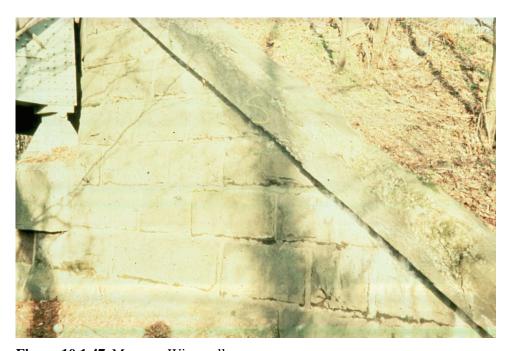
Figure 10.1.47 Masonry Wingwall

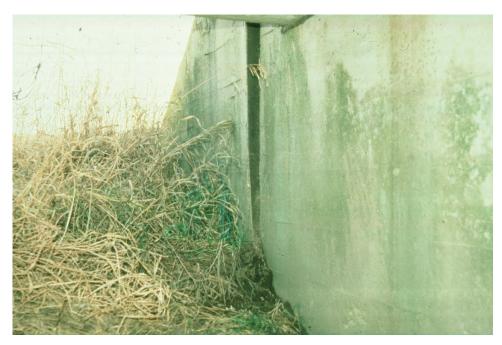
Figure 10.1.49 Rotational Movement at Concrete Wingwall

- Vertical movement
- Lateral movement
- Rotational movement (see Figure 10.1.49)
- Material defects (see Figure 10.1.50)
- Scour/undermining (see Figure 10.1.51)
- Drainage systems
- Areas subjected to high stresses
- Areas exposed to traffic

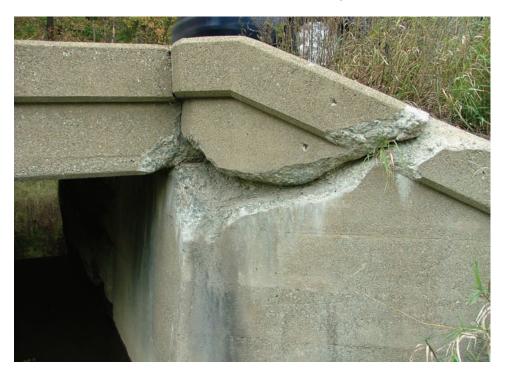
Figure 10.1.50 Deteriorated Concrete Wingwall

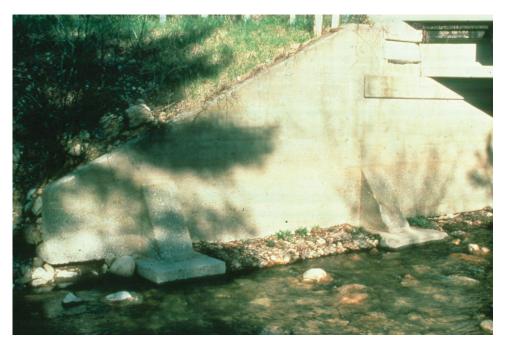
Figure 10.1.51 Scour and Possible Undermining of Concrete Wingwall

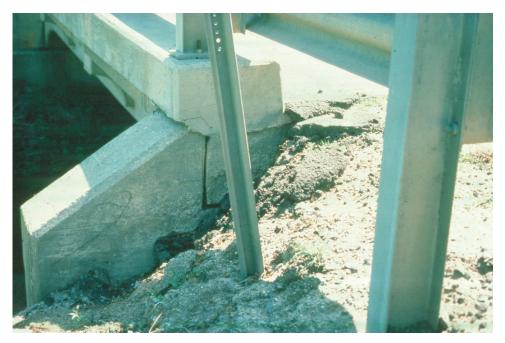
Figure 10.1.52 Roadway Shoulder Erosion Behind Wingwall

Material defects to look for include shoulder erosion, cracks, concrete deterioration, stone masonry deterioration, timber decay, and steel buckling (see Figures 10.1.52 to 10.1.55).

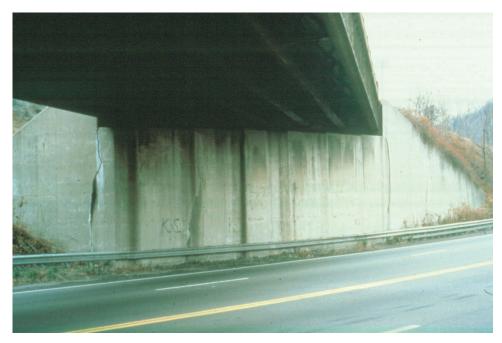
Figure 10.1.53 Settlement Cracks at Integral Concrete Wingwalls

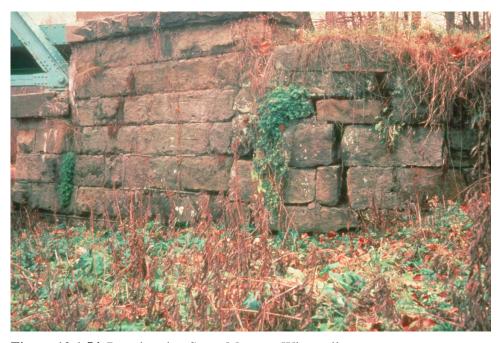
Figure 10.1.54 Deteriorating Stone Masonry Wingwall

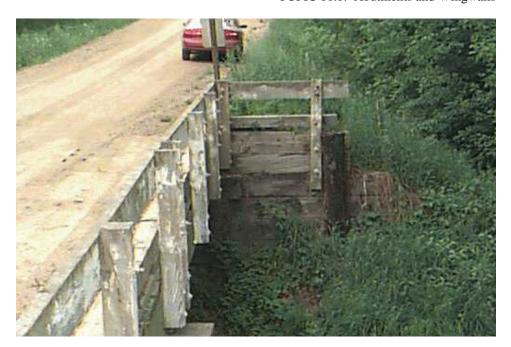
Figure 10.1.55 Timber Wingwall
