Coastal Buildings – Maintenance and Retrofits

14 Maintaining the Building

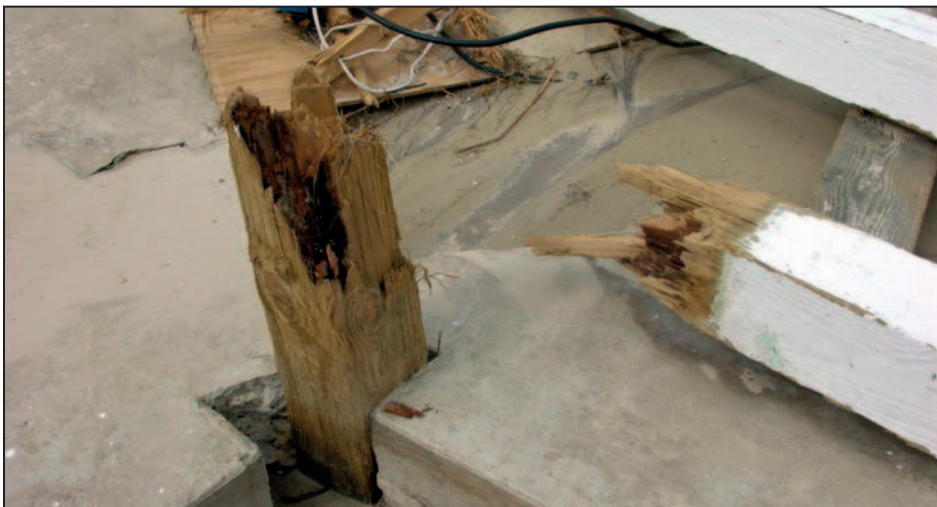
Figure 14-1.
Pile that appears acceptable from the exterior but has interior decay

acceptable condition but is weakened by interior decay, which can be determined only through a detailed inspection. This post failed under the loads imposed by a natural hazard event.
