Evaluation and Repair of Concrete Structures

CECW-EG Engineer Manual 1110-2-2002	Department of the Army U.S. Army Corps of Engineers Washington, DC 20314-1000	EM 1110-2-2002 30 June 1995
	Engineering and Design EVALUATION AND REPAIR OF CONCRETE STRUCTURES	
	Distribution Restriction Statement Approved for public release; distribution is unlimited.

Engineering and Design
EVALUATION AND REPAIR OF CONCRETE STRUCTURES

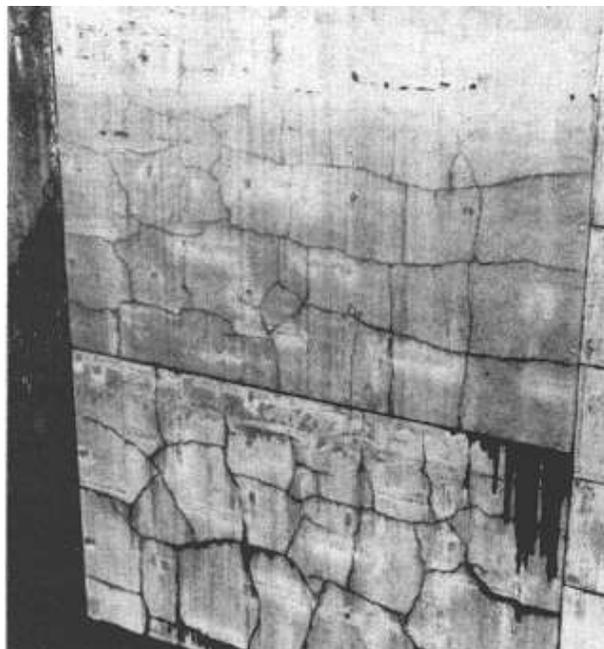
Figure 2-5. Pattern cracking caused by restrained volume changes

(a) Surface appearance of cracks. The surface appearance of cracks can give the first indication of the cause of cracking. Pattern cracks (Figures 2-5 through 2-7) are rather short cracks, usually uniformly distributed and interconnected, that run in all directions. Pattern cracking indicates restraint of contraction of the surface layer by the backing or inner concrete or possibly an

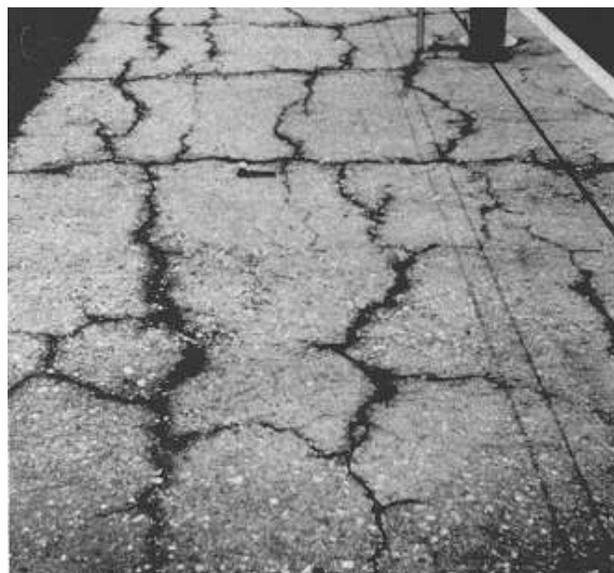
Figure 2-6. Pattern cracking resulting from alkali-silice reaction

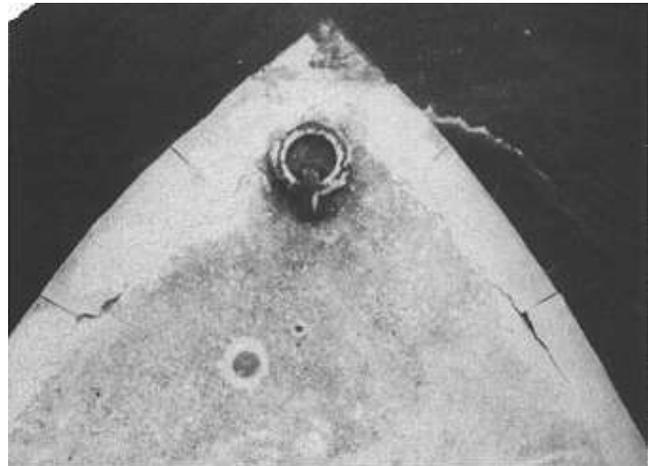
Figure 2-9. Isolated cracks as a result of restraint in the direction perpendicular to the crack

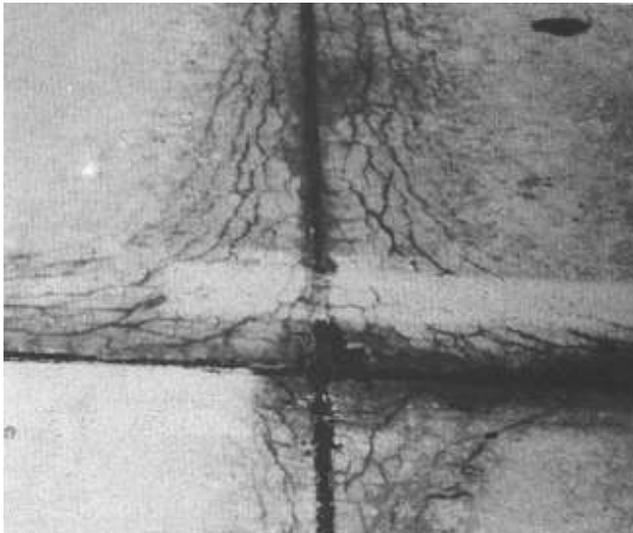
Figure 2-8. D-cracking in a concrete pavement

increase of volume in the interior of the concrete. Other terms used to describe pattern cracks are map cracks, crazing, and checking (see Glossary, Appendix B, for definitions). Another type of pattern crack is D-cracking. Figure 2-8 shows typical D-cracking in a concrete pavement. D-cracking usually starts in the lower part of a concrete slab adjacent to joints, where moisture accumulates, and progresses away from the corners of the slab. Individual cracks (Figures 2-9 through 2-11) run in definite directions and may be multiple cracks in parallel at definite intervals. Individual cracks indicate tension in the direction perpendicular to the cracking. Individual cracks are also frequently referred to as isolated cracks. Several terms may be used to describe the direction that an individual or isolated crack runs. These terms include diagonal, longitudinal, transverse, vertical, and horizontal.

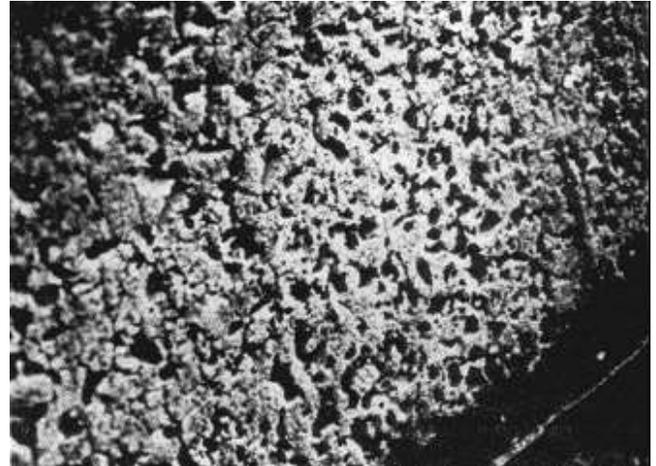
Figure 2-12. Disintegration of concrete caused by exposure to aggressive water

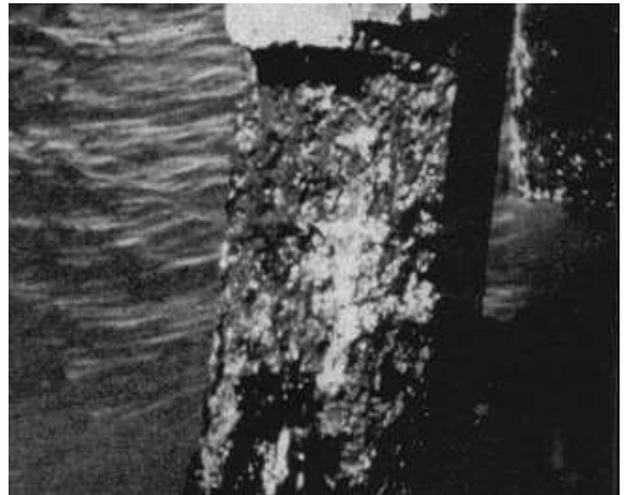
Figure 2-13. Disintegration of concrete caused by exposure to acidic water

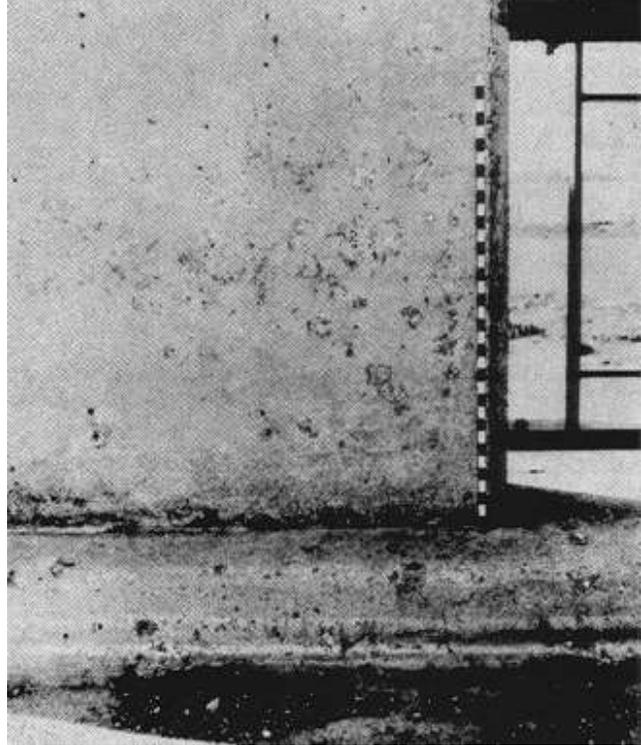
Figure 2-16. Light scaling

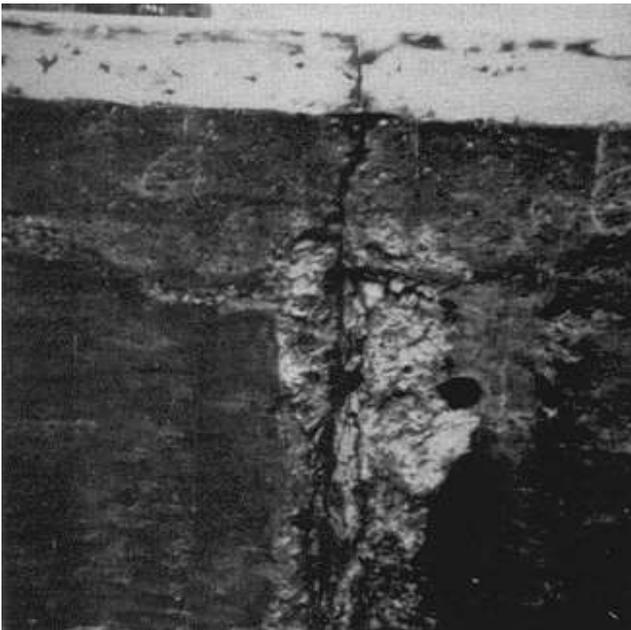
Figure 2-15. Disintegration at a monolith joint as a result of repeated cycles of freezing and thawing and barge impact

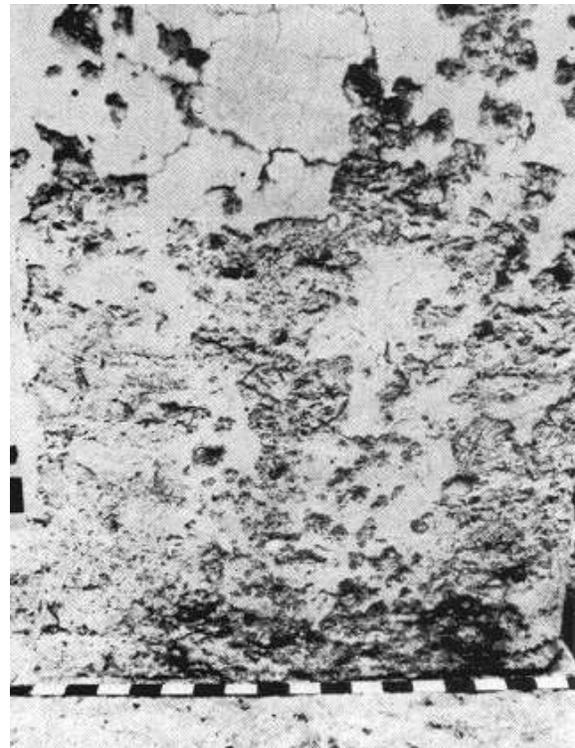
Figure 2-17. Medium scaling

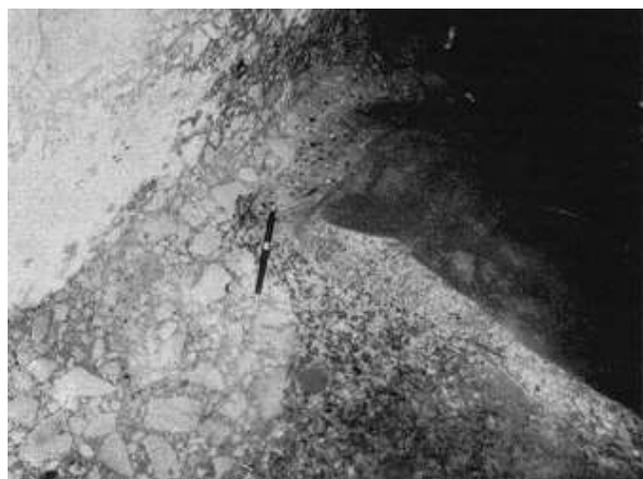
Figure 2-20. Smooth, worn, abraded concrete surface caused by abrasion of waterborne debris

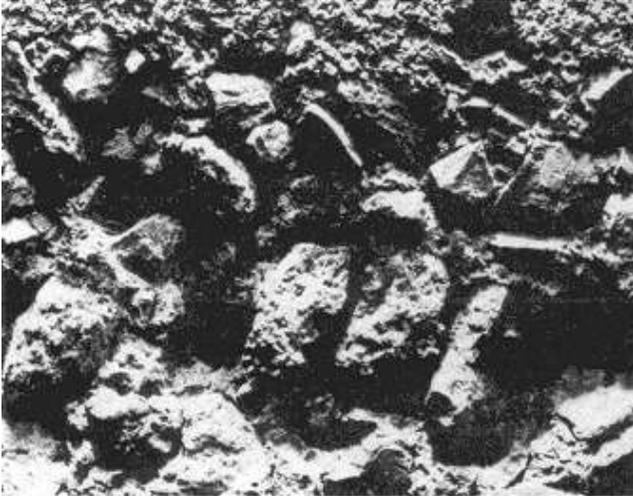
Figure 2-21. Rough, pitted concrete surface caused by cavitation

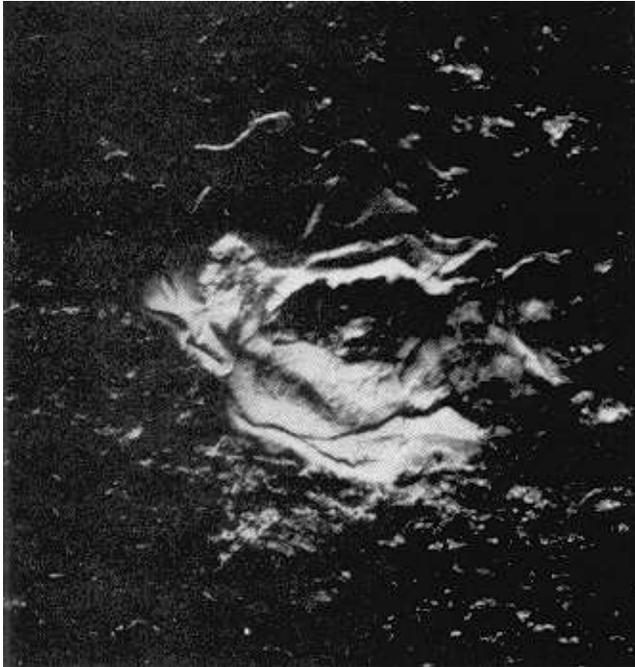
Figure 2-25. Exudation

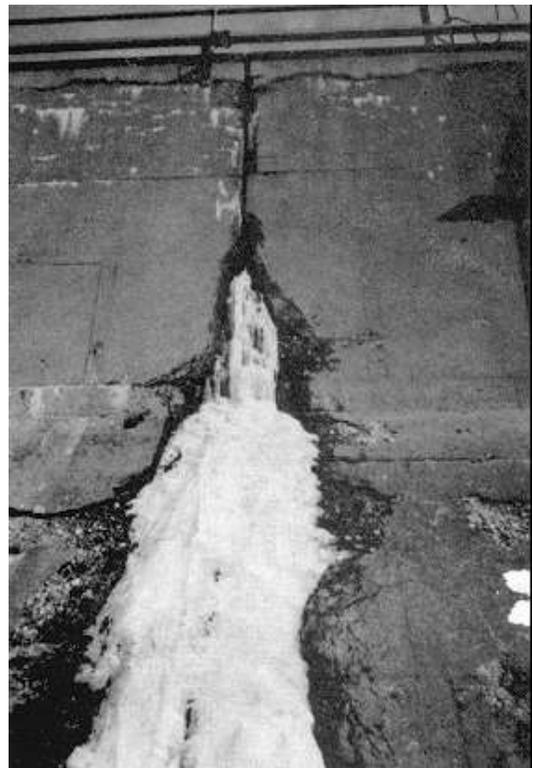
Figure 2-28. Water seepage through joint

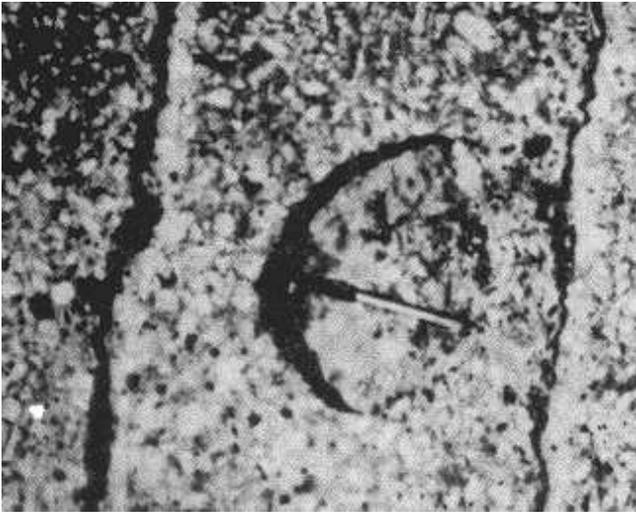
Figure 2-29. Small spall

(a) Small spall. Not greater than 20 mm (0.8 in.) in depth nor greater than 150 mm (6 in.) in any dimension (Figure 2-29).

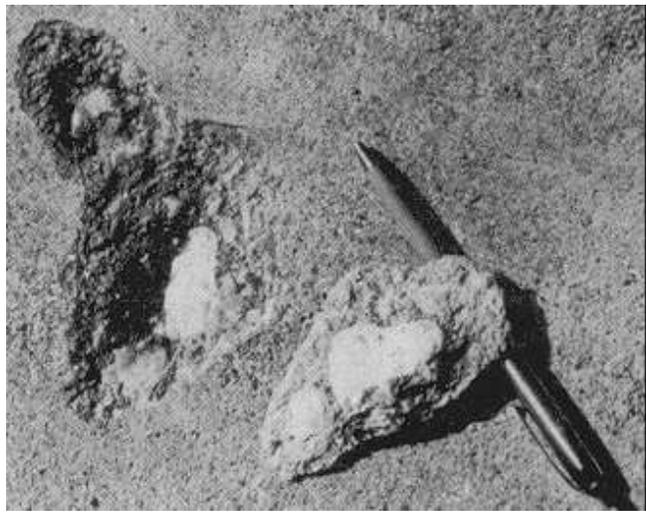
Figure 2-31. Popout

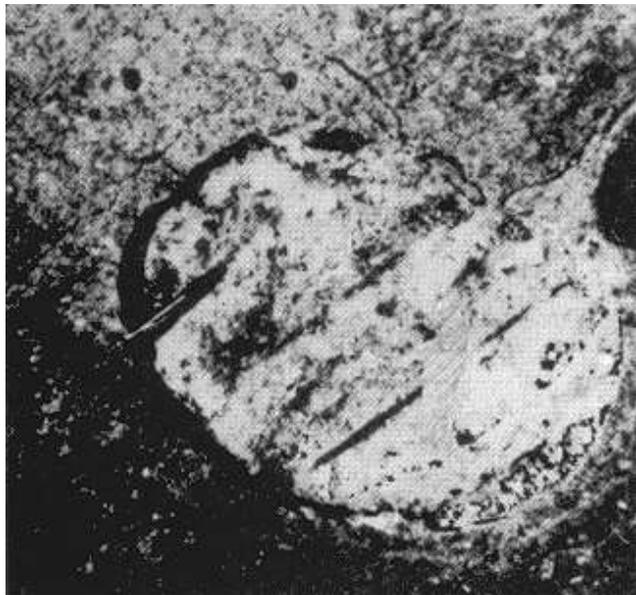
Figure 2-30. Large spall

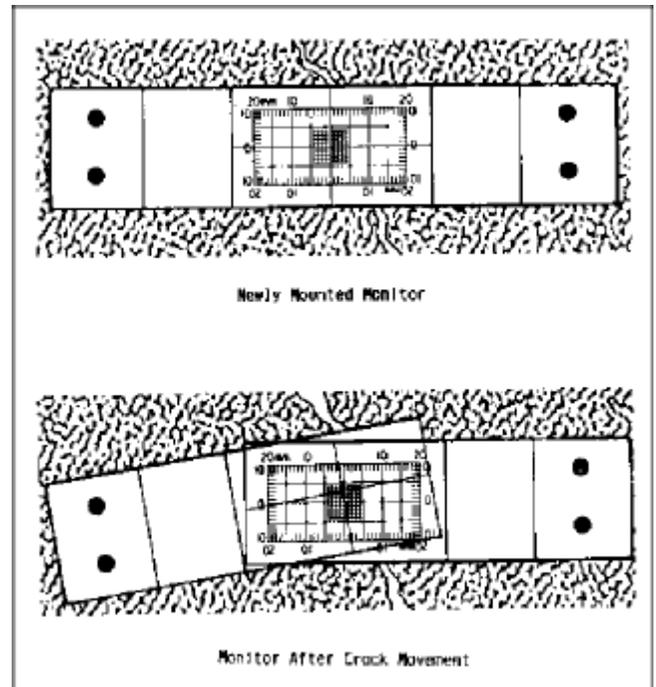
Figure 2-33. Crack monitor

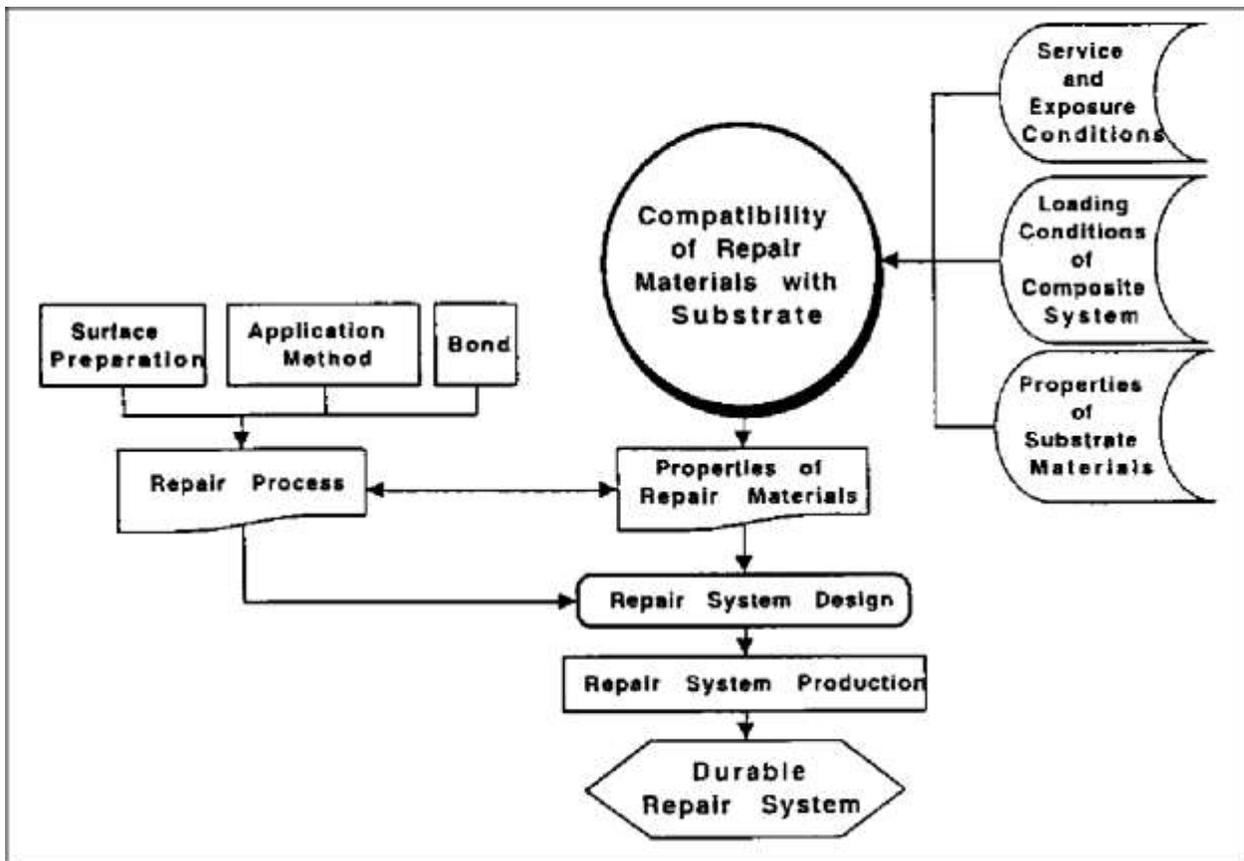
Figure 4-1. Factors affecting the durability of concrete repair systems (Emmons and Vaysburd 1995)

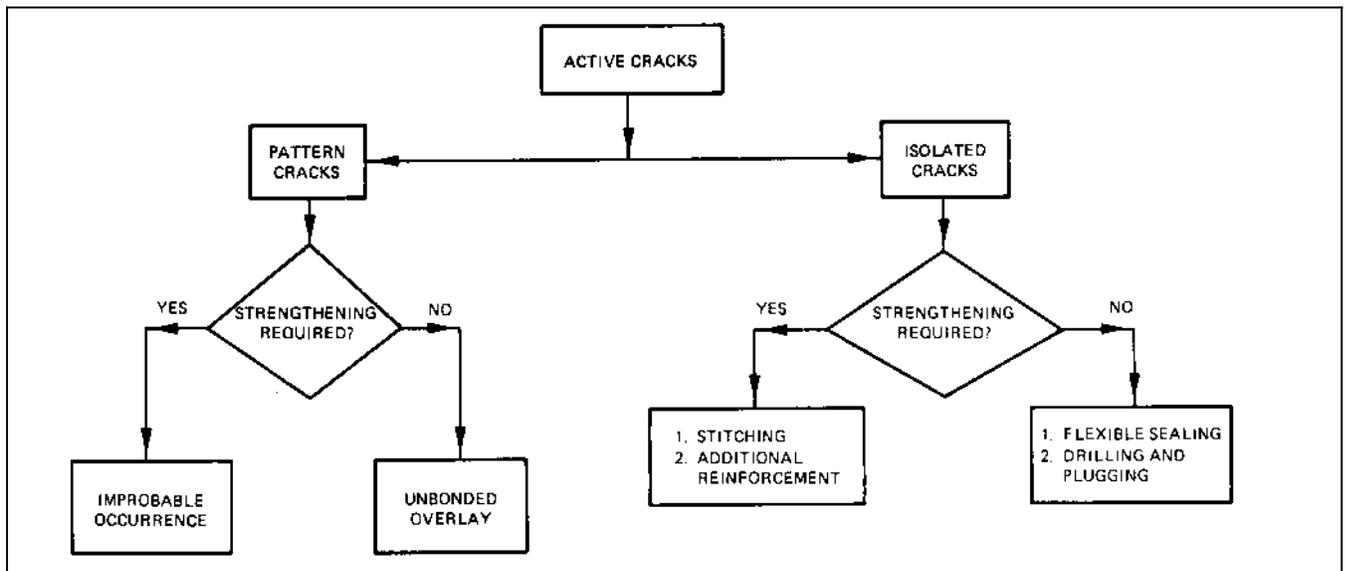
Figure 4-3. Selection of repair method for active cracks (after Johnson 1965)

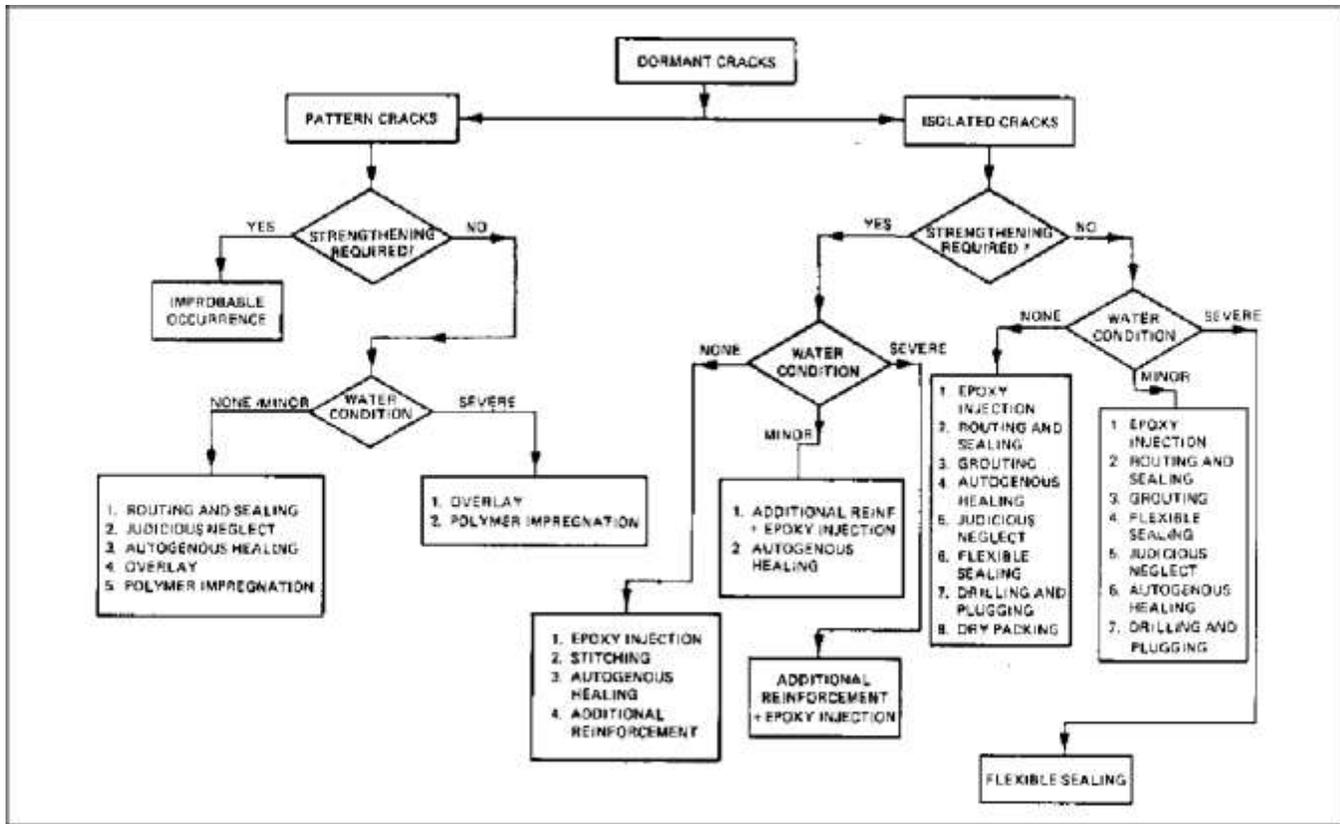
Figure 4-4. Selection of repair method for dormant cracks (after Johnson 1965)

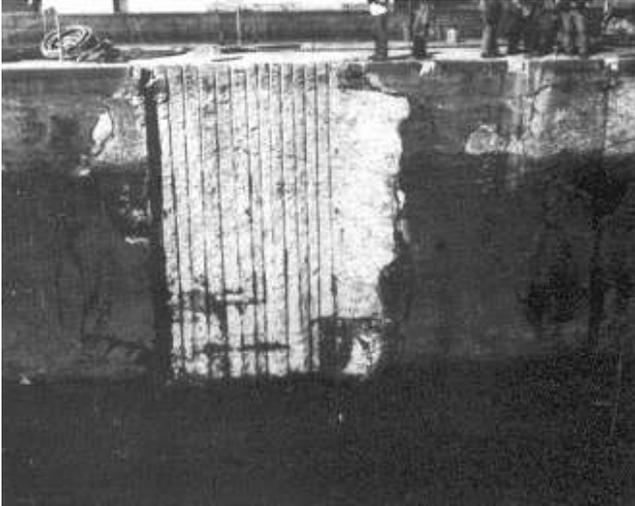
Figure 5-1. Surface removal of deteriorated concrete by explosive blasting

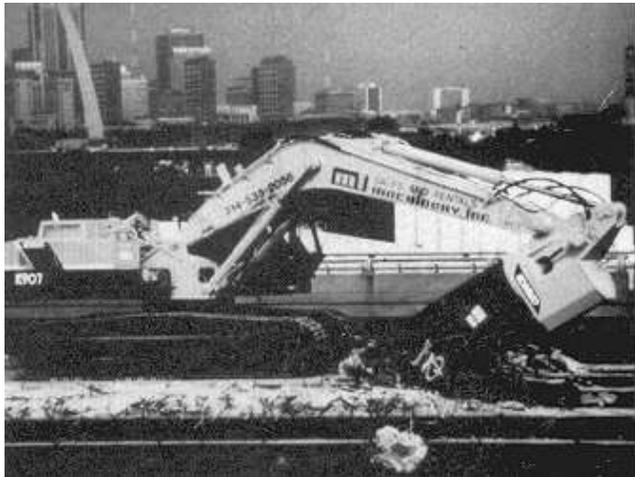
Figure 5-2. Boom-mounted concrete crusher

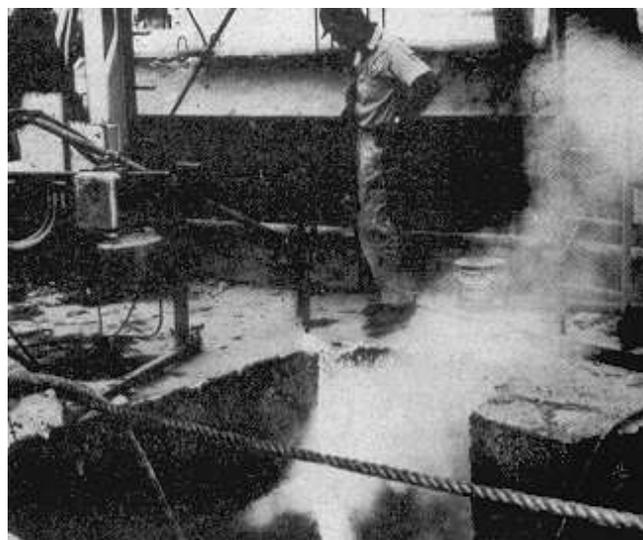
Figure 5-5. Powder torch

(5) *Thermal cutting.* Thermal-cutting methods are applicable for making cutouts through heavily reinforced decks, beams, walls, and other reinforced members where site conditions allow efficient flow of molten concrete from cuts. Flame tools (Figure 5-5) are typically employed for cutting depths of 600 mm (24 in.) or less, and lances (Figure 5-6), for greater depths. Thermal cutting tools are of limited commercial availability and are costly to use. The concrete that remains has a layer of thermal damage with more extensive damage occurring around steel reinforcement. Personnel must be protected from heat and hot flying rock produced by the cutting operation. Additional safety precautions are required because of the hazards associated with the storage, handling, and use of compressed and flammable gases. The

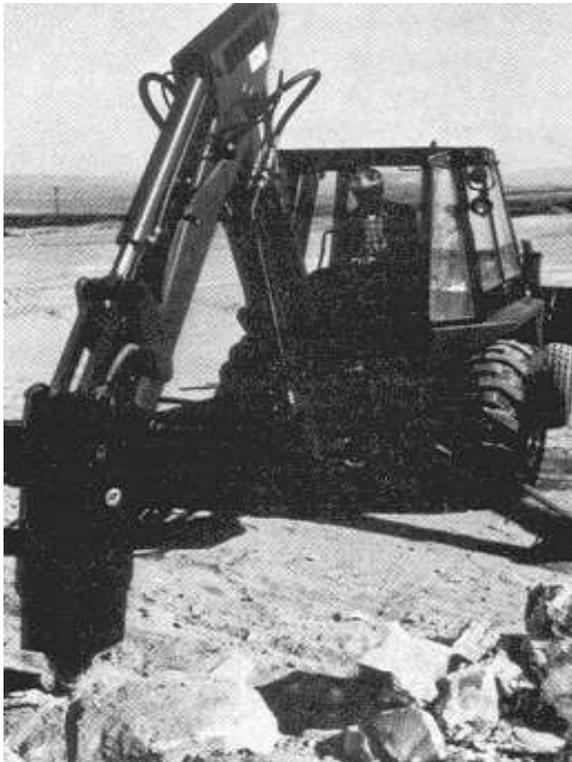
Figure 5-7. Boom-mounted breaker

(1) Boom-mounted breakers. Boom-mounted impact breakers are applicable for both full- and partial-depth removals where production rates required are greater than can be economically achieved by the use of hand-held breakers. The boom-mounted breakers are somewhat similar to the hand-held breakers except that they are considerably more massive. The tool is normally attached to the hydraulically operated arm of a backhoe or excavator (Figure 5-7) and can be operated by compressed air or hydraulic pressure. The reach of the hydraulic arm enables the tool to be used on walls at a considerable distance above or below the level of the machine. Boom-mounted breakers are a highly productive means of removing concrete. However, the blow energy delivered to the concrete should be limited to protect the structure being repaired and surrounding structures from damage resulting from the high cyclic energy generated. Saw cuts

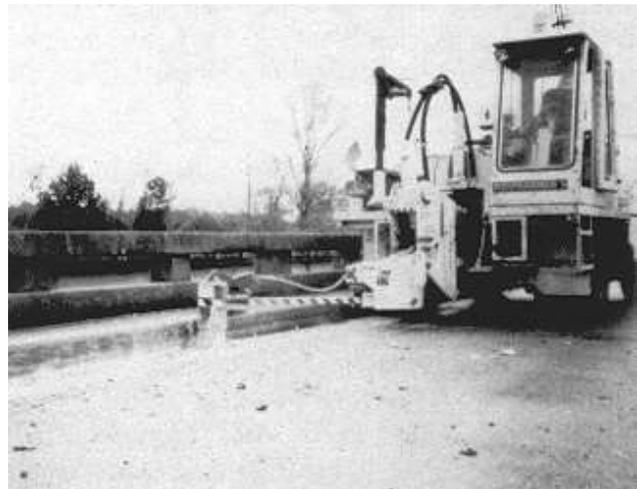
Figure 5-8. Spring-action hammer (mechanical sledgehammer)

(2) Spring-action hammers. Spring-action hammers (sometimes referred to as mechanical sledgehammers) are boom-mounted tools that are applicable for breaking concrete pavements, decks, walls, and other thin members where production rates required are greater than can be economically achieved with the use of hand-held breakers. Hammers are more applicable for total demolition of a concrete member than for removal to rehabilitate or repair. The arm of the hammer is hydraulically powered, and the impact head is spring powered. The spring is compressed by the downward movement of the arm of the backhoe or excavator and its energy released just prior to impact. There are truck units available that make it easier to move between projects. The operation of the hammer and advancement of the truck during removal are controlled from a cab at the rear of truck (Figure 5-8). The blow energy delivered to the concrete should be limited to protect the structure being repaired and surrounding structures from damage caused by the high cyclic energy generated. Saw cuts should be employed at removal boundaries to reduce the occurrence of feathered edges. The concrete that remains may be damaged (microcracking) along with the exposed reinforcing steel.

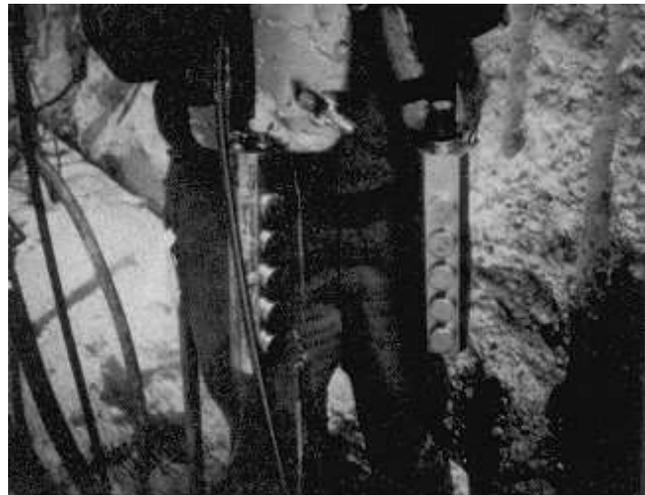
Figure 5-13. Piston-jack splitter

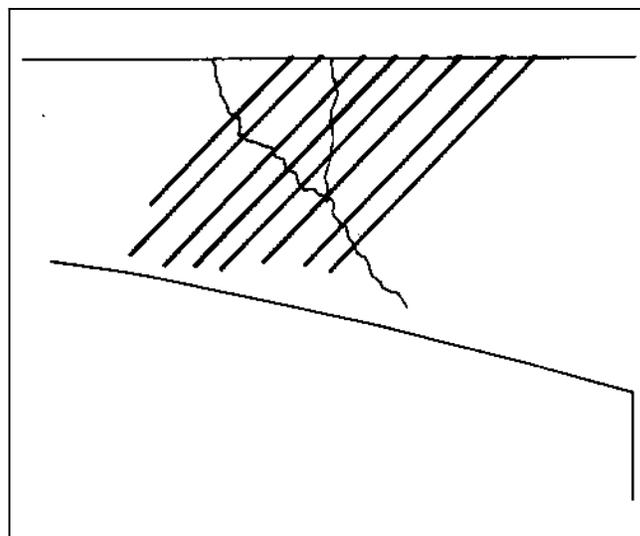
Figure 6-1. Crack repair using conventional reinforcement with drillholes 90 deg to the crack plane

(a) This technique consists of sealing the crack, drilling holes 19 mm (3/4 in.) in diam at 90 deg to the crack plane (Figure 6-1), cleaning the hole of dust, filling the hole and crack plane with an adhesive (typically epoxy) pumped under low pressure 344 to 552 KPa (50 to 80 psi), and placing a reinforcing bar into the drilled hole. Typically, No. 4 or 5 bars are used, extending at least 0.5 m (1.6 ft) on each side of the crack. The adhesive

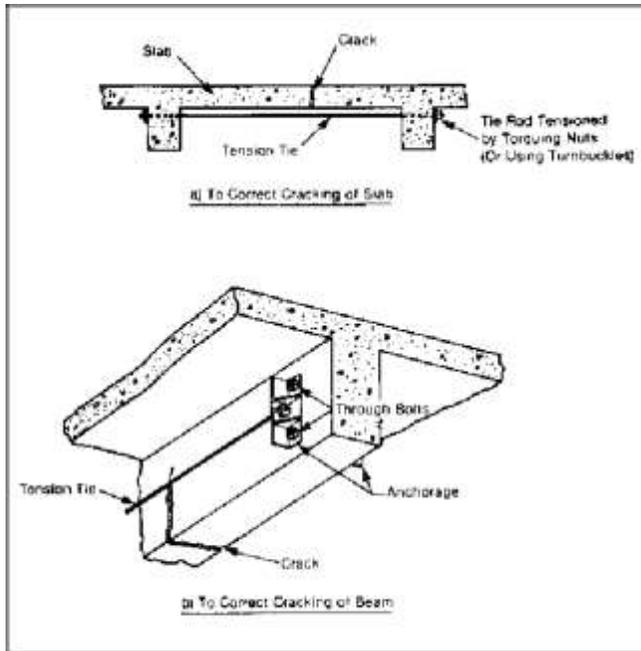
Figure 6-2. Crack repair with use of external prestressing strands or bars to apply a compressive force

(2) Prestressing steel. This technique uses prestressing strands or bars to apply a compressive force (Figure 6-2). Adequate anchorage must be provided for the prestressing steel, and care is needed so that the problem will not merely migrate to another part of the structure. The effects of the tensioning force (including eccentricity) on the stress within the structure should be carefully analyzed. For indeterminate structures posttensioned according to this procedure, the effects of secondary moments and induced reactions should be considered.

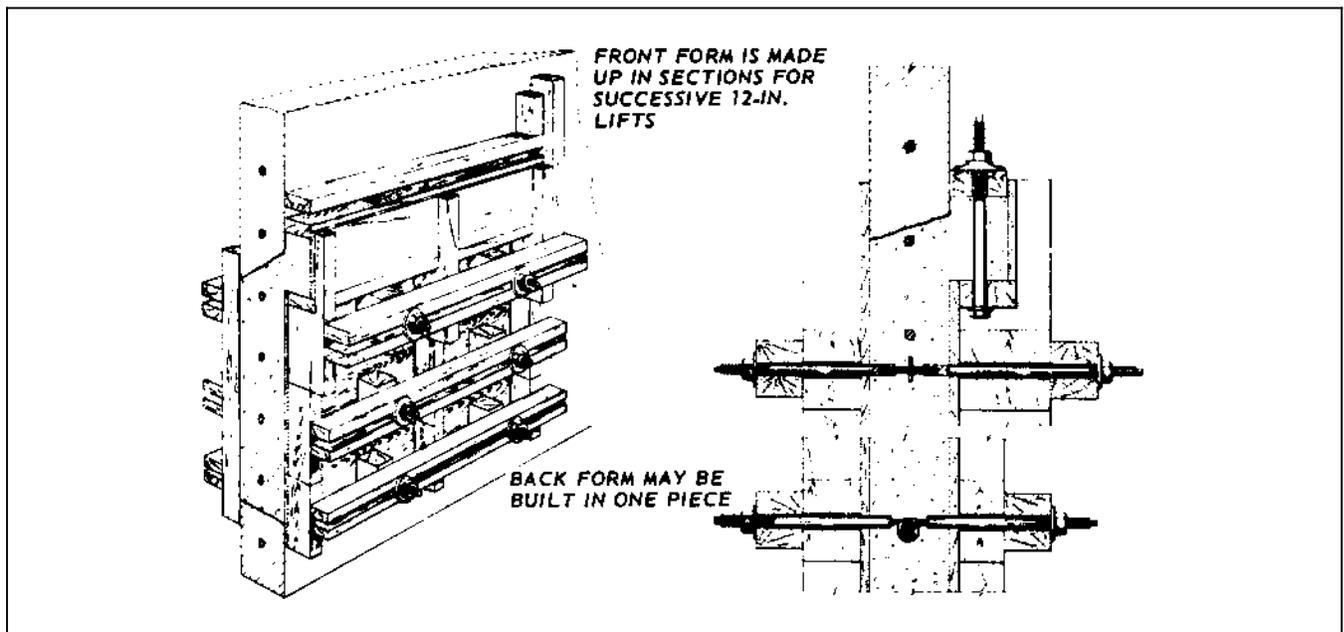
Figure 6-3. Detail of form for concrete replacement in walls after removal of all unsound concrete

(3) Forming will usually be required for massive repairs in vertical surfaces. The front form and the back form, where one is required, should be substantially constructed and mortar-tight. The back form may be assembled in one piece, but the front panel should be constructed as placing progresses so that the concrete can be conveniently placed in lifts. The contact surface should be dry at the time of patching. Small, thin repairs (less than 50 mm (2 in.) thick) should receive a bonding coat while thicker placements usually do not require a bonding coat (see paragraph 5-3a(2)(f)). The surface is first carefully coated with a thin layer of mortar, not exceeding 3 mm (1/8 in.) in thickness, containing sand passing the No. 16 sieve, and having the same w/c as the concrete to be used in the replacement. Hand-rubbing the mortar into the surface is effective. Epoxy resin

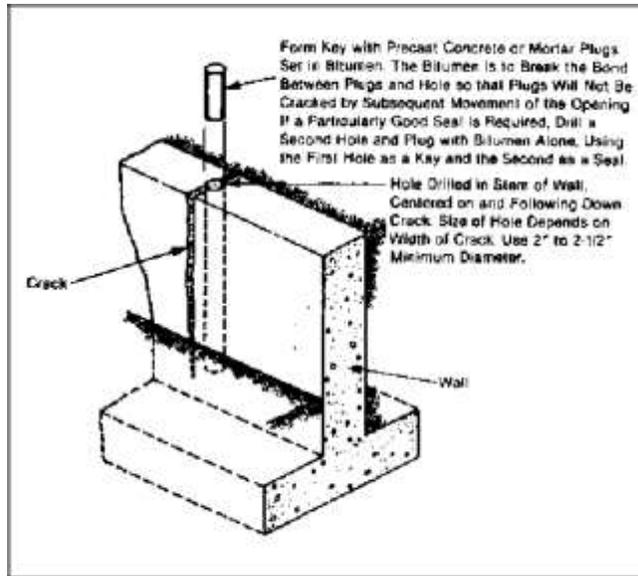
Figure 6-5. Repair of crack by drilling and plugging

a. *Description.* Drilling and plugging a crack consists of drilling down the length of the crack and grouting it to form a key (Figure 6-5).

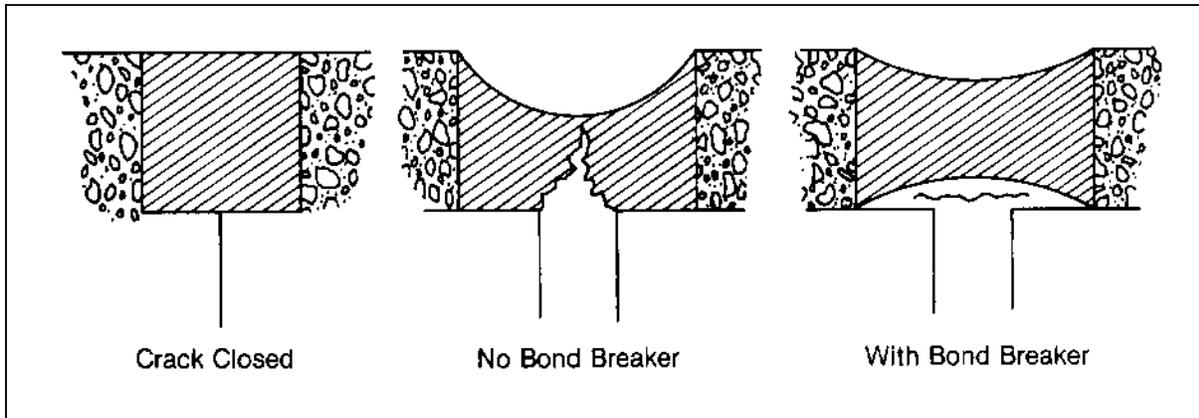
Figure 6-6. Effect of bond breaker involving a field-molded flexible sealant

(1) A bond breaker should be provided at the bottom of the slot to allow the sealant to change shape without a concentration of stress on the bottom (Figure 6-6). The bond breaker may be a polyethylene strip, pressure sensitive tape, or other material which will not bond to the sealant before or during cure.

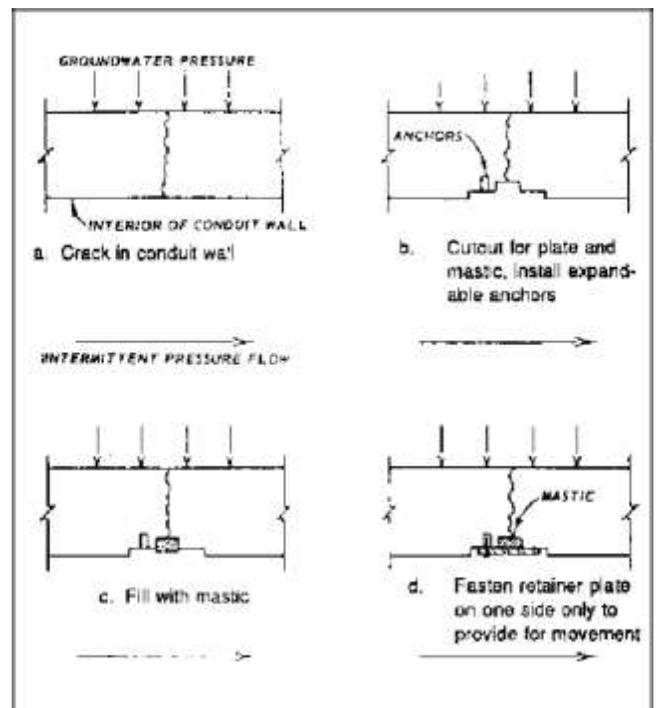
Figure 6-8. Repair of crack by use of a retainer plate to hold mastic in place against external pressure

necessary to cut the concrete surface adjacent to the crack and to place the retaining cap flush with the original flow lines (Figure 6-8).

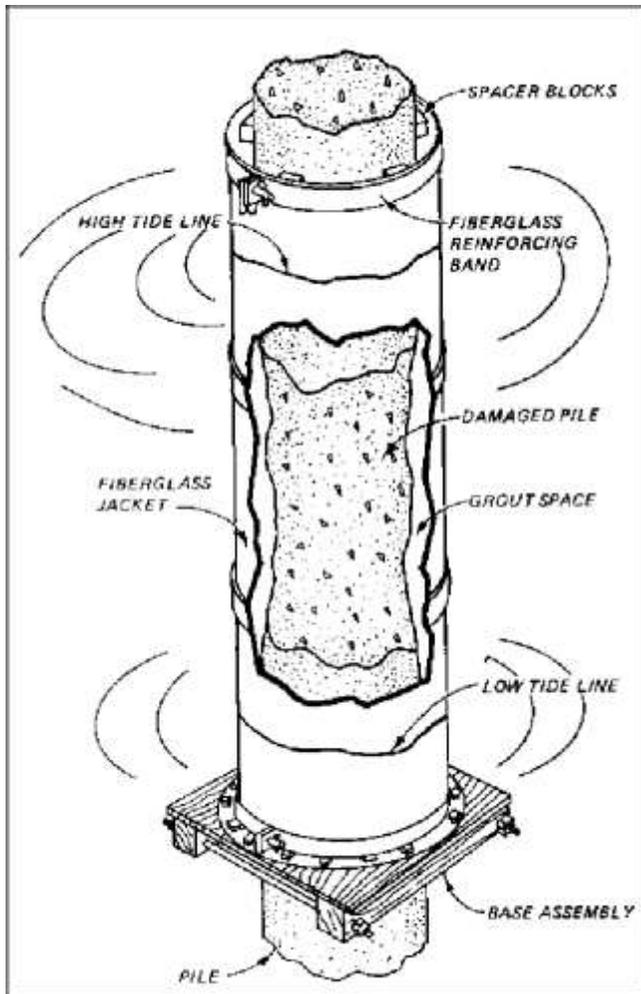
Figure 6-9. Typical preformed fiberglass jacket being used in repair of a concrete pile

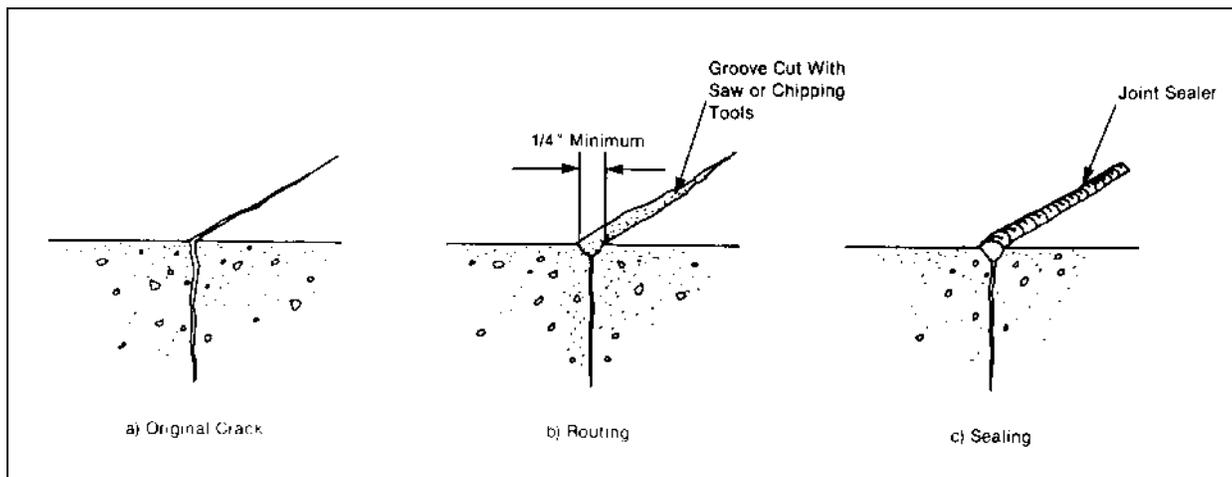
Figure 6-10. Repair of crack by routing and sealing

a. Description. This method involves enlarging the crack along its exposed face and filling and sealing it with a suitable material (Figure 6-10). The routing operation may be omitted but at some sacrifice in the permanence of the repair. This is the simplest and most common method for sealing dormant cracks.

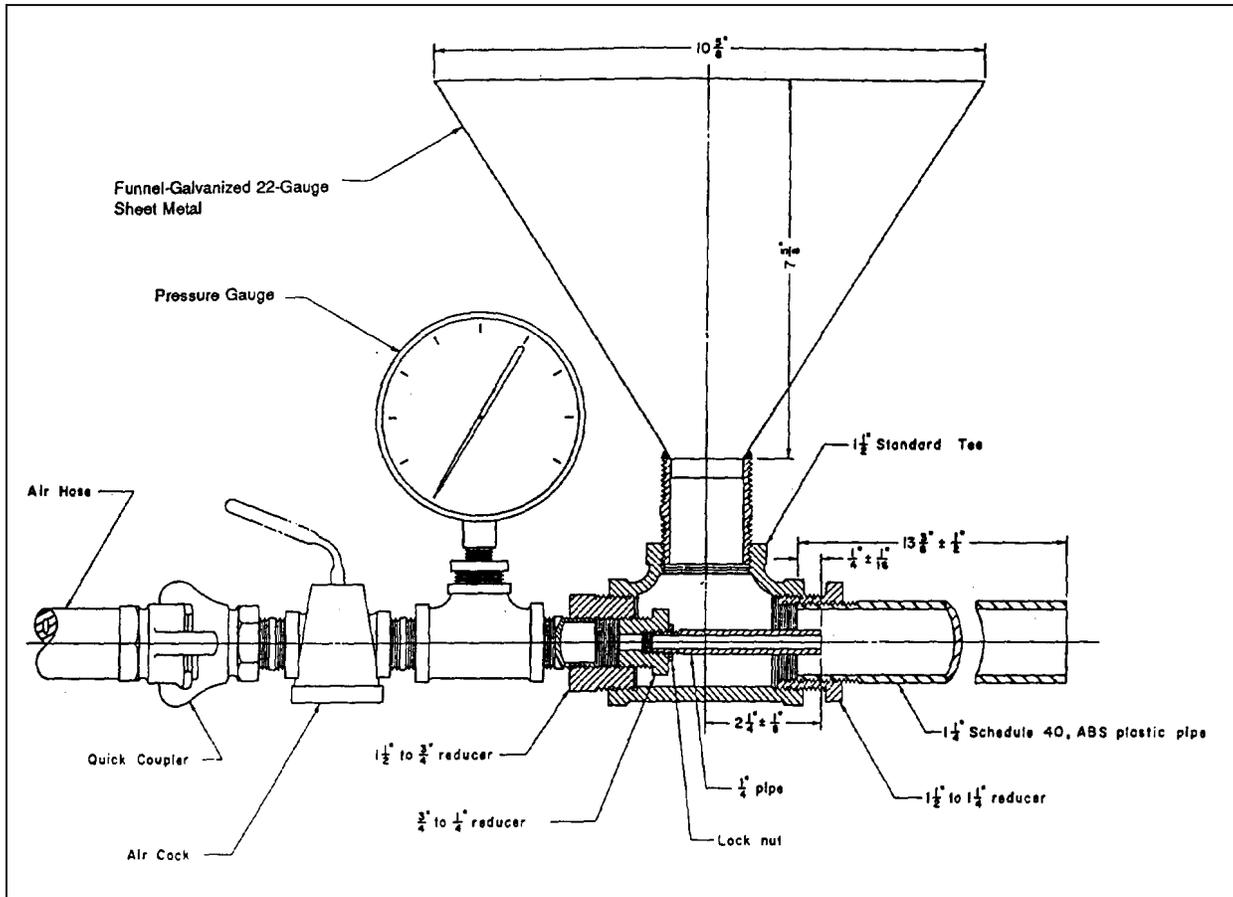
Figure 6-11. Mortar gun for concrete repair (U.S. Army Engineer Division, Missouri River 1974)

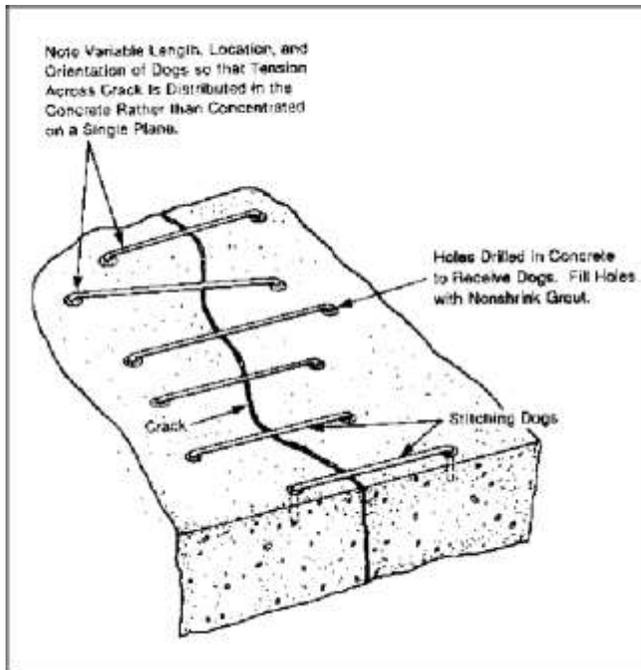
Figure 6-13. Repair of a crack by stitching

b. Applications and limitations. Stitching may be used when tensile strength must be reestablished across major cracks. Stitching a crack tends to stiffen the structure, and the stiffening may accentuate the overall structural restraint, causing the concrete to crack elsewhere. Therefore, it may be necessary to strengthen the adjacent

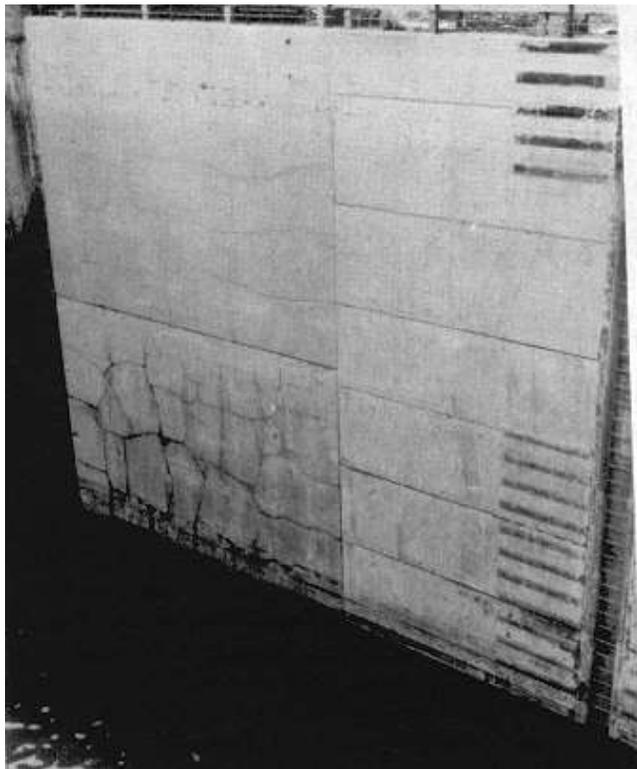
Figure 8-3. Concrete cracking in resurfaced monolith (left) compared to reconstructed monolith, Lock No. 1, Mississippi River

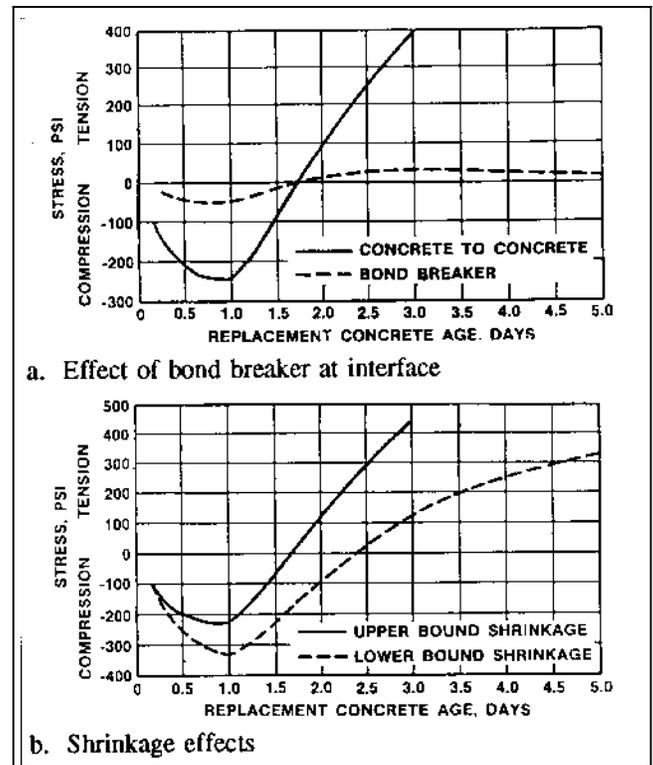
Figure 8-4. Results of a finite element analysis of a typical lock wall resurfacing

(a) A finite element analysis of a typical lock wall resurfacing (Norman, Campbell, and Garner 1988) also demonstrated the effect of restraint by the existing concrete. Under normal conditions of good bond between the two concretes, stress levels sufficient to cause cracking in the replacement concrete developed within about 3 days (Figure 8-4a). In comparison, a bond breaker at the interface resulted in almost no stress in the replacement concrete. The analysis also indicated that shrinkage was a significant factor (Figure 8-4b). Even the lower bound shrinkage resulted in tensile stresses in excess of 2.1 MPa (300 psi).

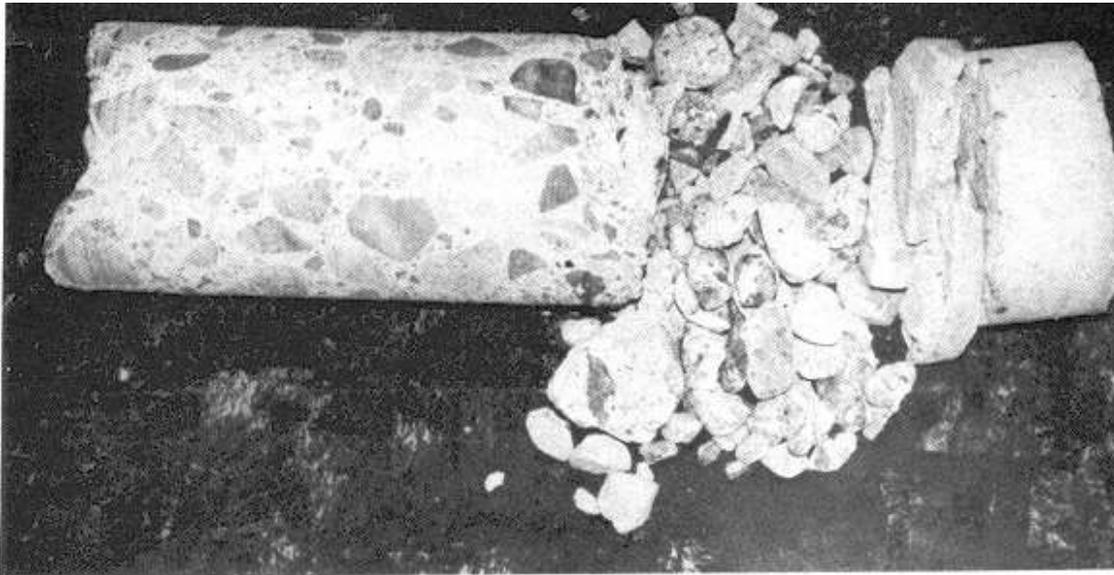
a. Concrete deterioration immediately behind shotcrete overlay

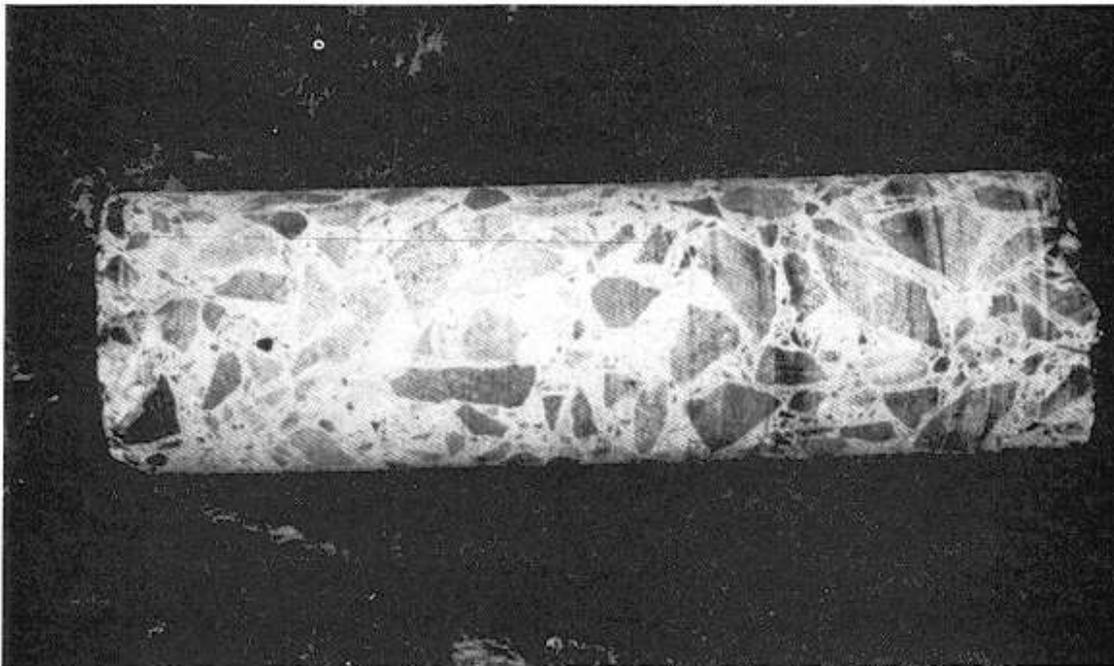
b. Concrete not refaced with shotcrete

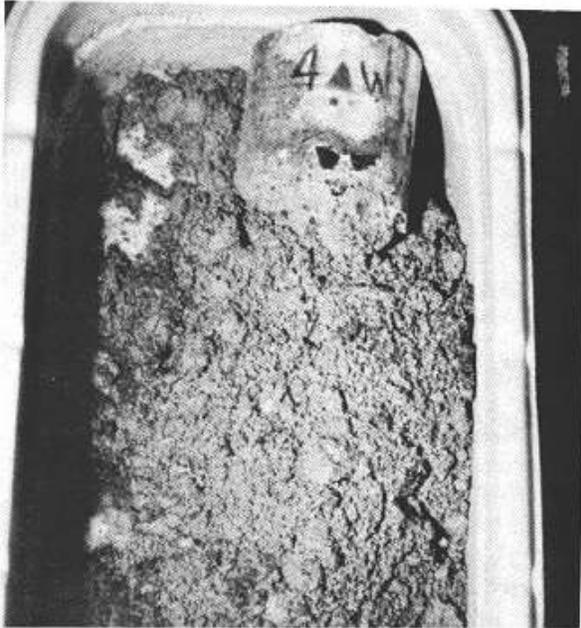
b. After freezing and thawing

Figure 8-8. Combination shotcrete and concrete core before and after 35 cycles of freezing and thawing in a saturated condition
