Evaluation and Repair of Concrete Structures

CECW-EG Engineer Manual 1110-2-2002	Department of the Army U.S. Army Corps of Engineers Washington, DC 20314-1000	EM 1110-2-2002 30 June 1995
	Engineering and Design EVALUATION AND REPAIR OF CONCRETE STRUCTURES	
	Distribution Restriction Statement Approved for public release; distribution is unlimited.

Engineering and Design
EVALUATION AND REPAIR OF CONCRETE STRUCTURES

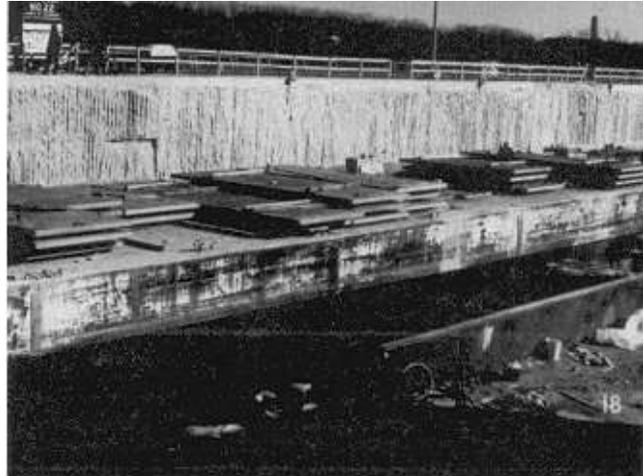
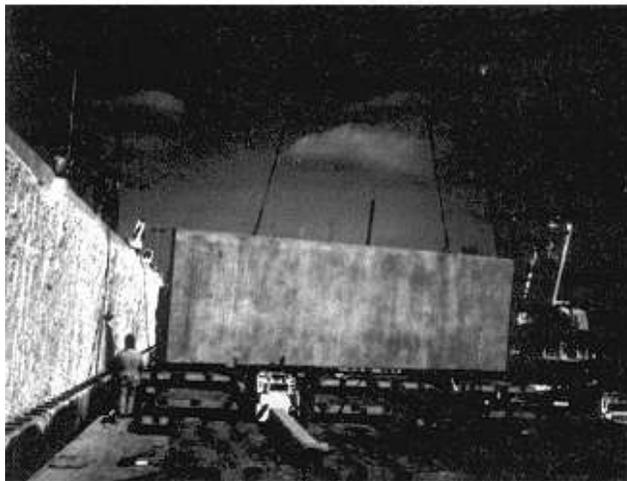
Figure 8-14. Installation of precast concrete stay-in-place forms at Lock 22, Mississippi River

(d) This application of the precast concrete stay-in-place forming system demonstrated the potential for eliminating the need to close and dewater a lock during rehabilitation. Consequently, concepts for installation of the system in an operational lock were developed as part of the REMR research program (ABAM 1989). A mobile cofferdam was selected as the preferred installation method and a final design completed for this concept. This study indicated that it is feasible to repair the walls in an operational lock with only minimal impact on costs.

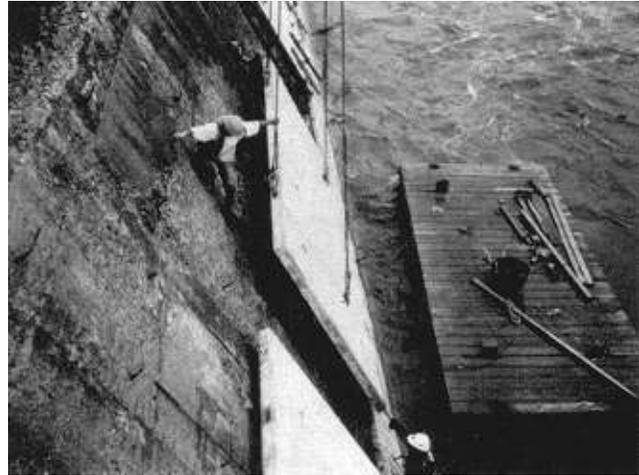
Figure 8-17. Installing precast concrete panels used to overlay the back side of the river wall at Troy Lock, Hudson River (Miles 1993)

(k) In addition to resurfacing the lock chamber, precast concrete panels were used to overlay the back side of the river wall at Troy Lock (Figure 8-17). Original plans for repair of this area required extensive removal of deteriorated concrete and replacement with shotcrete. This repair, which would have had to be accomplished in the dry, would have required construction of an expensive cofferdam to dewater the area. Therefore, it was decided that concrete removal could be minimized and the need for a cofferdam eliminated if this area was repaired with precast concrete panels. Three rows of precast panels were used in the overlay. The panels were installed in 1992 while the lock was in operation. The bottom row of panels was partially submerged during installation and

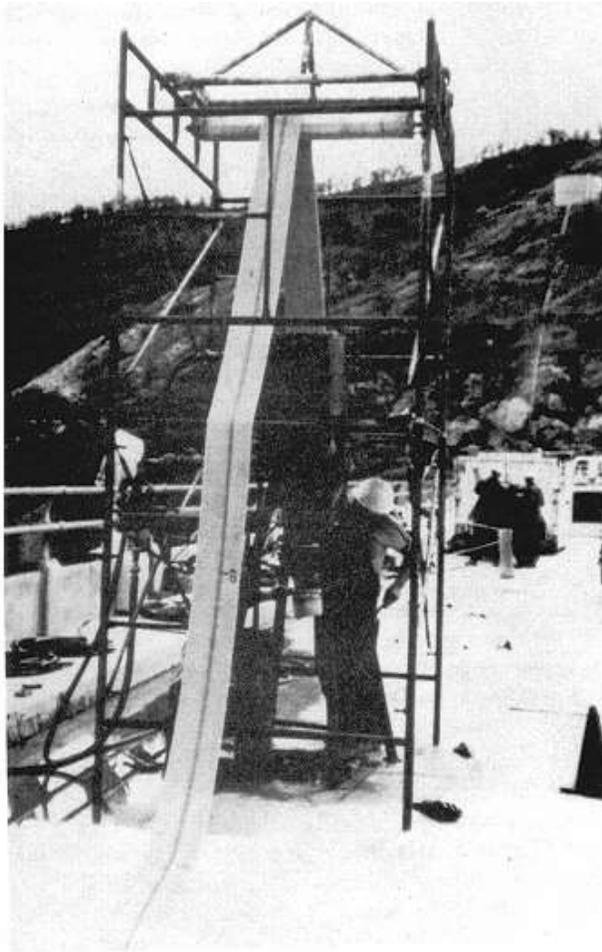
Figure 8-24. Inversion apparatus for installing tube in drill hole, Pine Flat Dam

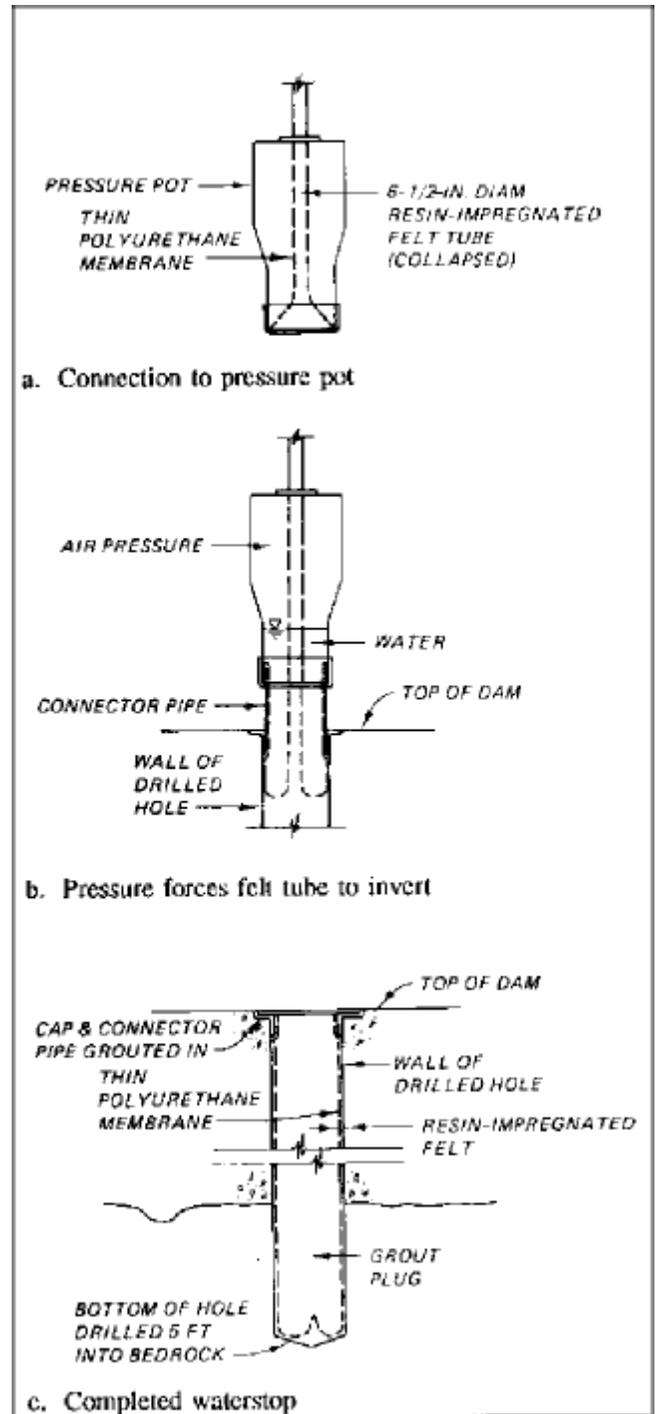
Figure 8-25. Remedial waterstop installation, Pine Flat Dam

(1) Interior joints. The repair procedure consists of drilling an array of small-diameter holes from various locations within the gallery or conduit to intercept the

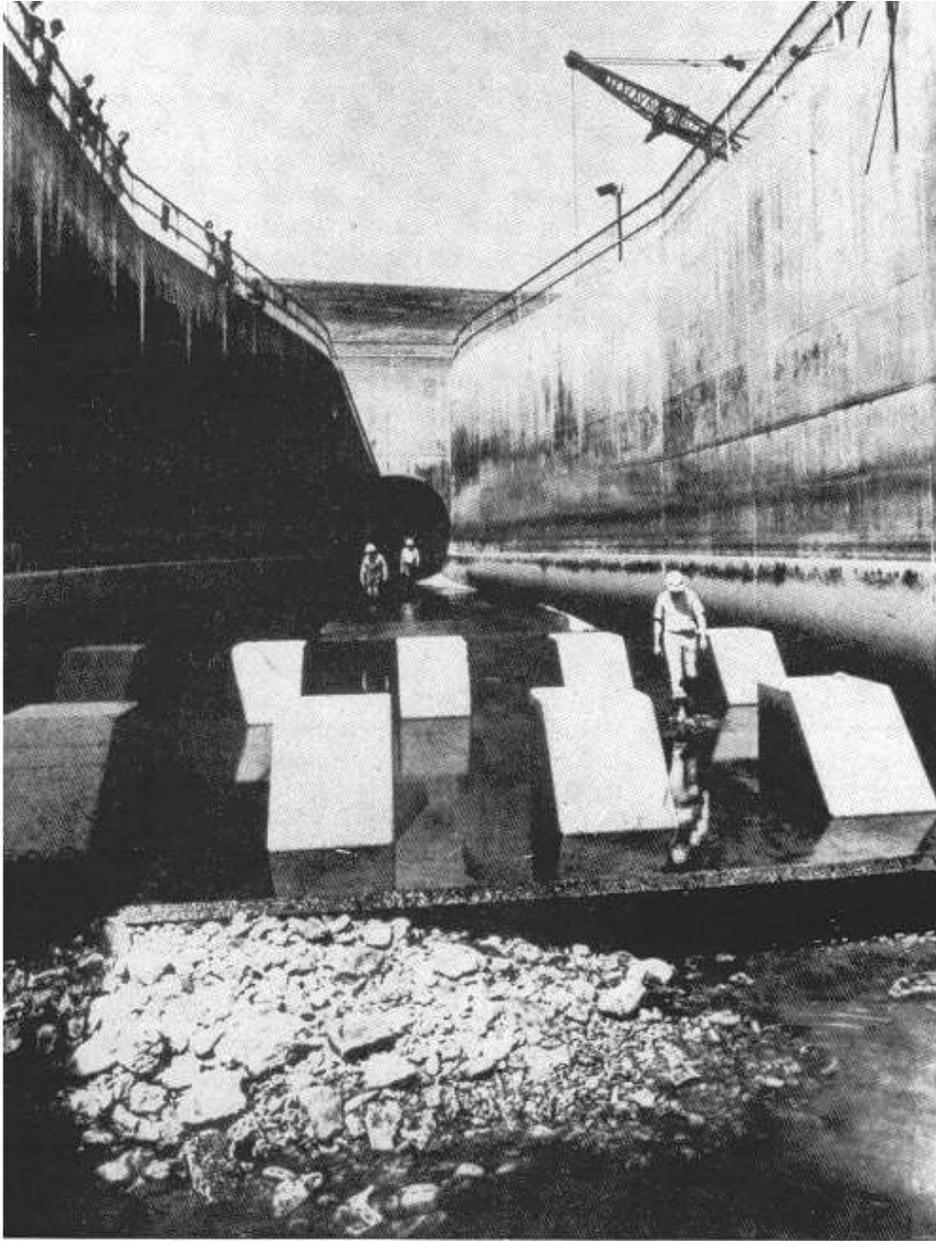
Figure 8-30. Stilling basin dewatered for inspection, Pomona Dam

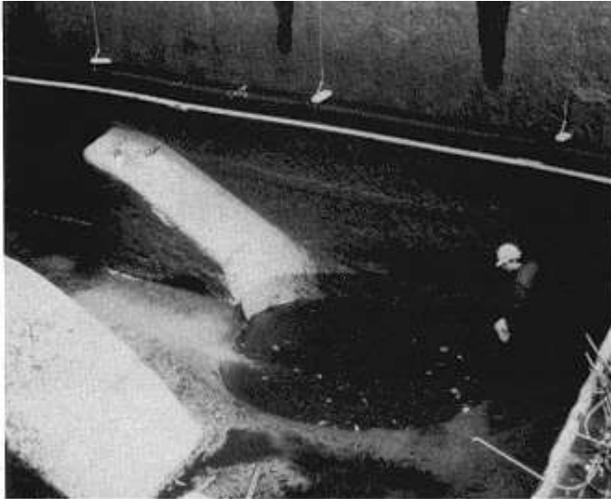
a. Scour holes behind baffles

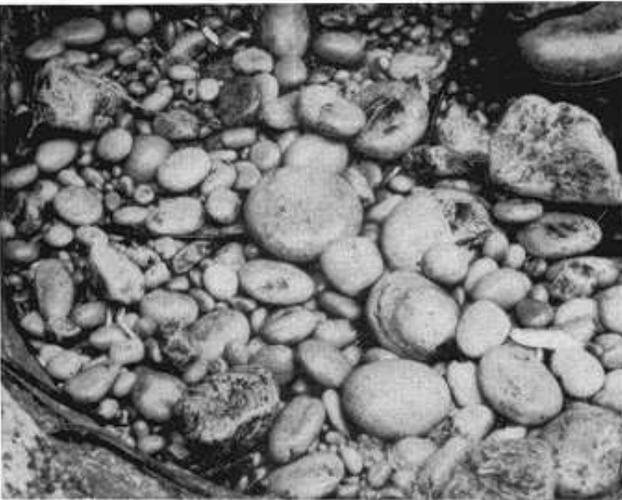
b. Debris in scour holes

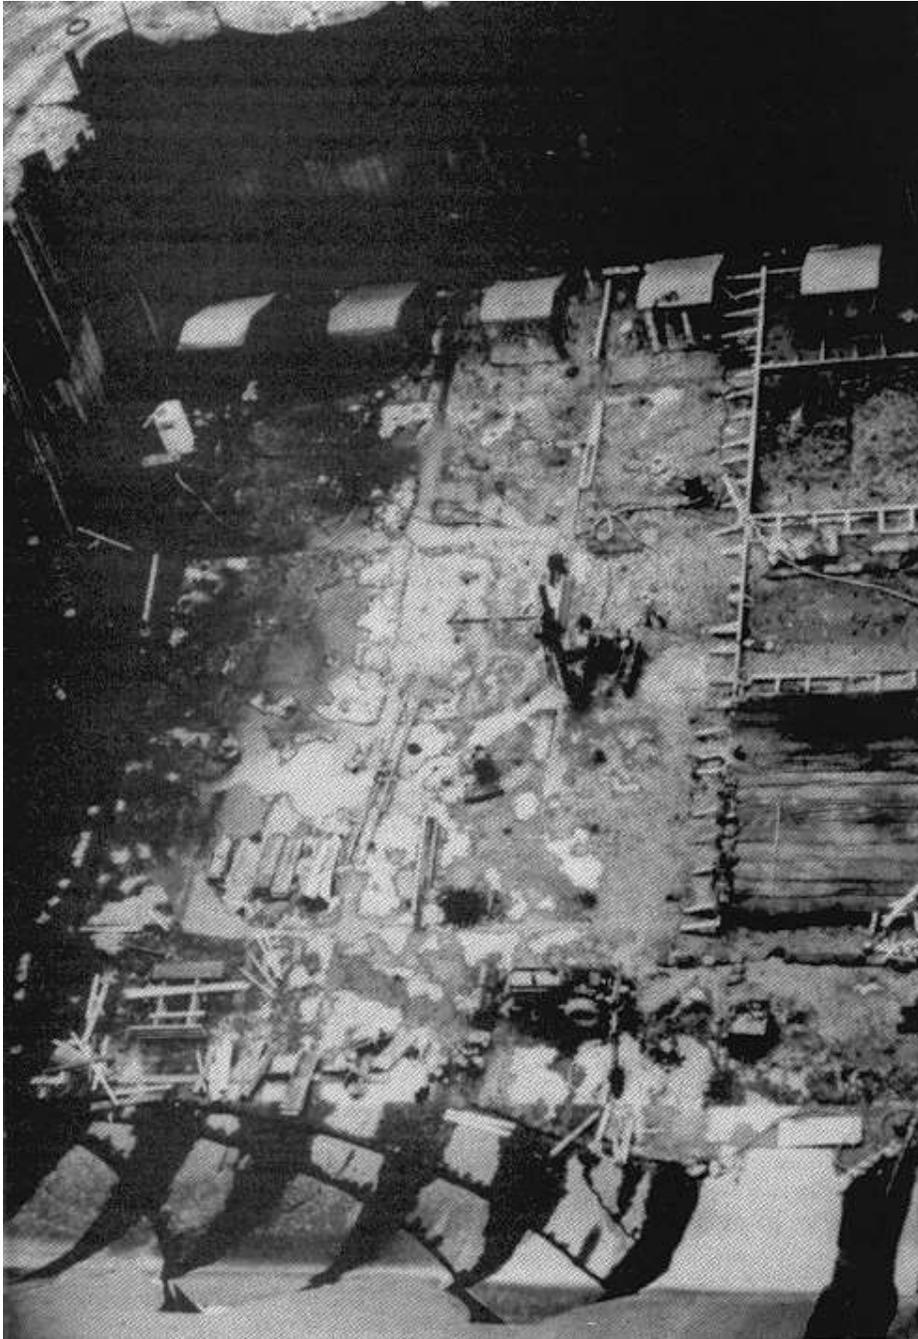
Figure 8-34. General view of repair operations, Kinzua Dam, 1974

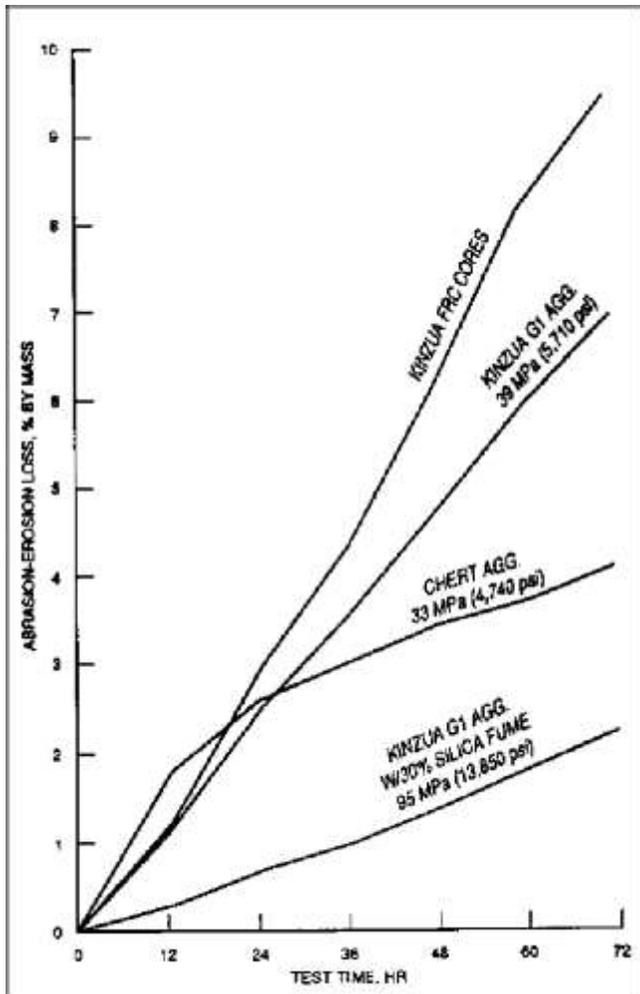
Figure 8-35. Results of selected abrasion-erosion tests, Kinzua Dam

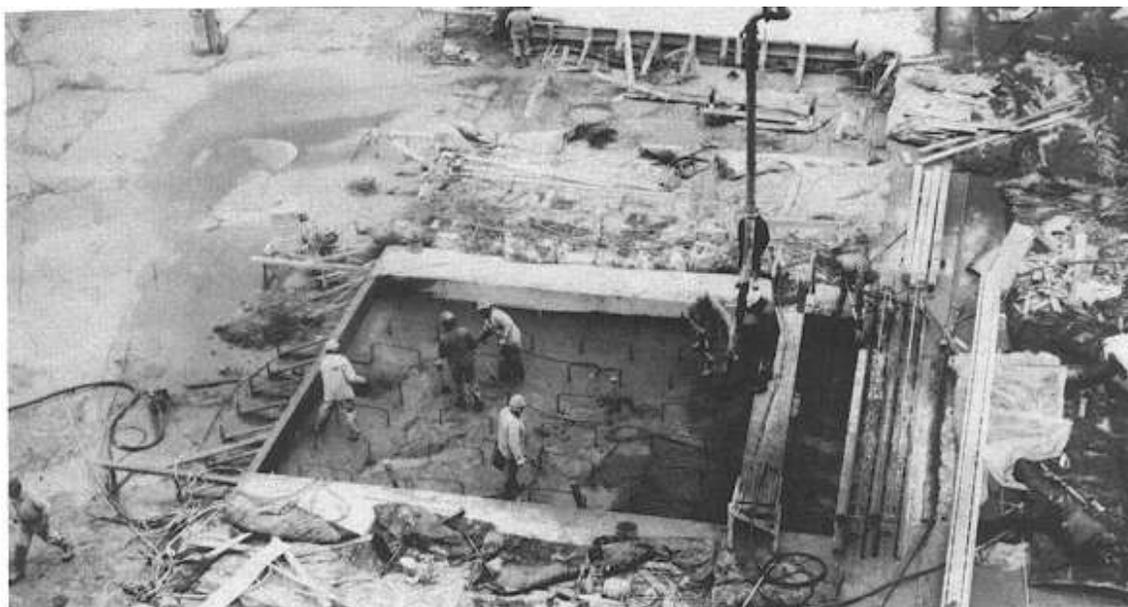
Figure 8-36. Pumping silica-fume concrete into the stilling basin from the top of the right training wall, Kinzua Dam

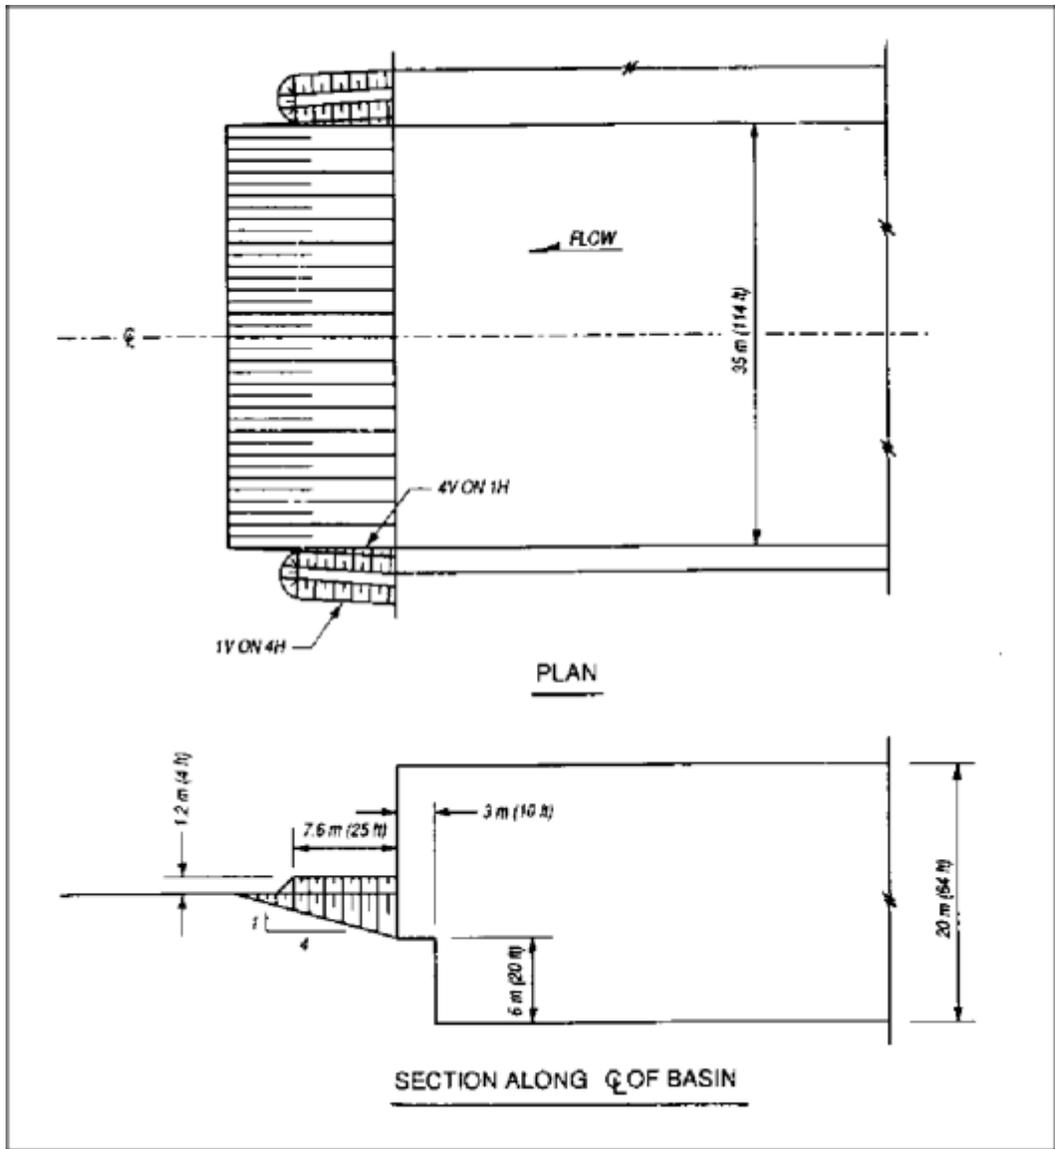
Figure 8-37. Stilling basin wall extension fills, Dworshak Dam

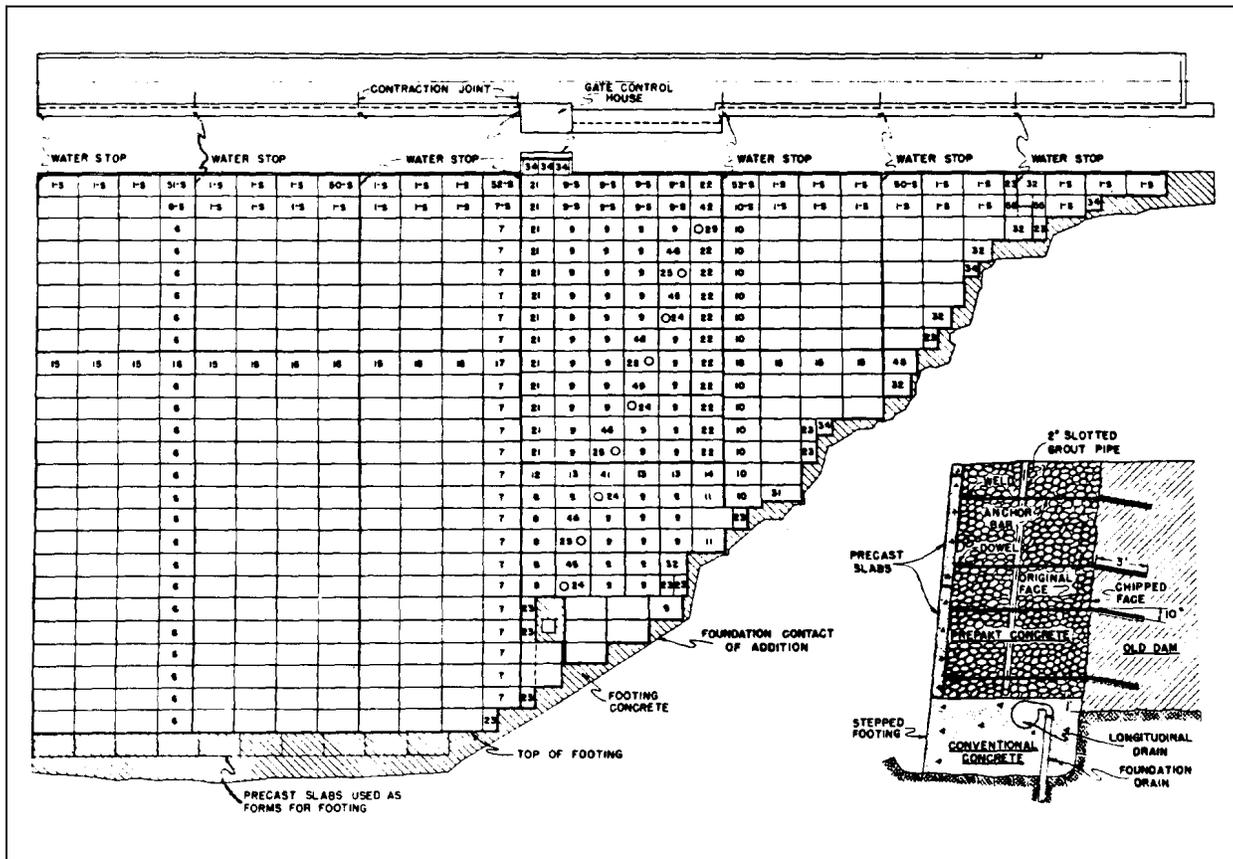
Figure 8-38. Footing and slab layout, south half of Barker Dam (from Davis, Jansen, and Neelands 1948)

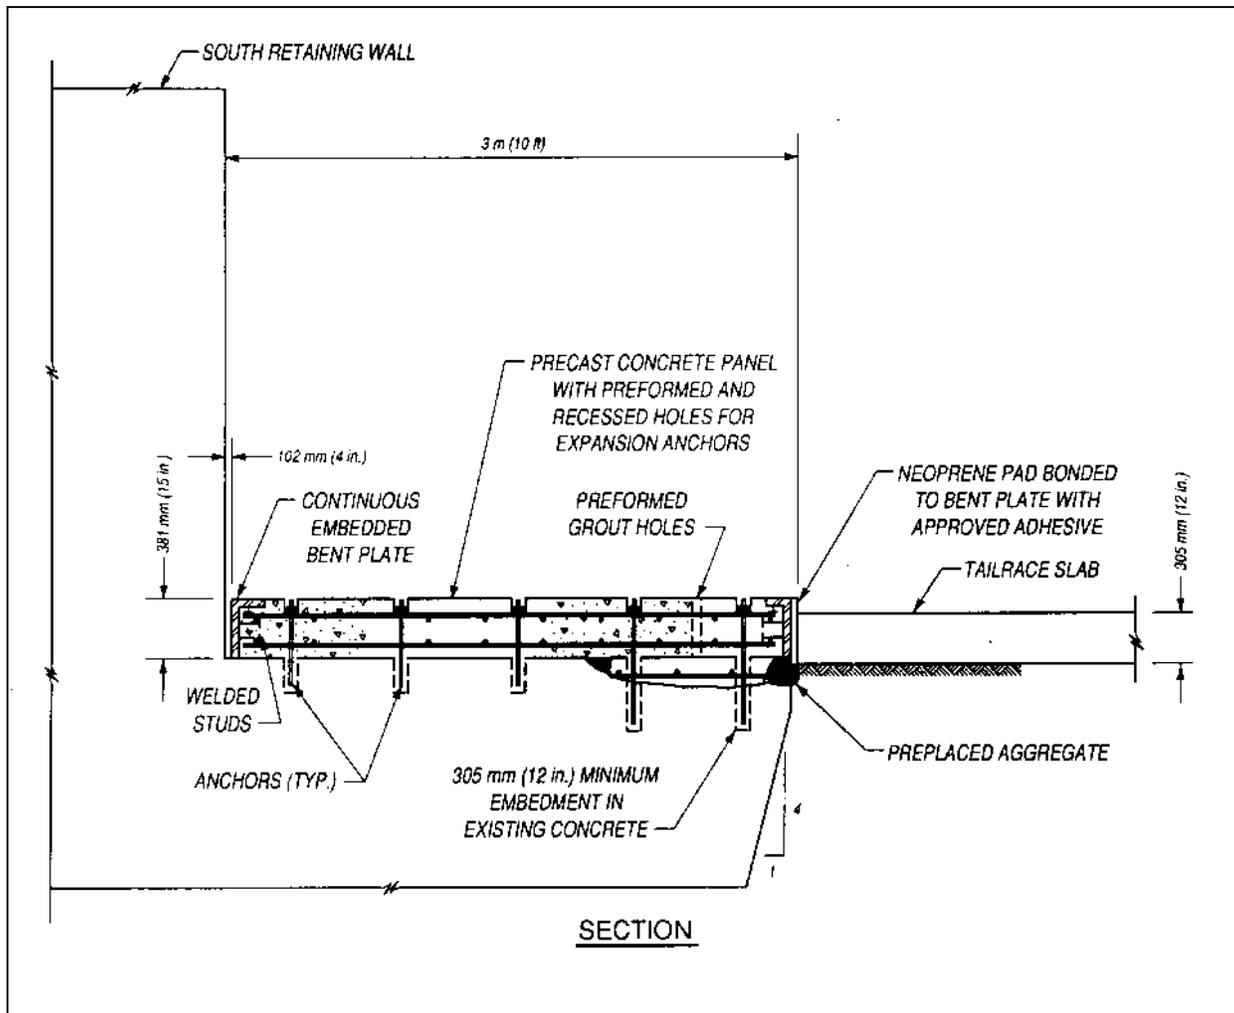
Figure 8-39. Underwater repair of concrete spalling, Gavins Point Dam

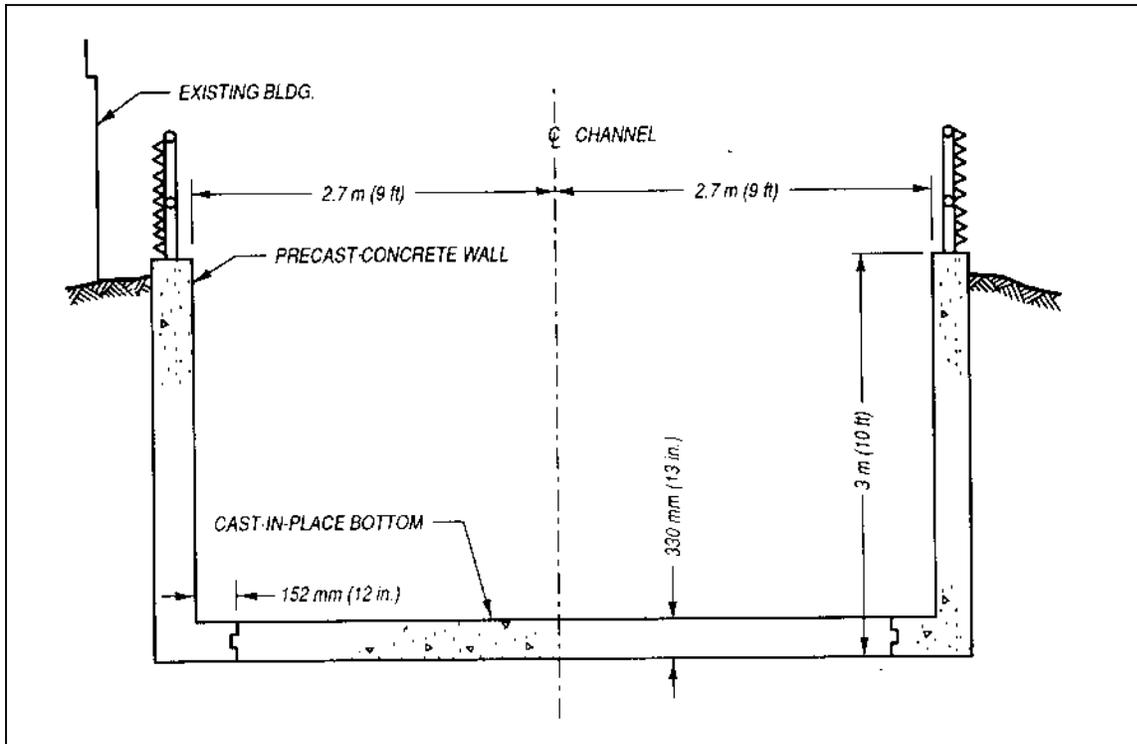
Figure 8-45. Typical channel repair section, Placer Creek (after Hacker 1986)

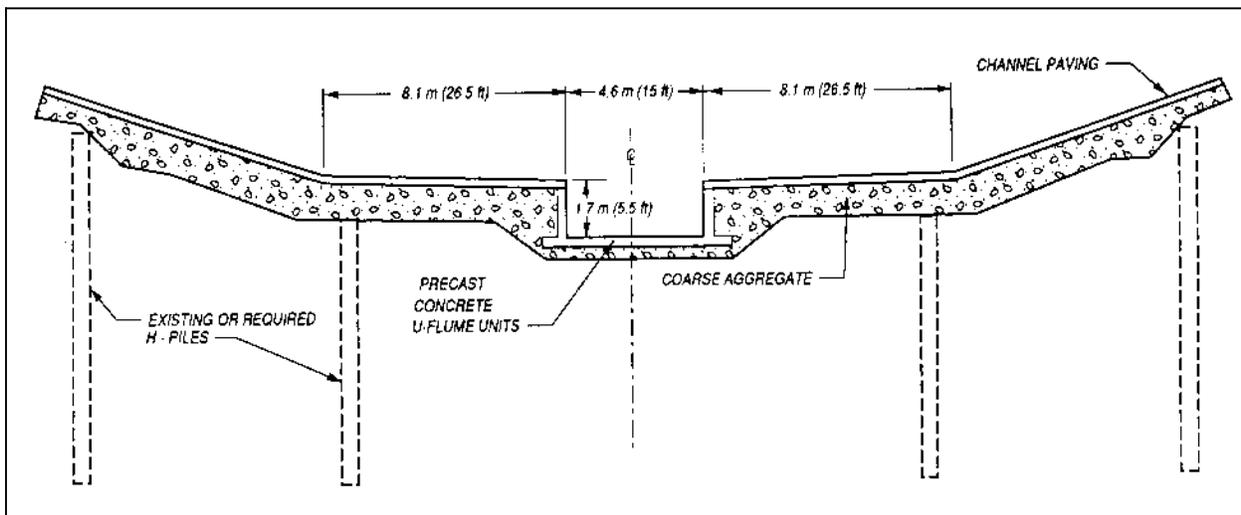
Figure 8-46. Cross section of precast low-flow channel, Blue River Channel (after Mitscher 1992)

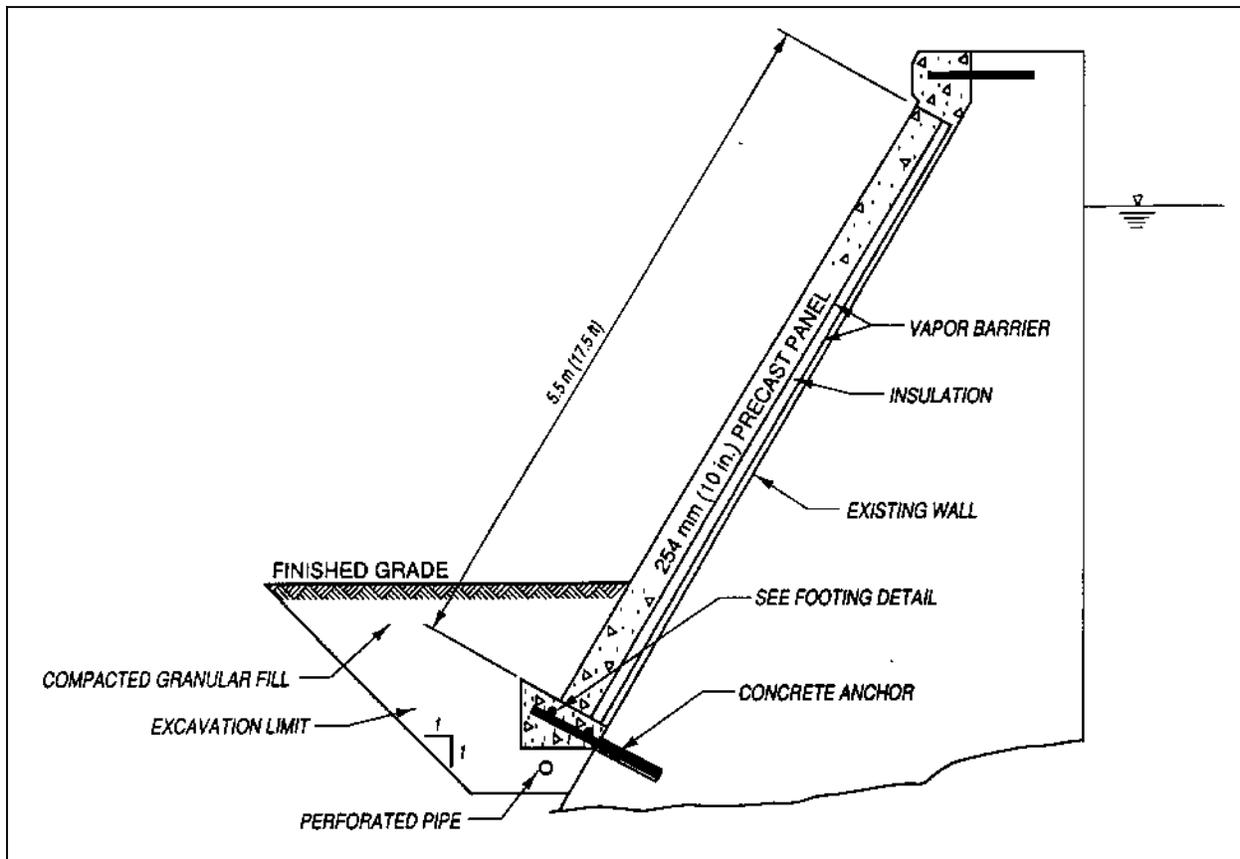
Figure 8-49. Typical repair section, Joliet Channel Wall

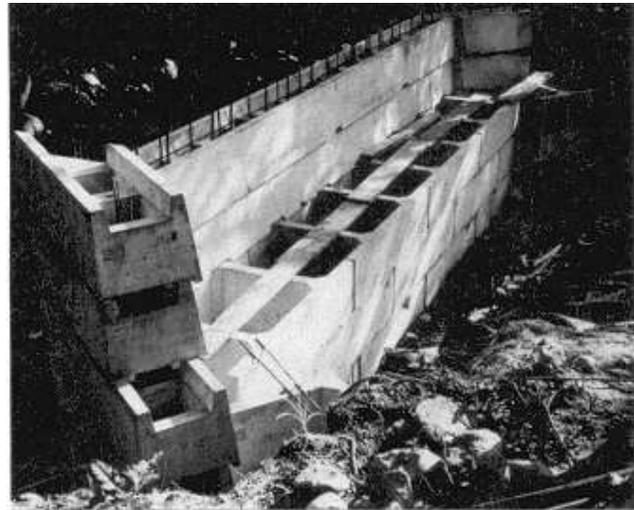
Figure 8-51. Top view of precast abutment prior to backfilling, Ulsterville Bridge

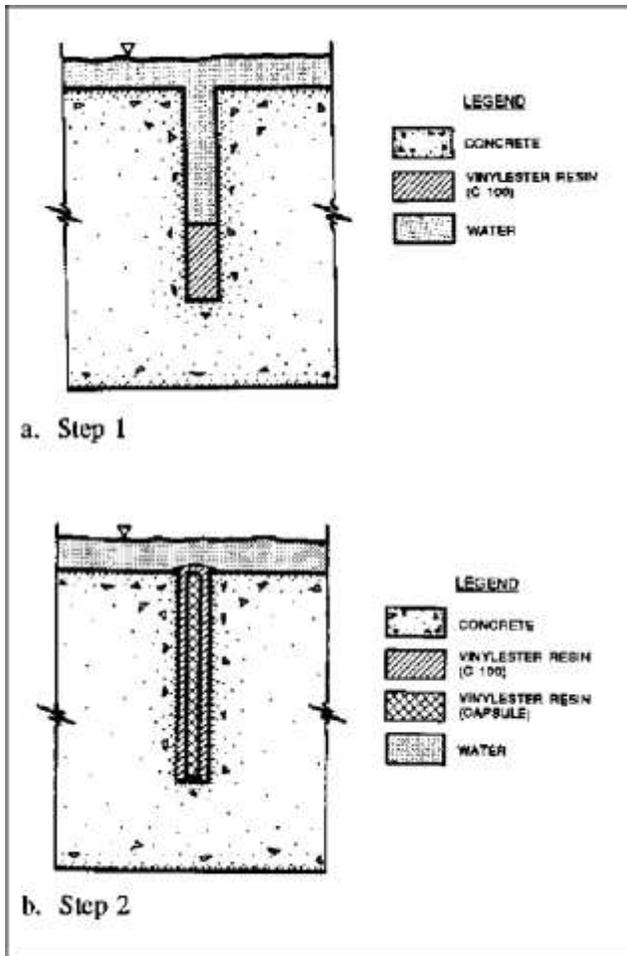
Figure 8-56. Two-step procedure for anchor installation under submerged conditions

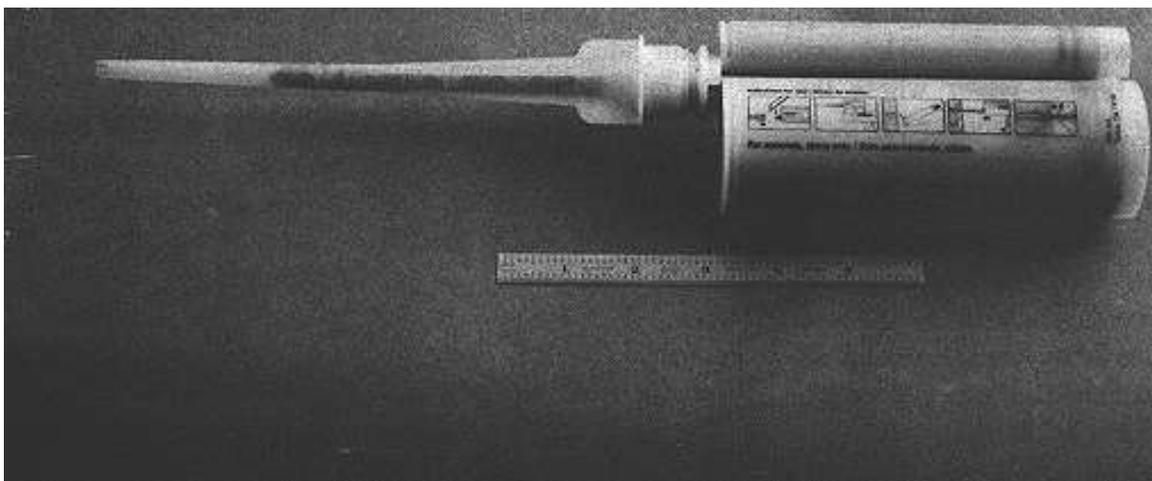
Figure 8-57. Paired disposable cartridges and static mixing tube

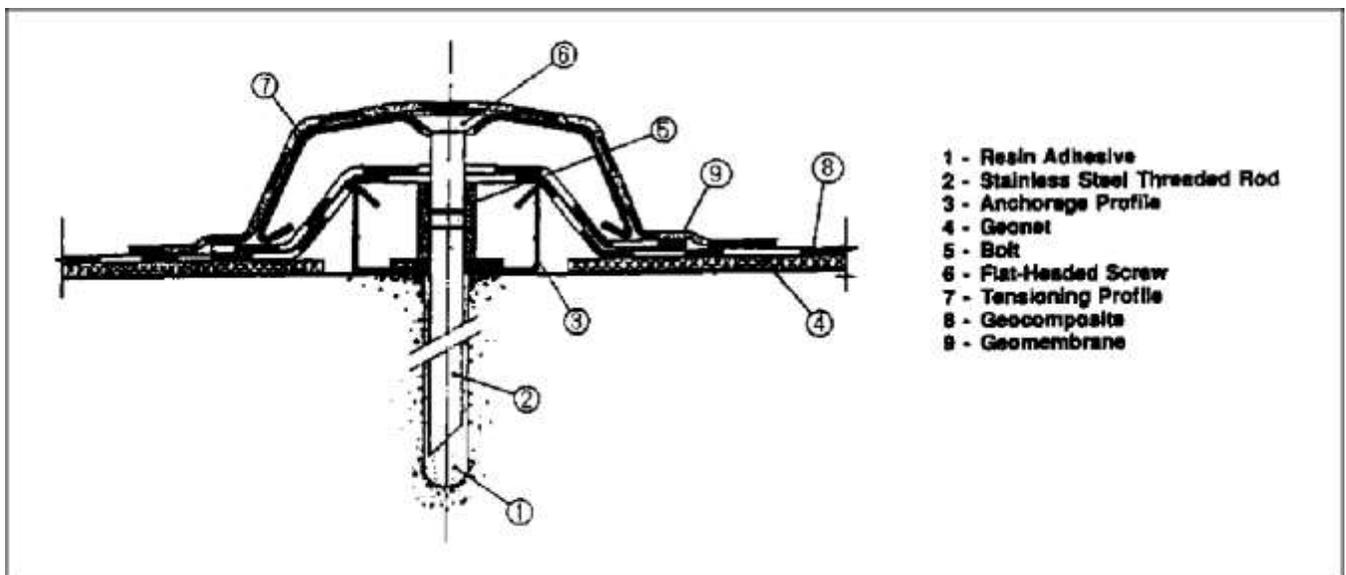
Figure 8-58. Detail of vertical anchorage and drainage profile

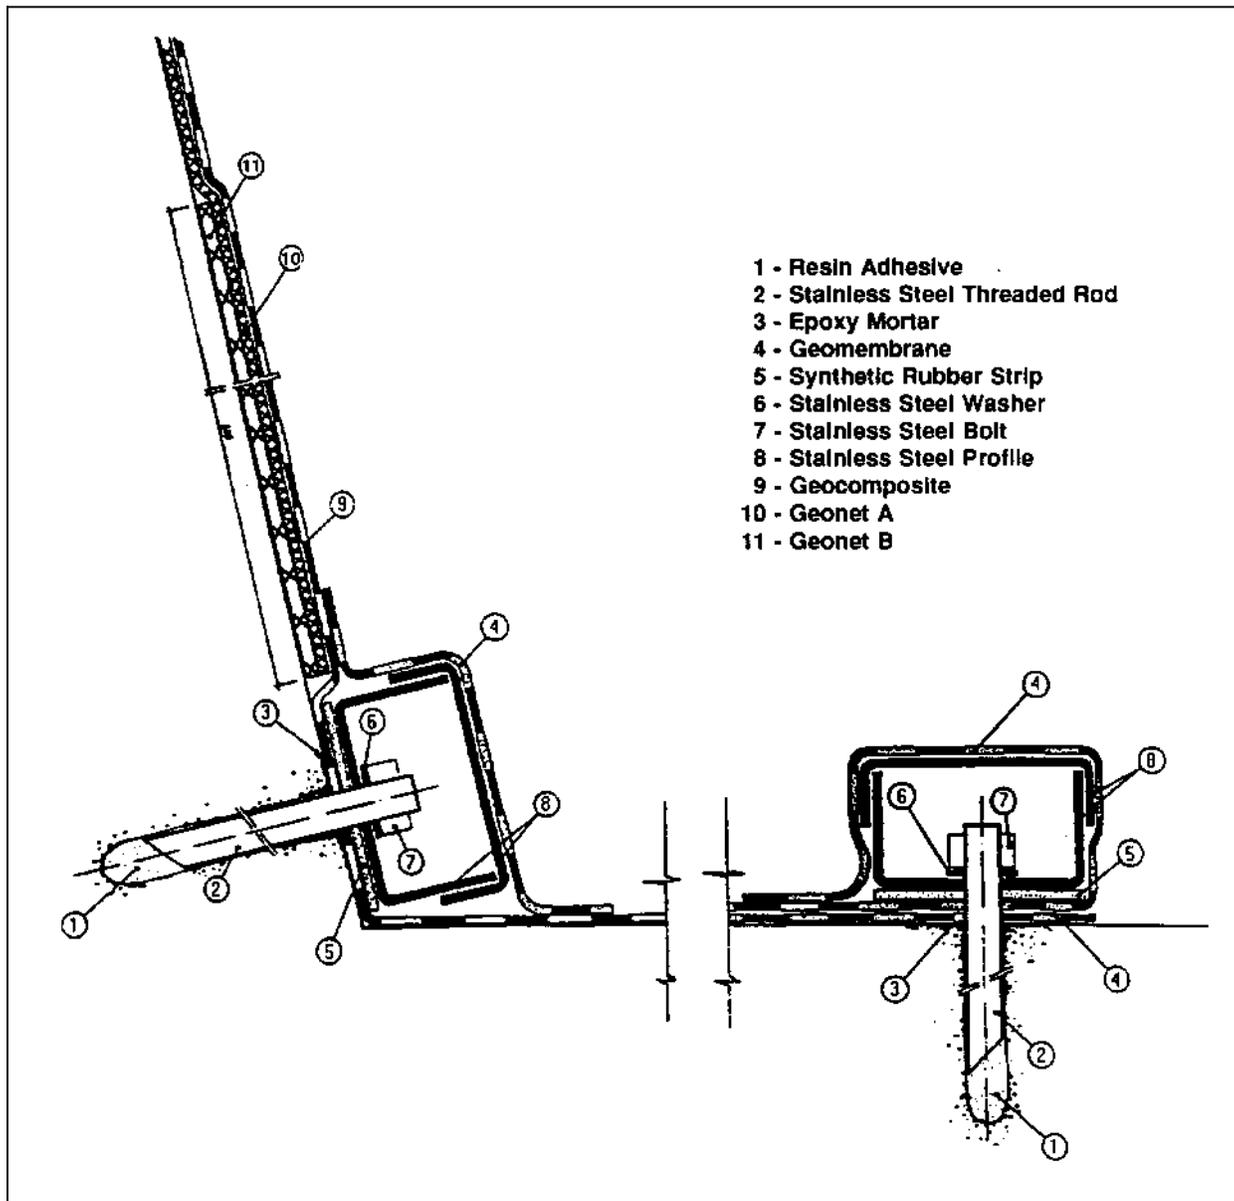
Figure 8-59. Detail of sealing profiles

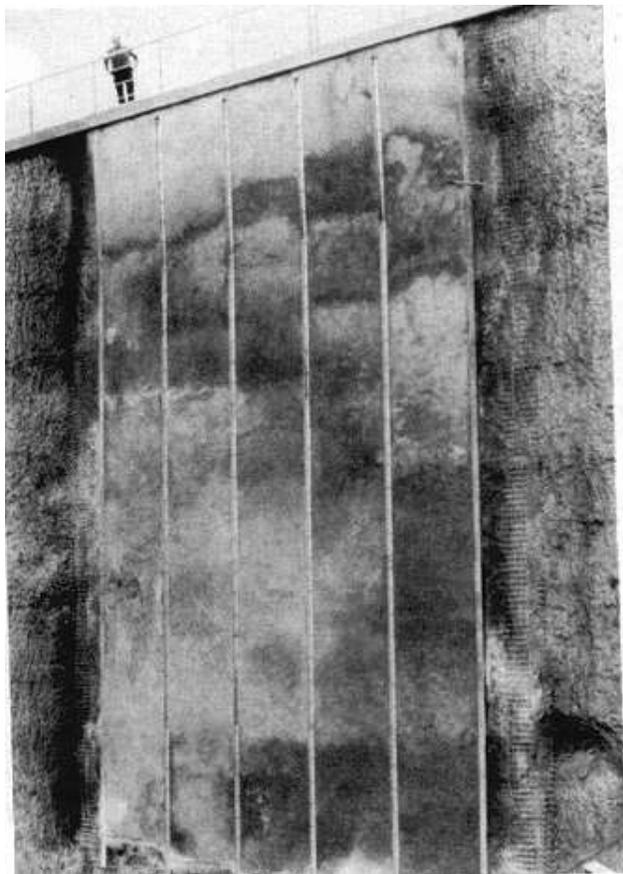
Figure 8-61. Steel profiles embedded in shotcrete, Cignana Dam

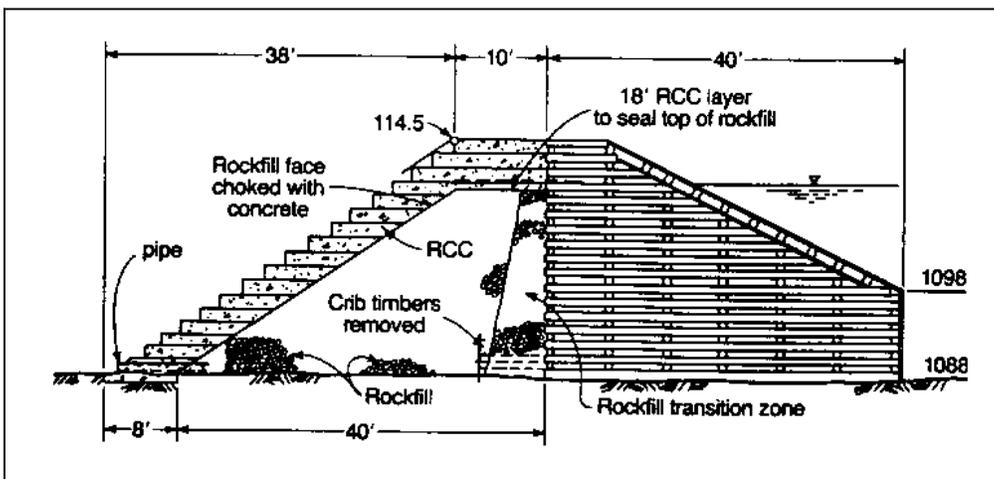
Figure 8-63. Section through modified dam, Ocoee Dam No. 2 (Hansen 1989)

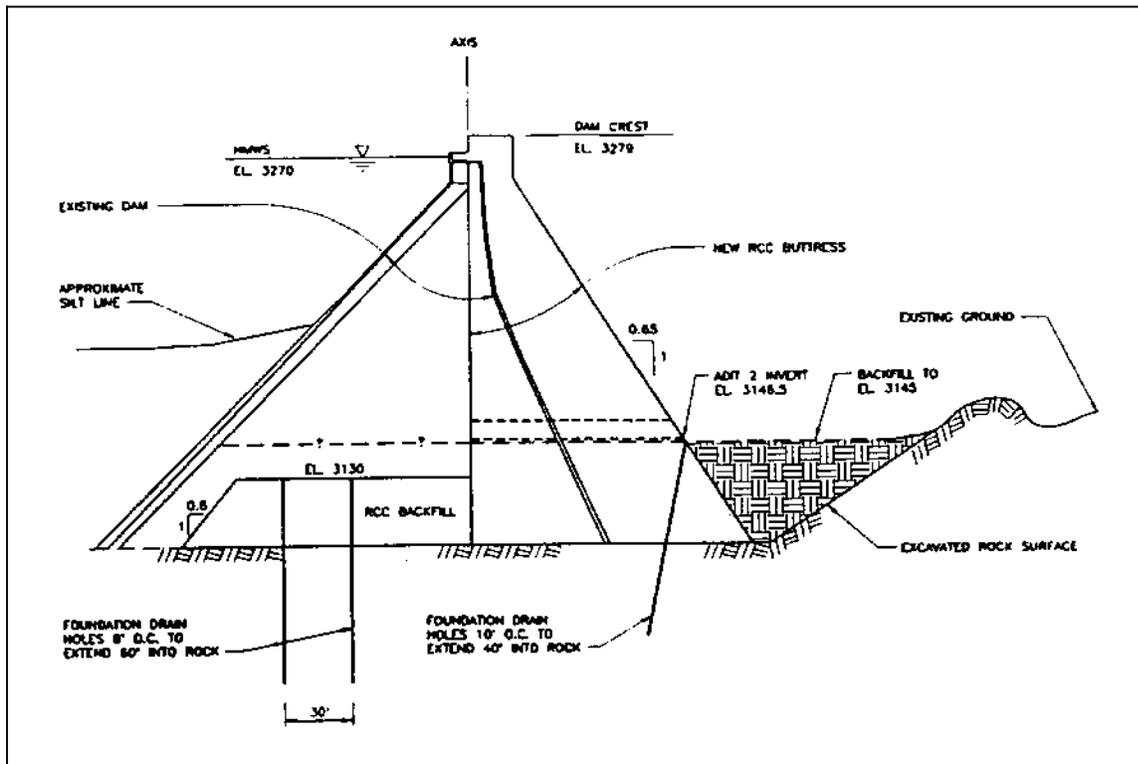
Figure 8-70. Littlerock Dam modification (Bischoff and Obermeyer 1993)
